OPERATING EXPERIENCE SUMMARY

**U.S. Department of Energy
Office of Environment, Safety and Health**

OE Summary 2003-24

December 1, 2003

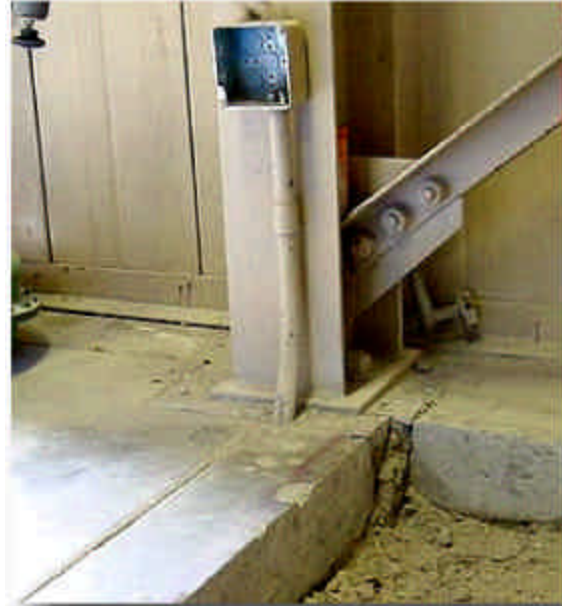
A survey crew, assigned to perform utility locates for the slab removal work, identified the wall-mounted receptacle and believed the conduit entered the floor and ran parallel to the cut line and an expansion joint (Figure 1-1). However, the conduit entered the floor and immediately angled toward the cut area (Figure 1-2).

Ground penetrating radar surveys did not determine the change in direction of the conduit because of interference from embedded steel reinforcement. The crew did not survey beyond the cut area, and drawings did not indicate the routing of the conduit. Based on the survey markings, supervisors concluded that the area was free of hidden electrical hazards and therefore de-energizing the nearby 120-volt circuit was deemed unnecessary. Survey crews need to consider that concealed utilities do not

Figure 1-1. Electrical receptacle and conduit penetrating the floor and the location of the saw cut

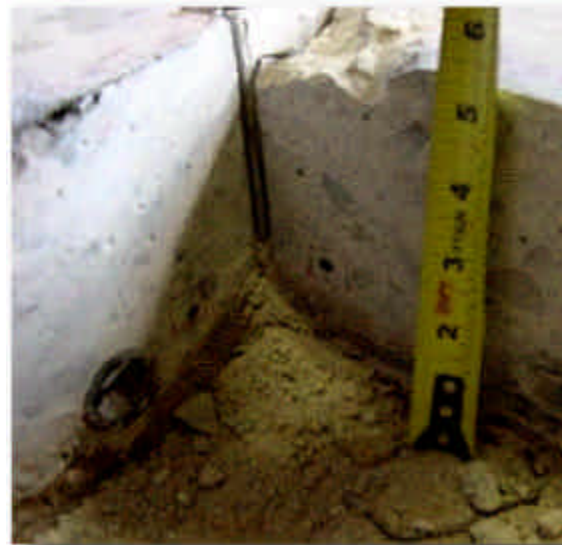
Figure 1-2. Cut conduit (left) crossing into corner of the cut area

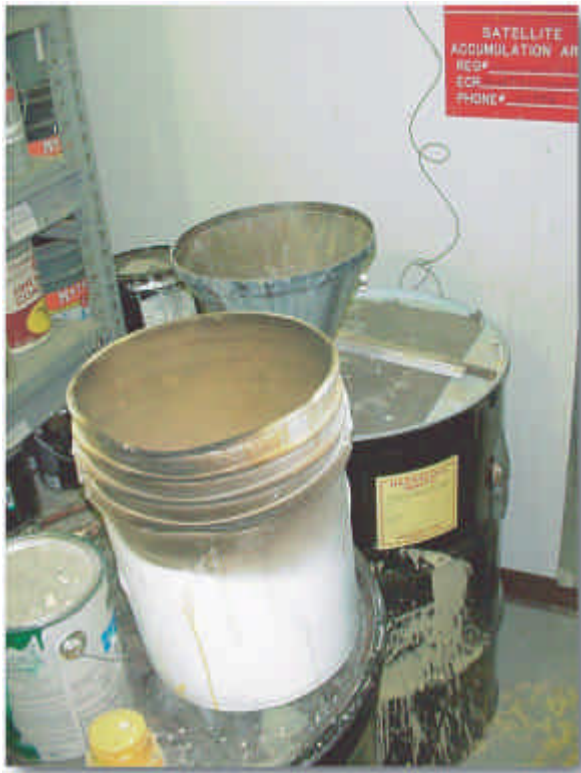
A similar event involving a fire that resulted from static discharge occurred on October 17, 2003, at Argonne National Laboratory–West. A journeyman painter was pouring used solvent from a 5-gallon plastic container through a metal funnel in the top of a 55-gallon drum being used temporarily to store used solvent (Figure 2-1). The painter used a nylon paintbrush to remove the solvent and paint residue, and a static discharge from the plastic bucket to the metal drum ignited the solvent vapors. The painter's gloves and brush caught fire, so the painter dropped the paintbrush, shook off the gloves (Figure 2-2), left the paint storage room, and actuated the nearest fire alarm. The painter and two co-workers

Figure 2-1. The solvent drum and plastic bucket involved in the fire

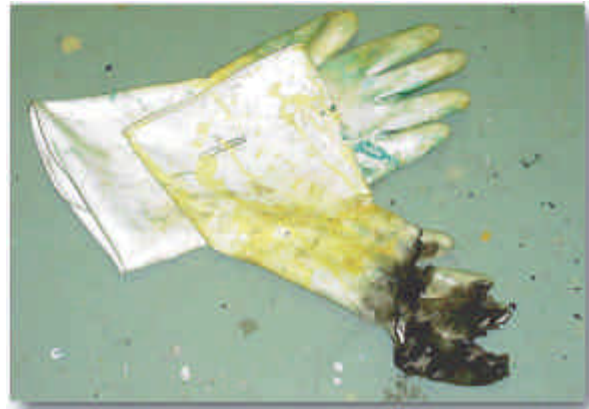
Figure 2-2. The burned gloves

doused the area with water. The painter suffered no physical injuries, but her hair was singed. (ORPS Report CH-AA-ANLW-ANLW-2003-0004)

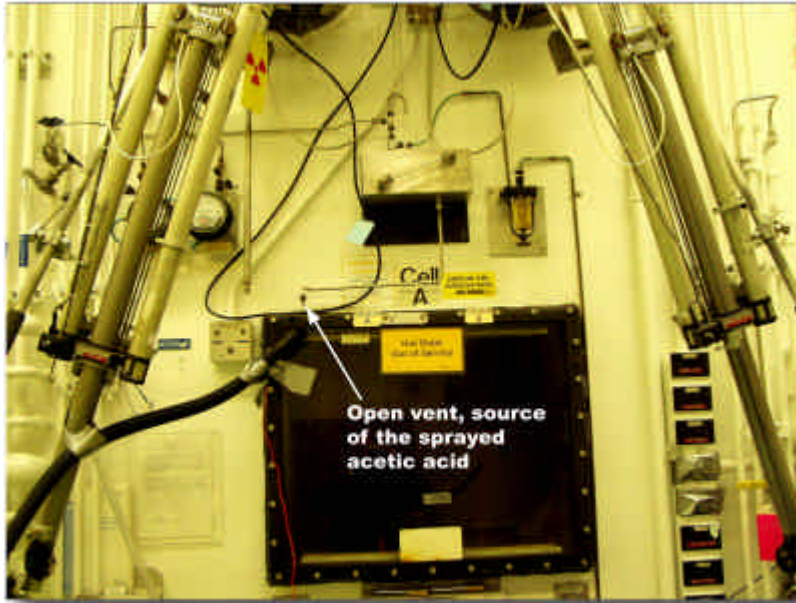
The hot cell window, an old (1960s) design, was being cleaned in place with chemicals instead of removing it from inside the cell (i.e., the “hot” side) to avoid substantial radiological exposures to the workers. The gaskets were deteriorating and leaking, requiring the window to be refilled with progressively heavier mineral oil to reduce leakage into the cell. The high-viscosity mineral oil was difficult to remove from the hot cell windows, and heavy oil and “festoons” (semisolid gel remnants) remained on the window even after the workers flushed it nine times with a cleaning solvent.

Workers had to remove the expansion tank vent line to protect the window against overpressurization, but the process safety summary prepared for this work did not address removing the tank vent. Removing the expansion tank vent also removed one barrier between the acid and the workers. When the liquid level in the window reached the open vent (see Figure 3-1), about 500 ml of acid sprayed out of the vent onto the workers.

Figure 3-1. The hot cell window and vent

occurrence. The leaking window gaskets required heavier mineral oil to be added to reduce leakage, which required the workers to use a more aggressive agitation source (pressurized argon gas) to clean the windows. Also, disconnecting the cell window expansion tank vent line led directly to the discharge of acetic acid into the workspace and onto the workers.

- Discontinue sparging with pressurized argon gas until the safety implications of the technique can be analyzed.
- Repair the leaking gaskets around the hot cell window so normal-weight mineral oil can be used.
- Evaluate new cleaning processes, agitation techniques, and different configurations during work planning.
- Identify and implement controls (e.g., lower liquid level in the window, contained venting capability, personal protective equipment) for sparging should it be used again.

- Use a finer metering valve for supplying argon gas to the liquid should sparging be used again.
