OPERATING EXPERIENCE SUMMARY

**U.S. Department of Energy
Office of Environment, Safety and Health**

OE Summary 2003-24

December 1, 2003

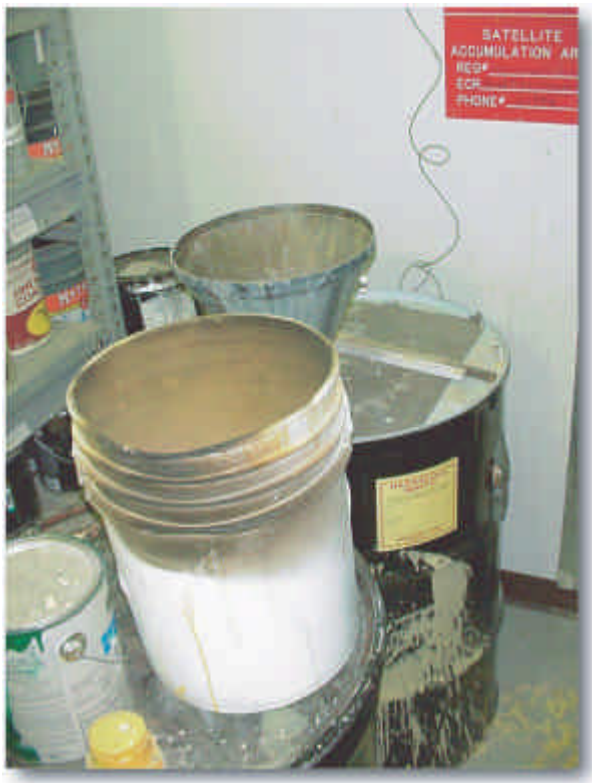
A similar event involving a fire that resulted from static discharge occurred on October 17, 2003, at Argonne National Laboratory–West. A journeyman painter was pouring used solvent from a 5-gallon plastic container through a metal funnel in the top of a 55-gallon drum being used temporarily to store used solvent (Figure 2-1). The painter used a nylon paintbrush to remove the solvent and paint residue, and a static discharge from the plastic bucket to the metal drum ignited the solvent vapors. The painter's gloves and brush caught fire, so the painter dropped the paintbrush, shook off the gloves (Figure 2-2), left the paint storage room, and actuated the nearest fire alarm. The painter and two co-workers

Figure 2-1. The solvent drum and plastic bucket involved in the fire

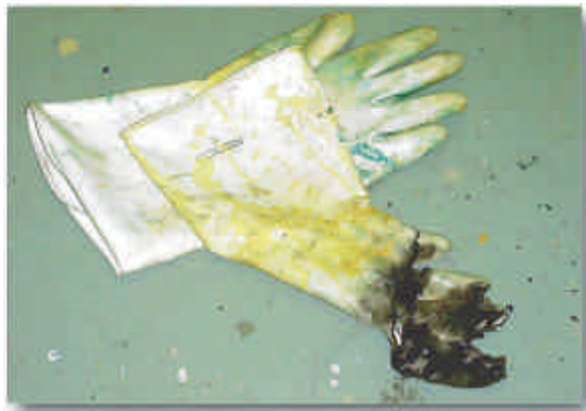
Figure 2-2. The burned gloves

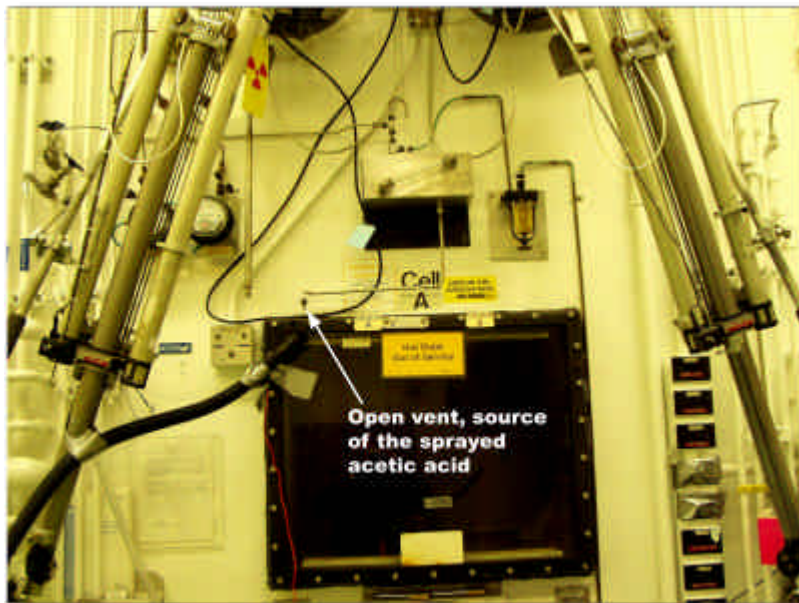
Workers had to remove the expansion tank vent line to protect the window against overpressurization, but the process safety summary prepared for this work did not address removing the tank vent. Removing the expansion tank vent also removed one barrier between the acid and the workers. When the liquid level in the window reached the open vent (see Figure 3-1), about 500 ml of acid sprayed out of the vent onto the workers.

Figure 3-1. The hot cell window and vent

occurrence. The leaking window gaskets required heavier mineral oil to be added to reduce leakage, which required the workers to use a more aggressive agitation source (pressurized argon gas) to clean the windows. Also, disconnecting the cell window expansion tank vent line led directly to the discharge of acetic acid into the workspace and onto the workers.

- Discontinue sparging with pressurized argon gas until the safety implications of the technique can be analyzed.
- Repair the leaking gaskets around the hot cell window so normal-weight mineral oil can be used.
- Evaluate new cleaning processes, agitation techniques, and different configurations during work planning.
- Identify and implement controls (e.g., lower liquid level in the window, contained venting capability, personal protective equipment) for sparging should it be used again.

- Use a finer metering valve for supplying argon gas to the liquid should sparging be used again.
