# OPERATING EXPERIENCE SUMMARY

**U.S. Department of Energy**  
**Office of Environment, Safety and Health**  
OE Summary 2003-25  
December 15, 2003

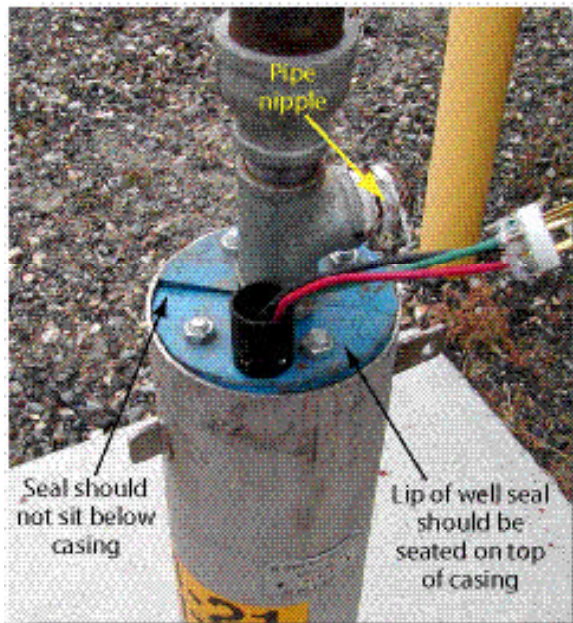
On October 20, 2003, at the Hanford Site groundwater protection project, a subcontractor well services worker installing a submersible well pump pinched his finger between a pipe nipple and the well casing (Figure 2-1), severing ½ inch from his right index finger. An ill-fitting seal assembly slipped into the well casing while the

**Figure 2-1.** The well casing and seal assembly

worker was trying to remove a discharge fitting from the pipe nipple. The well seal was not included in the pump installation package, and a substitute seal that was too small for the casing was used. (ORPS Report RL--PHMC-GPP-2003-0004; update/final report issued December 4, 2003)

- The manager met with all well services workers instructing them not to install any well pump systems without first verifying that the installation packages contain the appropriate components. Any deviation from the work procedure or changing conditions must be communicated to the manager.
- The procedure manual was revised to require workers to test the well seal that will be used to support the well pump assembly.
- Line managers and safety personnel will periodically inspect work sites to review work practices and document these inspections.

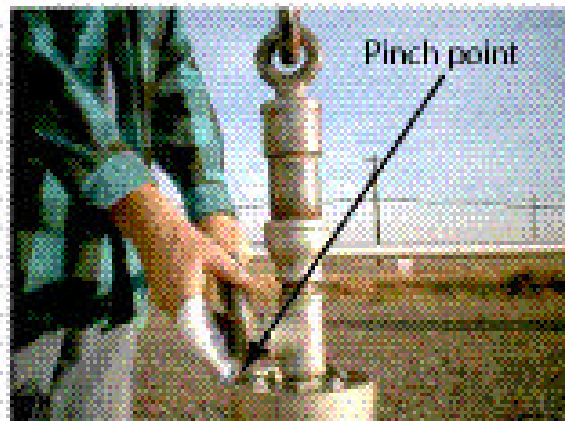
The worker was highly-experienced and had performed similar installations in the past. He was wearing personal protective equipment, including leather work gloves, while using a pipe wrench to remove the discharge fitting from the pipe nipple. He had one hand on the wrench; the other was on the bottom of the fitting holding the wrench in place (Figure 2-2). When the worker exerted force on the wrench, the seal slipped down inside the casing. The end of his right index

**Figure 2-2.** Re-enactment of the event

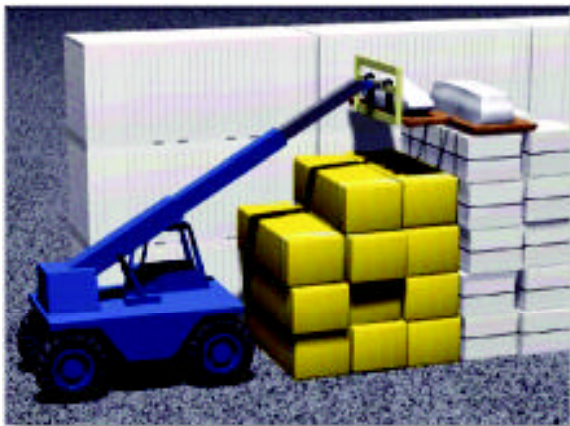
The LLW disposal pit is 30 feet deep, with containers stacked 24 feet high. The forklift operator was going to place the non-standard, 5½-ton package (a milling machine part on a pallet) on top of a stack of empty fuel racks located in front of a stack of LLW containers. As he positioned the pallet to place it on top of the fuel racks, the adjacent stack of containers collapsed. Figure 4-1 shows the position of the forklift immediately before the accident. Figure 4-2 is a photograph of the scene after the accident. To view a computer animation of this event, [click here](#).

*Figure 4-1. Position of forklift before the accident*

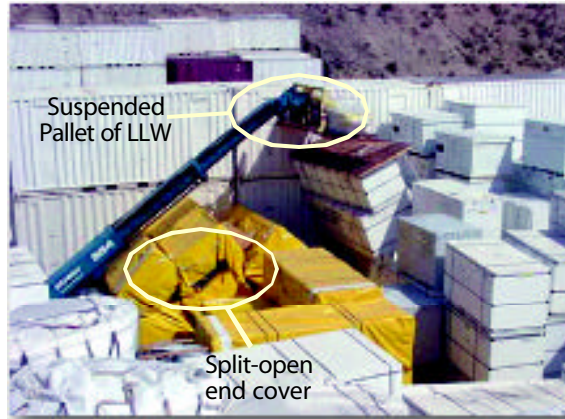
*Figure 4-2. Accident scene following stack collapse*

- Retract the forklift boom and lower the pallet of waste.
- Remove all vehicles from the SDA except the forklift.
- Drain the fuel from the forklift to reduce fire risk.
- Repair the split Herculite™ wrapping.

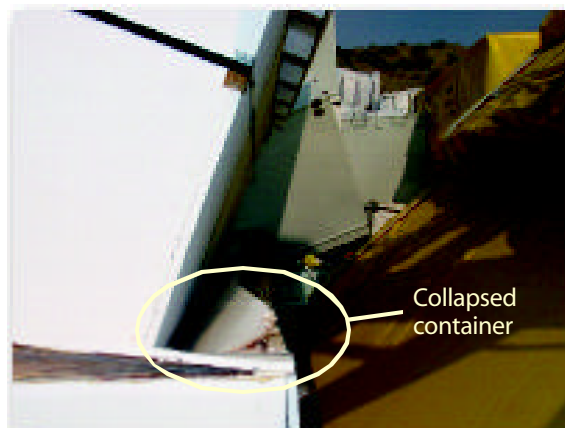
Inspections at the accident scene revealed that the stack that collapsed into the fuel racks comprised five standard containers topped by a 9,000-pound packaged milling machine part resting on a pallet. A container in the middle of the stack apparently collapsed under the weight of the containers on top of it (see Figure 4-3).

Inspectors determined that the container on top of the collapsed box was smaller than the other containers, which may have caused uneven, excessive loading on the collapsed box. A recovery plan to stabilize the collapsed waste containers and prevent the release or spread of contamination was completed on July 29, 2003.

*Figure 4-3. Container that collapsed*

- The stacking of containers in the bulk pit section was not conducted in accordance with a pre-engineered design to ensure stack stability.
- The stacking procedures did not adequately address waste stack stability or include plans, methods, or limits for maintaining stable waste stacks.

1. Revise the hazard analyses for LLW disposal pit operations.
2. Prepare stacking plans and guidelines for placing non-standard boxes and items in the bulk pits of the SDA.

5. Revise procedures to include RWMC evaluations of container load support capabilities and placement methodology.
6. Require RWMC Lifting and Handling Engineer review and approval of all proposed stacking configurations.
