OPERATING EXPERIENCE SUMMARY

U.S. Department of Energy
Office of Environment, Safety and Health

OE Summary 2003-26

December 29, 2003

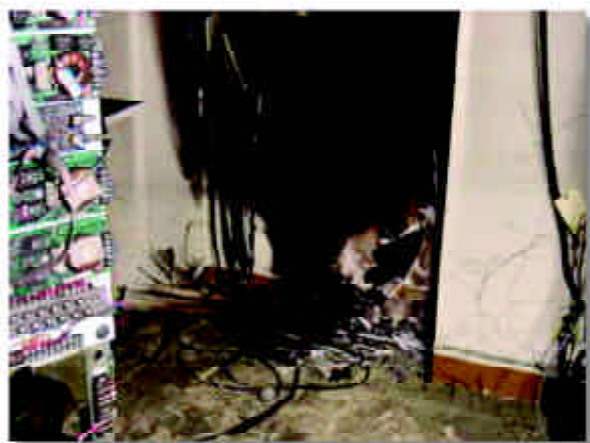
On November 11, 2003, an early morning fire at Stanford Linear Accelerator Center (SLAC) resulted in severe smoke damage to electronic equipment and destroyed an air conditioner. No one was in the building at the time, but a maintenance worker saw the fire and alerted the fire department. Responders found the wall-mounted air conditioner plugged into an extension cord instead of a single-outlet circuit, as required. Based on burn patterns and damage to the extension cord, the SLAC fire marshal determined the extension cord was overloaded and was the point of origin for the fire. (OAK--SU-SLAC-2003-0004)

The fire was limited to the air conditioner and the extension cord. Photographs of the scene show that the fire originated at the floor and moved up the wall to the air conditioner (see Figure 1-1). An inspection of the electrical connection and interior components of the air conditioner

Figure 1-1. Burn pattern indicating point of origin

Light-duty, household extension cords should never be used with high-wattage appliances such as air conditioners. Special, heavy-duty cords should be used instead. It is also essential for an extension cord to have a ground connection if the tool or appliance being plugged into it has a ground plug, and a three-prong connector should never be plugged into a two-pronged cord.

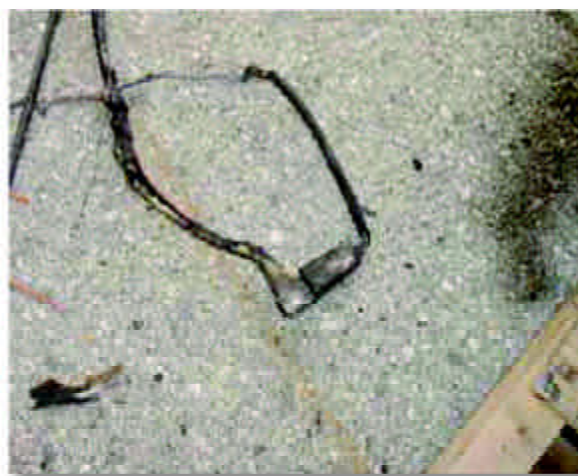
indicated that the damage was from external heat (i.e., from the fire), not from the failure of any air conditioner components. Figure 1-2 shows the burned cords.

Figure 1-2. Burned cords

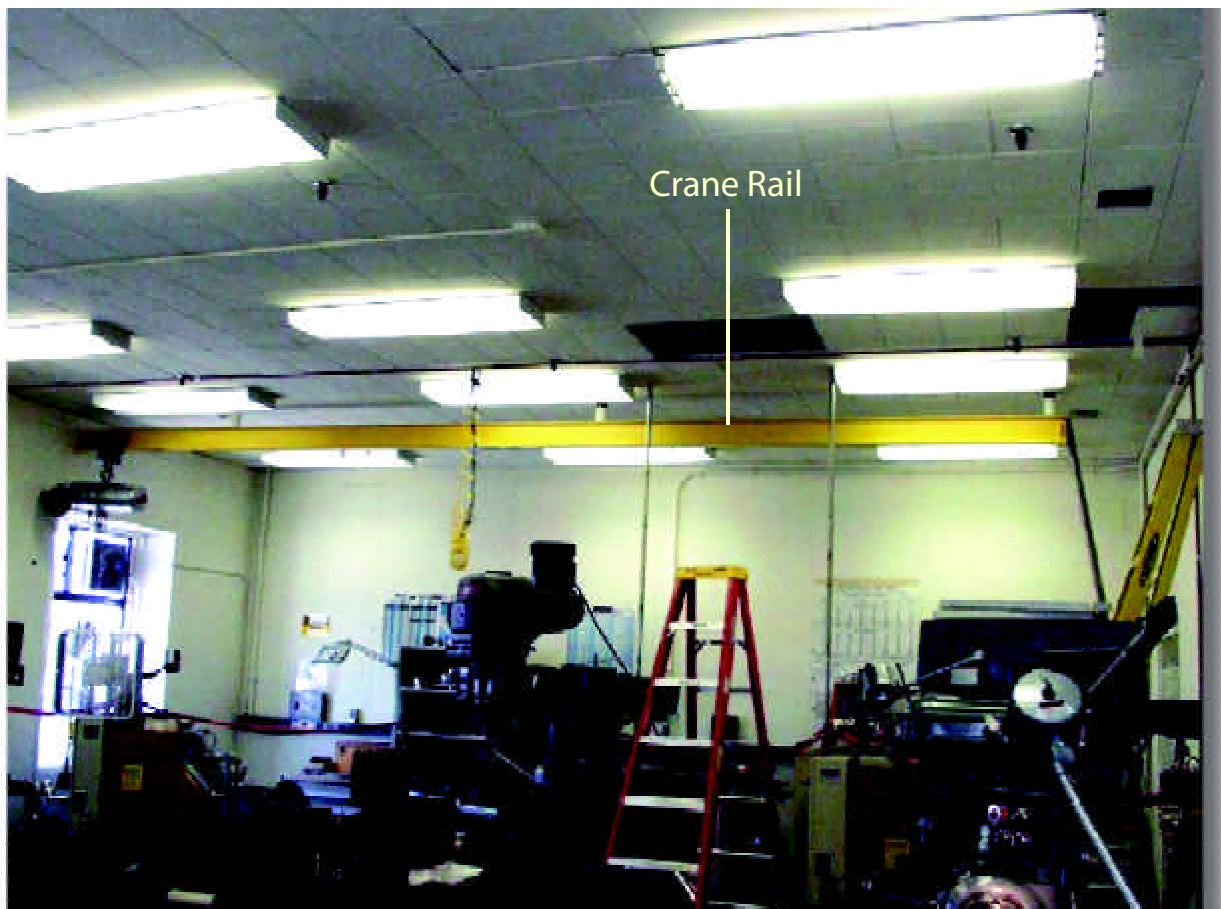
A similar incident in which roof repair workers compromised the safety of building inhabitants occurred at the Los Alamos National Laboratory on April 24, 2003. In this near-miss occurrence, a monorail crane I-beam support at roof level was discovered with all 12 of its support bolt heads ground off. The I-beam weighed approximately 1½ tons, and was located at ceiling level in an area occupied by workers on a daily basis. The I-beam did not fall because it was anchored at one end by four bolts in an 8-inch-thick reinforced concrete wall. This semi-detached condition of the crane rail, cantilevered from a concrete wall at one end, may have existed without detection for nearly 2 years. (ORPS Report ALO-LA-LANL-NUCSAFGRDS-2003-0001)

Figure 2-1 shows the as-discovered condition of the I-beam crane rail that was unsupported from above. As shown in the figure, the free end of the beam (opposite the hoist location) is lower than the end attached to the wall. (The visible portions of the three detached support struts increase in size from left to right in the photo.) Figure 2-2 shows where one of the three I-beam support struts was attached to the roof structure above the drop ceiling. Each of the three struts was attached by four bolts, one in each corner of the strut plate. Figure 2-3 shows one of the 12 bolts after the bolt head had been ground off.

Figure 2-1. As-found condition of the I-beam crane rail

Facility managers had the crane removed after this occurrence because it had not been used for several years and its maintenance requirements outweighed its usefulness. Technical personnel revised the annual inspection checklists for cranes and hoists to specifically identify what components should be inspected (e.g., support plates, anchor bolts) and to require detailed scrutiny by inspectors.

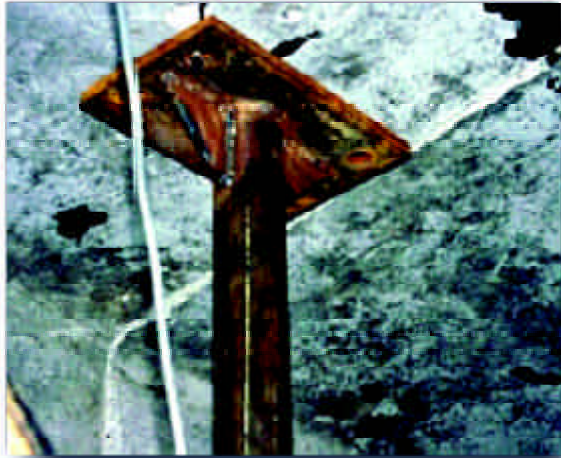
Figure 2-2. *Strut and support plate, with four missing bolts*

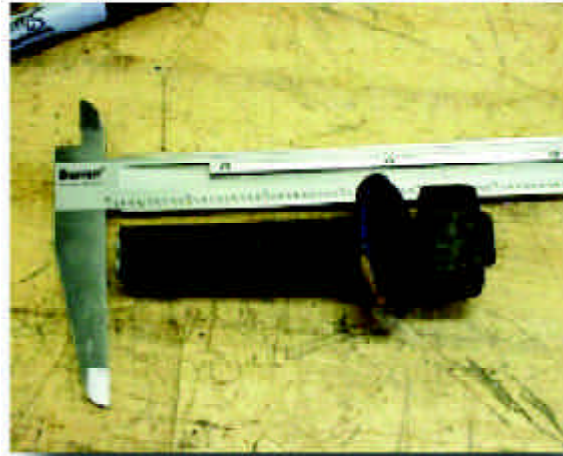
Figure 2-3. *Support bolt after its head was ground off*
