# OPERATING EXPERIENCE SUMMARY

**U.S. Department of Energy**  
**Office of Environment, Safety and Health**  
OE Summary 2003-10  
May 19, 2003

# Operating Experience Summary 2003-10

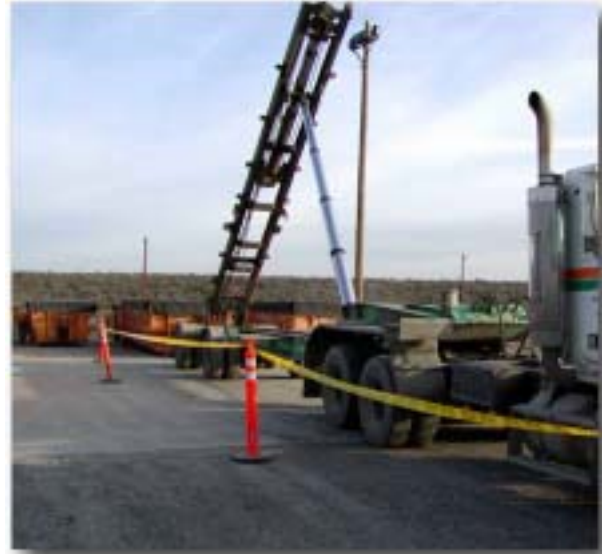
As the teamster offloaded the container, it rolled backwards until the wheels encountered an obstruction on the concrete pad and stopped. When the container stopped rolling, the teamster continued to elevate the hoist frame of the truck and simultaneously wound out cable from the hoist, creating slack in the cable. The slack in the cable caused the attachment ring on the hoist cable to disconnect from the container

Figure 2-1. The truck and container

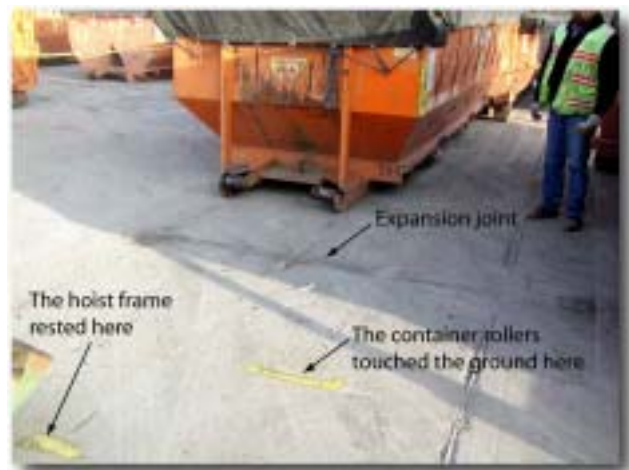
hook. With the hoist frame continuing to rise, the wheels came free from the obstruction, allowing the container to slide back. Figure 2-2 shows the locations where the hoist frame rested and where the container touched the ground. The figure also shows an expansion joint in the concrete pad that may have been the obstruction.

Figure 2-2. The container and concrete on which it rested

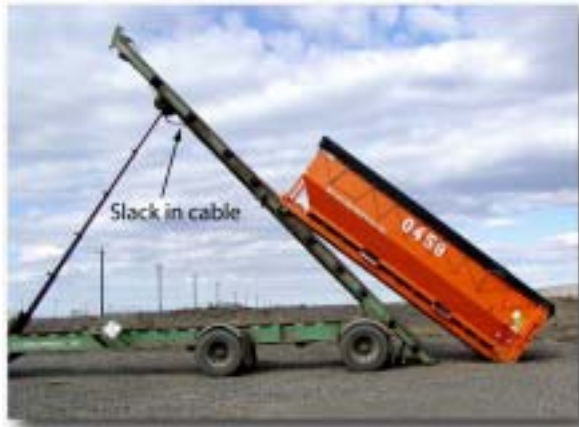
Along with a causal analysis, a field investigation was conducted to re-create the event. Investigators intentionally introduced slack in a cable to demonstrate the dynamics that can cause it to disengage from a container in the process of offloading. Figure 2-3 illustrates the test. The investigators tested other scenarios to

**Figure 2-3.** The investigators introduced slack in the hoisting cable

understand how slack can be introduced into a cable. When slack develops in a hoisting cable, longitudinal and rotational forces within the cable cause the cable end to ride up onto the container hook, rotate, and flip off of the hook. This can occur with both eyehooks and D-ring hooks.

The teamster did not stop hoisting and paying out cable when the container became caught up, which allowed slack to accumulate in the cable. Testing revealed that raising the hoist while paying out cable will cause the cable to slacken very rapidly; therefore, the container may have come disengaged before the teamster could stop hoisting.

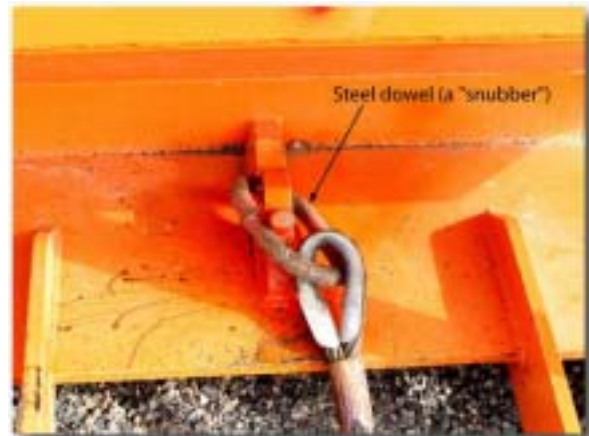
**Figure 2-4.** The modified configuration

- Facility management reviewed off-loading procedures with waste transportation drivers and emphasized the importance of avoiding slack in cables and maintaining focus on the container movement during the entire off-loading operation.
- All work crews at site waste disposal work locations were briefed on the event and the dynamics that can result in slacked cables and cable disengagement. In addition, a discussion followed on a proposed container hook modification in which a steel dowel would be welded onto the container hook to

prevent the cable from coming disconnected (Figure 2-4).

- The facility contacted the container manufacturer to obtain approval for the proposed modification and distributed sample containers with the dowel welded to the hook to all work sites.
- After obtaining feedback from workers on the effectiveness of the modification and manufacturer approval, the facility began installing modifications on applicable containers. Management documented the modified design to be included in future container procurements.

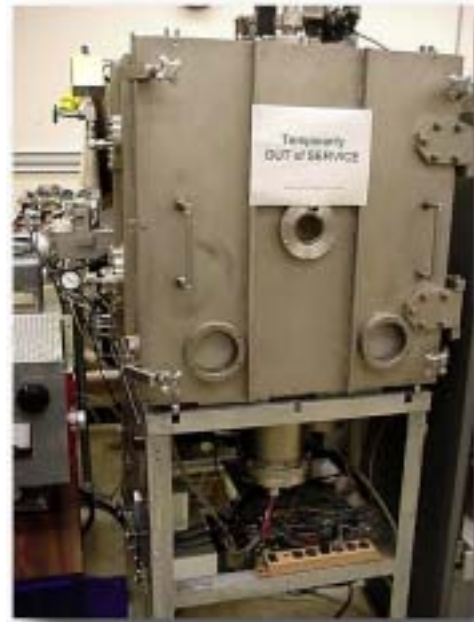
The researcher had installed the cathode assembly in the equipment approximately a week before the incident and had secured all the electrical connections. He knew that when the equipment was energized the entire bottom of the cathode assembly, including the cooling water connections, was energized. He understood immediately after the shock why it had occurred. Figure 4-1 shows the sputtering unit involved in this event; Figure 4-2 shows the underside of the cathode.

**Figure 4-1. The sputtering unit**

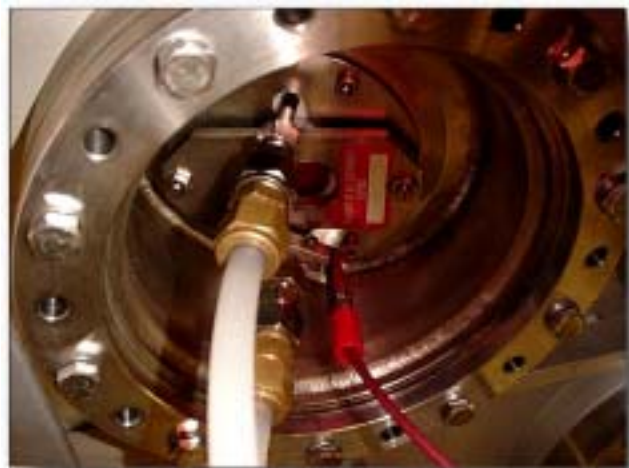
**Figure 4-2. Underside of cathode**

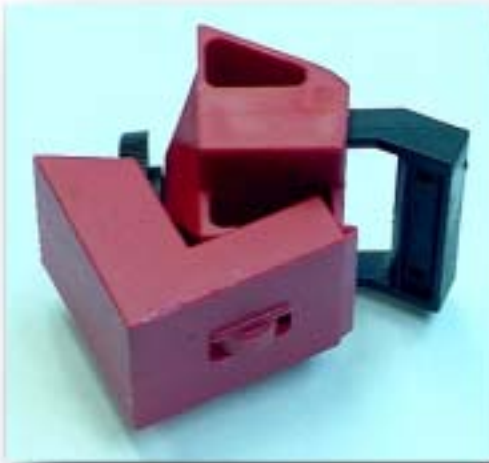
During a critique of the event, critique members learned that the electricians applied electrical tape to shim the handle in an attempt to get the locking device to remain in place and prevent operation of the circuit breaker. Figure 5-1 shows the locking device, which uses a thumb-screw to hold the device in place.

**Figure 5-1. Locking device that fell off the circuit breaker handle**

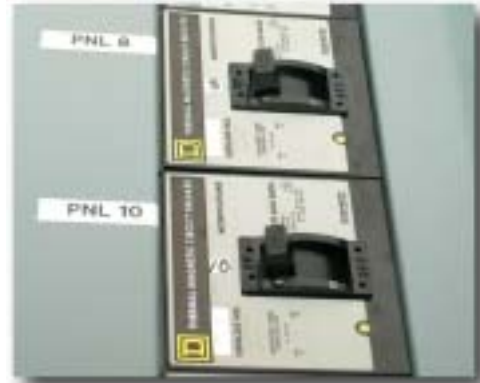
The design of the circuit breaker handle did not permit ready and secure attachment of the locking device because it was tapered (Figure 5-2). Figure 5-3 shows a reenactment of the lockout device installed using electrical tape.

**Figure 5-2. 200-amp circuit breakers showing thick tapered actuation handle**

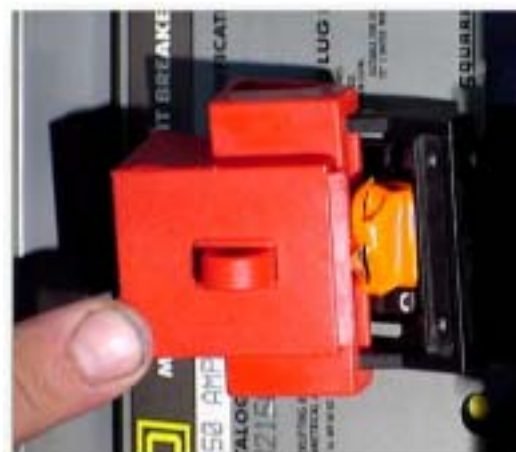
**Figure 5-3. Reenactment showing lockout device installed with electrical tape (orange) applied to circuit breaker handle**

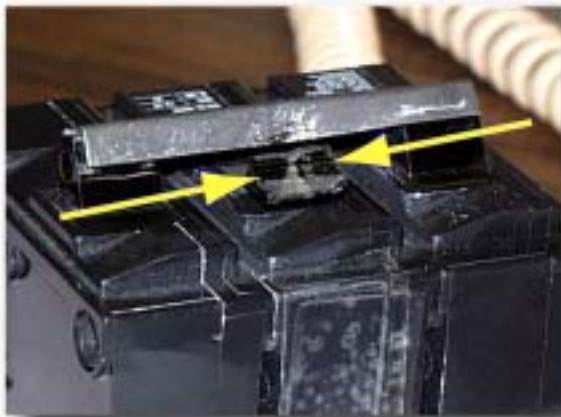
Figure 5-4 shows damage to the center pole operating handle of a circuit breaker caused by excessive and repeated tightening of the locking device set screw. The setscrew crushed the hollow part of the handle (shown between the arrows). This damage also allowed the center pole to remain closed when the breaker switch was placed in the open position.

**Figure 5-4. Damaged circuit breaker handle**

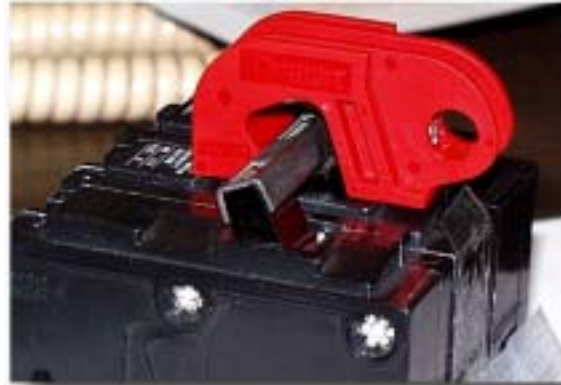
Figure 5-5 shows the set-screw-type locking device manufactured by Panduit (Model PSL-CB) installed on a multi-pole circuit breaker.

**Figure 5-5. Circuit breaker locking device that uses a setscrew**

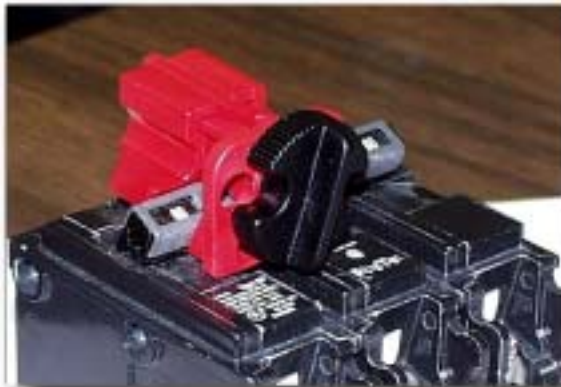
**Figure 5-6. Thumbscrew-type locking device for multi-pole circuit breakers**

To avoid recurrences, facility electrical engineers researched available multi-pole locking devices for circuit breakers with a tie-bar. Figure 5-6 shows a model manufactured by Brady (Item 5578) that uses a thumbscrew, which securely locks out the breaker without causing damage.
