OPERATING EXPERIENCE SUMMARY

U.S. Department of Energy
Office of Environment, Safety and Health
OE Summary 2004-03
February 9, 2004

EH PUBLISHES A REVIEW OF HOISTING AND RIGGING EVENTS

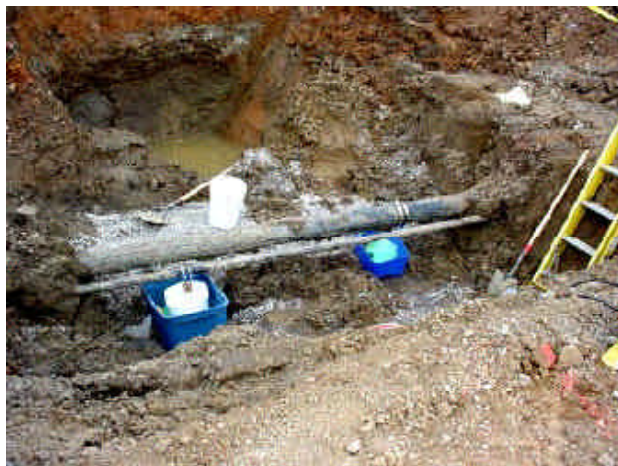
Figure 1-1. Typical LLWP pipeline

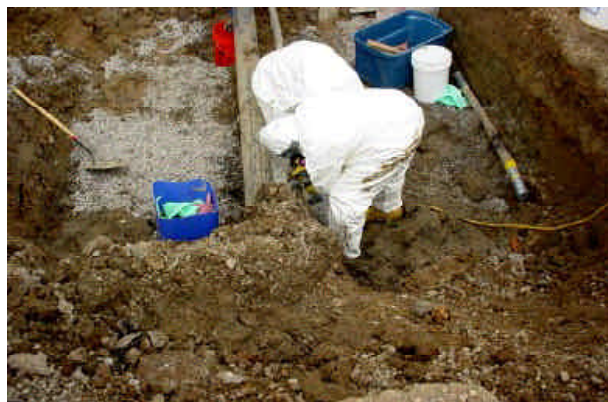
Figure 1-2. Workers cutting pipeline

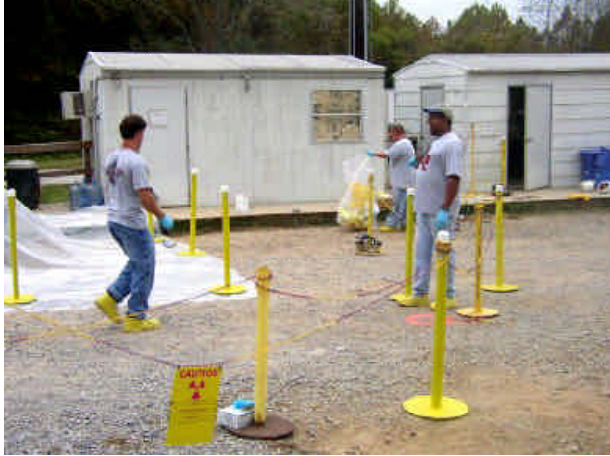
The RCT notified radcon and site managers, who mobilized additional resources, secured the area around the trailer, and conducted onsite surveys. They discovered contamination inside the trailer, on the boardwalk outside the trailer, on the gravel road in front of the trailer, and inside three subcontractor vehicles. A 370,000 dpm/large area wipe on the instrument shelf was the highest level of contamination found inside the trailer; the highest level inside the vehicles was 300,000 dpm/100cm². RCTs secured and posted the contamination areas. Decontamination activities at the trailer are depicted in Figure 1-3.

Figure 1-3. Trailer decontamination activities

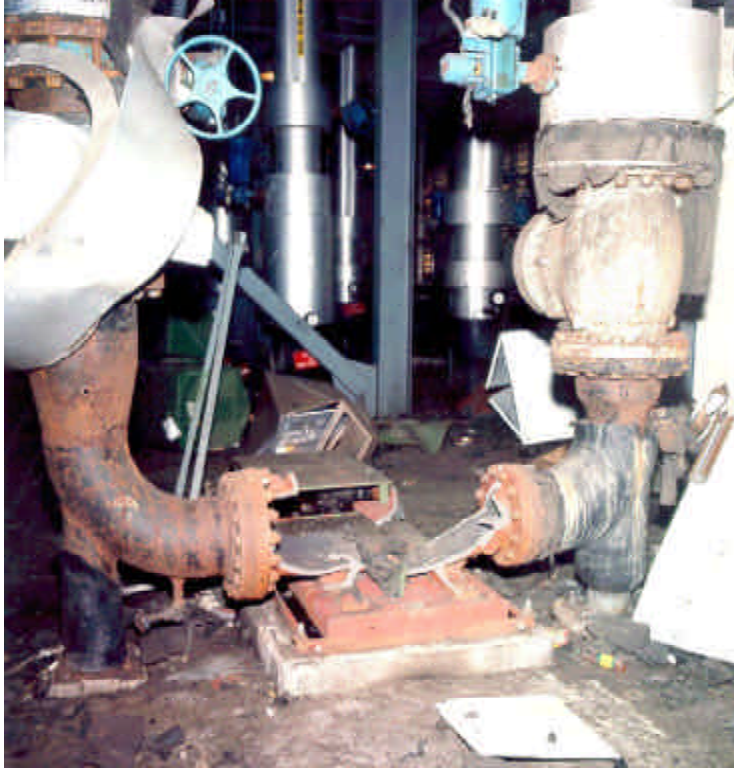
These two events are very similar to a 1998 event, where a pump casing failed catastrophically (Figure 2-1). The resulting explosion moved the pump motor 8 feet from its foundation, moved an adjacent pump motor 2 inches, and shattered the glass window of a control room (Figure 2-2). One operator received minor cuts on the face and chest from flying glass. A Type C accident investigation followed. Investigators concluded that the explosion occurred because the pump had been run with both its suction and discharge valves closed, increasing the pump's internal pressure to as high as 3,000 psi. Investigators also identified a number of other conduct of operations issues that led to the accident. (ORPS Report ORO--LMES-Y12SITE-1998-0039)

Figure 2-1. The scene of the 1998 event

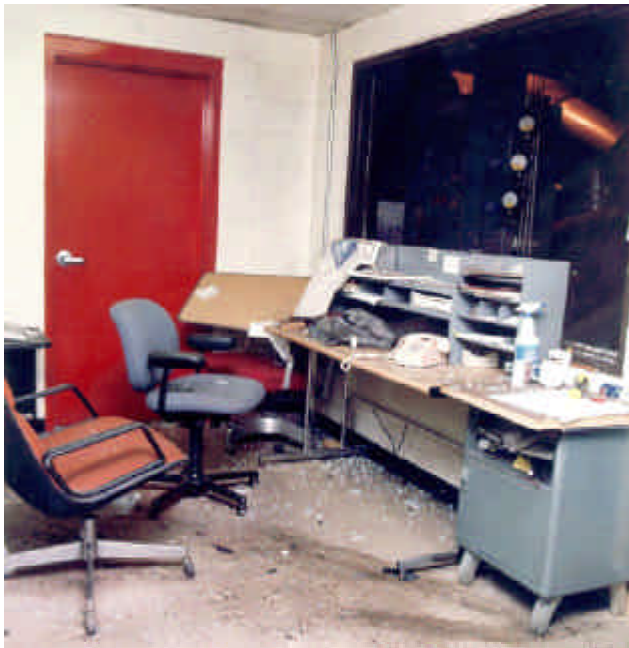
Figure 2-2. The control room window was shattered

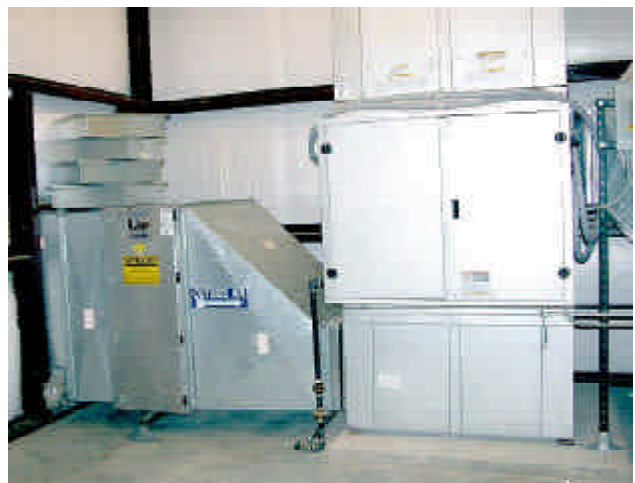
Facility management personnel suspect that the direct-fired heating system in the building may be the source of the carbon monoxide. Building construction was completed in 2003, and there are indications that the REZNOR® Model DV-115 furnace (Figure 3-1) may not have been installed in accordance with the manufacturer's specifications.

Figure 3-1. Direct-fired furnace (on right)

The LANL heating and ventilation subject-matter expert assessed the furnace installation to ascertain if it was installed according to specifications and in conformance with appropriate building codes. He determined the outside air inlet was about 25 percent smaller than specified by the manufacturer. This could have led to incomplete combustion and production of excessive CO. Investigators are reviewing whether reduced air inlet size, inoperative machinery exhaust, recycled air through the direct-fired heater, or a combination of these three factors caused the CO levels in the building to gradually increase.

LANL managers have identified five other buildings equipped with similarly vented heaters. Indoor air-quality monitoring is being conducted in each of these buildings, and CO/combustion gas monitoring alarms will be installed as appropriate. In some cases, auto-shutoff systems will also be installed on the heating systems. The

air inlet for the heater involved in the event will also be enlarged.
