# OPERATING EXPERIENCE SUMMARY

**U.S. Department of Energy**  
**Office of Environment, Safety and Health**

OE Summary 2004-05

March 8, 2004

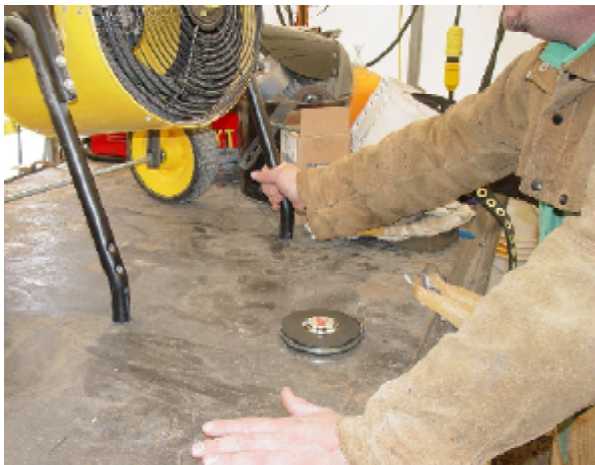
On December 3, 2003, at the Hanford Waste Treatment Plant Construction Project, an ironworker repositioning a 480-volt portable electric heater grasped the leg of the heater with one hand while touching a metal table with the other (see Figure 1-1) and received an electrical shock that literally knocked him to the floor. Investigators determined that the power plug for the heater had been miswired. (ORPS Report RP--BNRP-RPPWTP-2003-0006, final report filed January 23, 2004)

*Figure 1-1. Re-creation of incident*

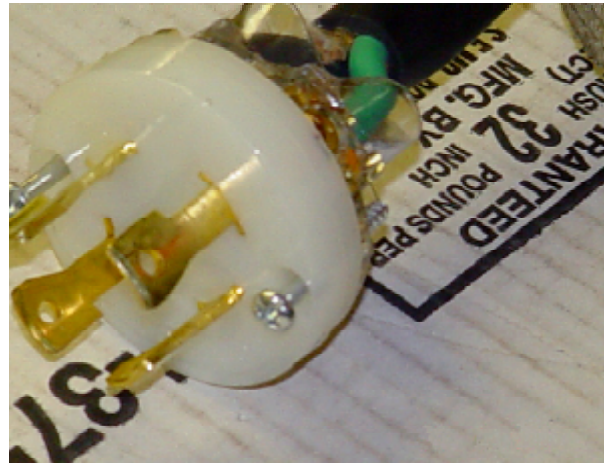
An experienced journeyman electrician had installed the plug on the new heater a few hours before the incident occurred. He incorrectly connected a hot leg of the three-phase, 480-volt conductor to the ground screw and the ground wire to a power prong. This caused the heater housing to become energized with 277 volts. The electrician did not test for continuity or proper grounding after he installed the plug. Figure 1-2 shows the miswired plug, with the ground (green) wire attached to the power prong.

*Figure 1-2. The miswired plug*

Investigators identified the principal cause of this incident as inattention to detail on the part of the electrician. They also determined that site management had not established a policy requiring testing after performing work on electrical equipment. If the electrician had checked his work, he probably would have caught the error before allowing the heater to be used. The electrician resigned because he held himself accountable for creating the unknown electrical hazard produced by the miswired plug. However, at the time of the incident, it was not standard practice for electricians to conduct acceptance testing after wiring components.

- Develop a guidance document instructing electricians to inspect their work and perform circuit testing at the completion of a task.
- Develop a grounding program, with procedures, including those for circuit and continuity testing.
- Issue instructions to site workers to tag equipment “Do Not Operate” immediately when they suspect it to be hazardous or defective.
- Reiterate the need for prompt notification and categorization of reportable occurrences.

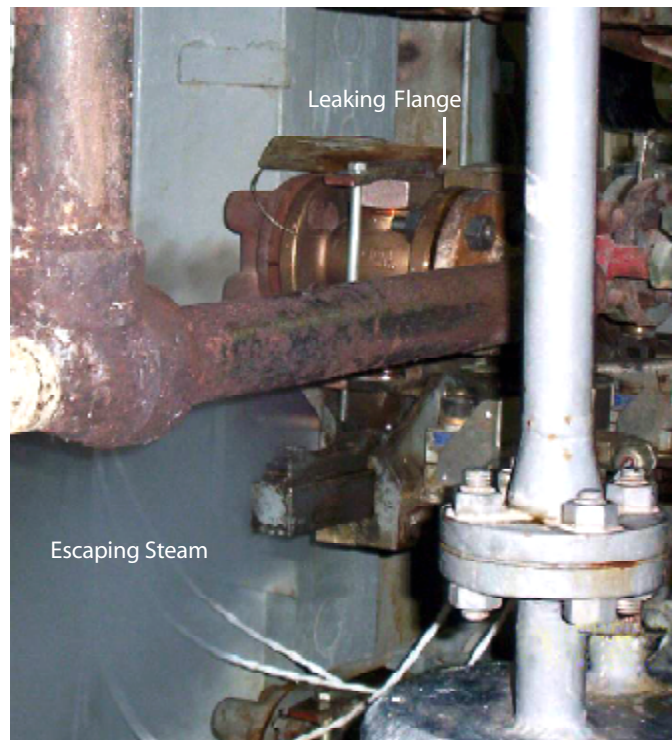
On November 20, 2003, at the Savannah River H-Canyon facility, a construction worker preparing to remove insulation from a steam manifold assembly narrowly escaped being scalded when 365° F steam leaked from a defective pipe flange. The worker was removing the piping insulation in proximity to a gang valve

Facility policy for removing insulation from steam pipes did not require the energy source to be locked closed and posted, with the steam stop valve barricaded, because the system would not be penetrated. However, a lockout/tagout should have been applied because workers knew that the flange leaked at the work location and that pressurized steam in the line could present a scalding hazard. Work planners also knew the task involved erecting a plastic tent (glovebag) to contain airborne asbestos and that heat from the steam lines could compromise the integrity of the glovebag. Investigators identified these work planning deficiencies as the root cause of the occurrence.

Although they used a “plan-of-the-day” process, work planners did not recognize the conflicts between the insulation removal task and the process transfer task. They performed a hazards analysis as part of the work planning, but incorrectly concluded there were no harmful sources of energy in the work area. Figure 2-1, a photograph taken after the insulation was removed from the piping, shows steam leaking from the defective flange.

*Figure 2-1. Actual steam leak*

- Facility management will issue a standing order to establish a lockout/tagout on the steam stop valve for any insulation work in the area of known steam leaks.
- Facility management will issue an operating experience description to the planning group to ensure that all sources of hazardous energy are identified in task hazards analyses.
- Facility personnel will walk down work spaces to identify unsafe conditions and ensure that appropriate postings and/or barricades are established.

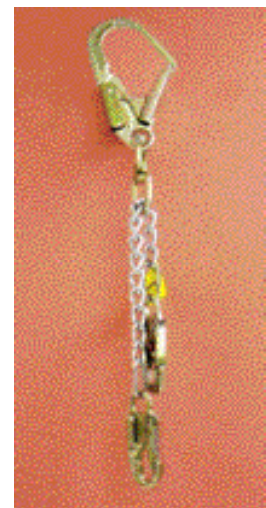
The iron worker was securing splice bars on a wall of reinforcing rods (rebar) about 14 feet above the slab. He was using a rebar chain assembly (Figure 3-1) attached to the front of his harness to position himself on the rebar wall so he could work with both hands. However when he changed positions during the task, he apparently did not ensure that the positioning hook was fully engaged. When he leaned back, the positioning hook came free and he fell.

**Figure 3-1. Chain assembly and positioning device**

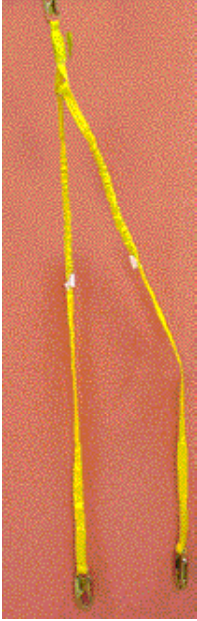
The worker was using a double shock absorber/lanyard system (Figure 3-2). This system allows the worker to be tied off with one lanyard while he is moving the other one. When the worker began to

**Figure 3-2.**  
**Double-lanyard**

fall, the lanyard performed according to design and stopped his fall before he hit the concrete floor.

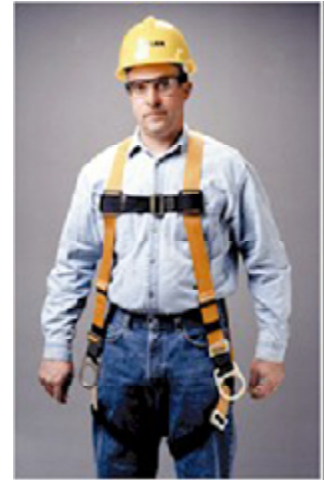
The lanyard the ironworker was using attaches to a full-body harness (Figure 3-3), and is designed to decelerate a fall, bringing the worker to a smooth, easy stop. Shock-absorbing material in the lanyard's inner core is surrounded by an extra-strong outer jacket. When a force of about 600 pounds is exerted on the lanyard, the outer jacket extends to its full length and acts as a backup web lanyard. After the worker's fall was arrested, he regained his footing and re-ascended the

**Figure 3-3.** *Typical full-body harness*

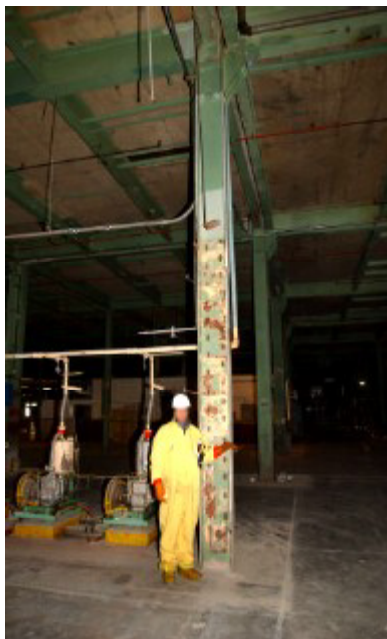
before the accident without incident. At the time of the accident, he was unable to pry loose blocks located at chest height in the column (Figure 4-1). He stopped working and, as he began to walk away, the top block fell, glanced off his raised face shield, and struck his left foot. After the accident, the blocks between the top block and those at chest height fell out of the column. Reportedly, no one in the area observed this.

**Figure 4-1. Wide-flange column involved in the accident (blocks removed)**
