OPERATING EXPERIENCE SUMMARY

U.S. Department of Energy
Office of Environment, Safety and Health
OE Summary 2004-07
April 5, 2004

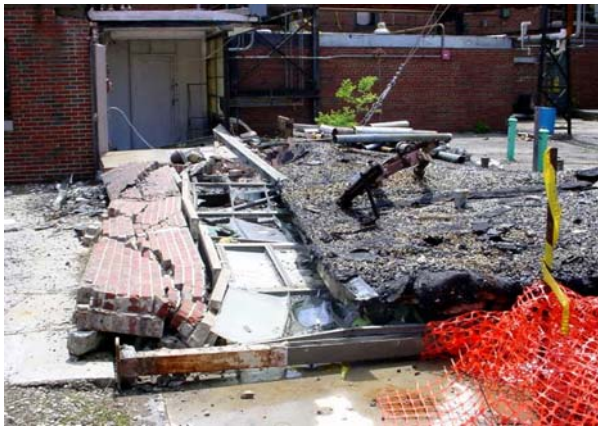
On April 29, 2004, during demolition operations at the Mound Plant, an operator was cutting the roof to a breezeway (Figure 1-1) connected to a building annex when he noticed that the roof was moving. As the operator moved the excavator away from the breezeway, it collapsed, and part of the breezeway overhang struck the excavator cab. The windshield and cab frame of the excavator were damaged, and the operator sustained a minor first-aid injury to his left index finger. (ORPS Report OH-MB-BWO-BWO04-2004-0005)

Figure 1-1. The collapsed breezeway

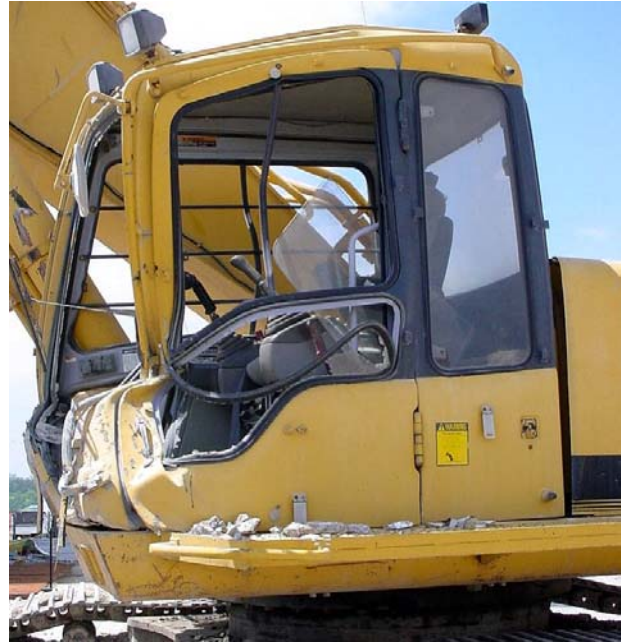
Figure 1-2 shows the extent of the damage to the excavator. An investigation disclosed that the breezeway collapsed because the supporting base plates were not bolted in place when it was constructed in the 1950s (Figure 1-3), although the construction drawings indicated that they were. The excavator operator had helped demolish two other buildings and their breezeways, and in both of those cases the breezeway base plates were bolted down.

Figure 1-2. Damage to the excavator

Facility management took the following corrective actions to preclude recurrence.

1. The structural engineer who previously reviewed the demolition plan re-evaluated his review.

2. Project personnel issued a summary on the breezeway collapse that focused on the changed configuration of the breezeway.
3. Other buildings and demolition plans are being reviewed to identify unanchored supports.
4. Facility management is considering the use of longer-reach equipment for future demolition activities to maintain a safe distance for equipment and operators.

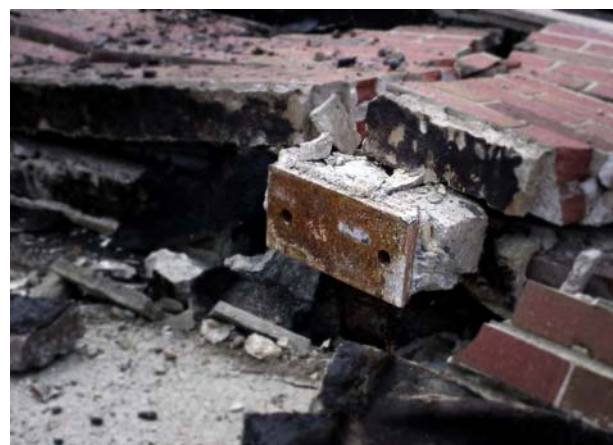
Figure 1-3. Unsecured base plate

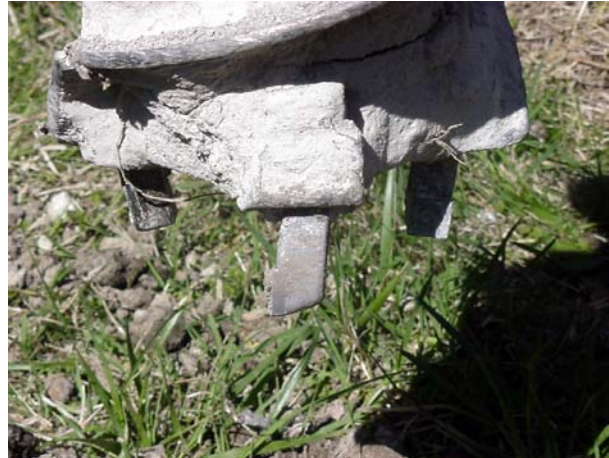
Figure 2-1. Concrete on drill bit

The drilling crew intended to collect soil samples to a depth of 50 feet. They had stopped drilling twice before this incident occurred: first at a depth of 2½ feet when they encountered gravel; then at 4¼ feet when they saw concrete coming off the drill bit (Figure 2-1). Because the concrete was neither marked nor color-coded, the crew resumed drilling, and once again stopped at 4½ feet, when the workers saw wire fragments and cable insulation coming out of the hole (Figure 2-2).

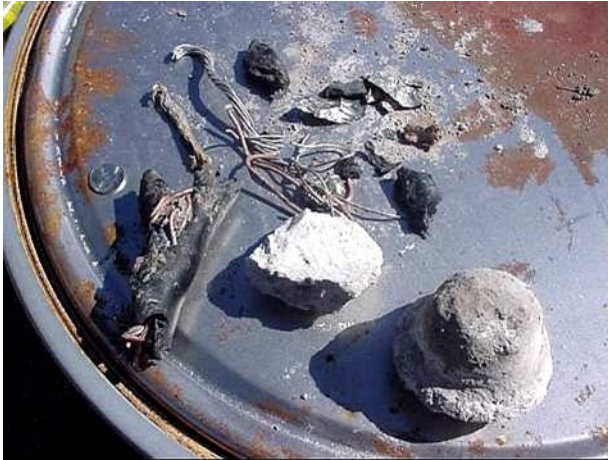
Investigators determined that the causal factors for this incident included failure of the assigned utility engineer to perform the utility locate scan and failure of the project manager to validate performance of the scan. They also identified violations of the work planning procedure (e.g., signing the excavation permit on the day of the job) as a causal factor for the event.

Figure 2-2. Pieces of wire and cable insulation

- Conduct a stand-down with facility and maintenance engineers to address roles, responsibilities, and expectations with regard to the planning and conduct of work.

- Investigate the accuracy of plant as-built drawings and make corrections as appropriate.
- Identify the person authorized to initiate work with the contractor in applicable documentation.

- Modify the work-planning process description with built-in mistake-proofing to the extent possible.
- Establish a maximum time interval between the scan and work start.

- Require that the utility engineer have direct knowledge of the performance of the utility locate scan before signing the excavation permit.
- Clearly identify the investigatory hold points to be imposed in excavation tasks whenever unexpected conditions are encountered.

- Clarify in appropriate documents the titles, functions of those who sign excavation permits, as well as what their signature on the permit signifies.

- Implement a ground-marking program for all buried utilities before excavation begins.
- Require that excavations be designated as a high-hazard activity to improve reviews and approvals.

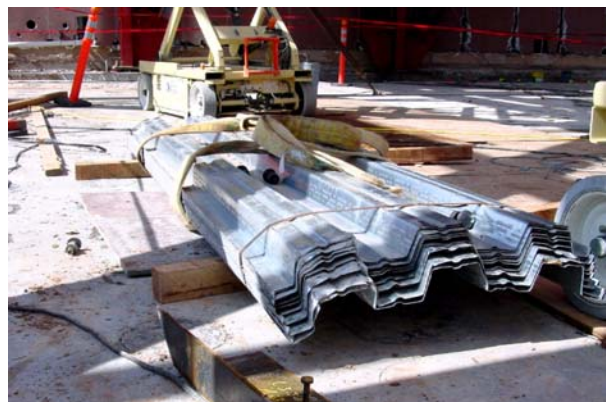
On February 25, 2004, at a Sandia National Laboratory (SNL) construction project, a third-tier steel-erection subcontractor dropped a 1,000-pound bundle of steel decking material (Figure 3-1) to a concrete deck 20 feet below. No one was injured, but the material was slightly damaged, as was a wooden guardrail (Figure 3-2) and an unoccupied scissor lift. (ORPS Report ALO-KO-SNL-1000-2004-0001; final report filed March 4, 2004)

The accident occurred as the worker directing the lift tried to readjust the suspended load. He pushed too hard on the load, and the decking slid out of the rigging and fell to the ground. The worker re-rigged the material and lifted it to its intended place without notifying his supervisor of the dropped load. He also failed to notify either the SNL general construction contractor or SNL management.

Figure 3-1. Dropped decking material

- Provide formal documentation of the qualification of all workers employed on this activity.
- Provide training or re-training to establish a full understanding of the administrative safety requirements on this project.
- Develop a plan for the oversight level of the subcontractor’s safety work practice activities.
- Develop a plan to meet the accountability requirement of all supervision provided by the subcontractor during the remaining steel erection activities.

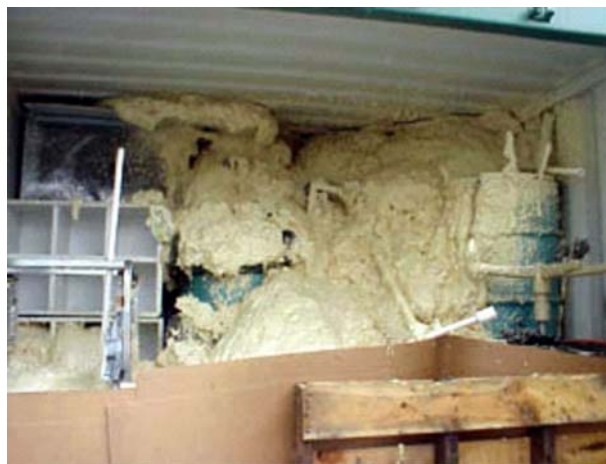
Autofroth had been used at the site as a cribbing/padding material in waste cargo containers (Figure 4-1) and as a filler for gloveboxes before disposing of them. In these high-volume applications, adjustments were made to the application process to dissipate the heat generated during the exothermic reaction, thus minimizing the potential for smoking and charring.

Figure 4-1. Autofroth in a waste cargo container
