# OPERATING EXPERIENCE SUMMARY

**U.S. Department of Energy**  
**Office of Environment, Safety and Health**  
**OE Summary 2004-10**  
**May 17, 2004**

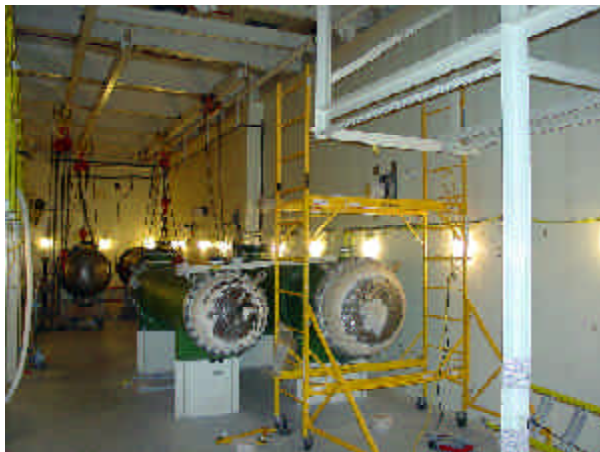
**Figure 1-1. Scaffold**

On May 24, 2004, at Rocky Flats, a D&D worker on a scaffold (Figure 1-1) was using a portable band saw and accidentally dropped a 6-foot piece of angle iron. The piece fell 5 feet and struck an RCT on the hardhat and shoulder. The RCT was not injured. (ORPS Report RFO--KHLL-374OPS-2004-0002)

Two workers (a saw operator and helper) cut and removed two pieces of angle iron without incident. The saw operator cut the third piece of angle iron while the helper repositioned the movable stair ladder. When he had finished, the operator turned the saw off, laid it on the scaffold platform, and attempted to lower the angle iron to the floor. As he was lowering it, the piece slipped out of the operator's hands and fell. An initial investigation identified the work planning and conduct of operations deficiencies summarized below.

- The saw operator held the saw with one hand and piece of angle iron with the other while cutting.
- The operator attempted to lower the angle iron to the ground without the assistance of the helper.
- The saw operator was cutting overhead, and the area below was inadequately secured.

To prevent recurrence, facility management will ensure that operators are retrained on the need to use both hands while using cutting tools and on the need to properly barricade areas near overhead work. Management will evaluate other methods for lowering equipment to the ground (e.g., rigging using beam clamps or rope tie-offs).

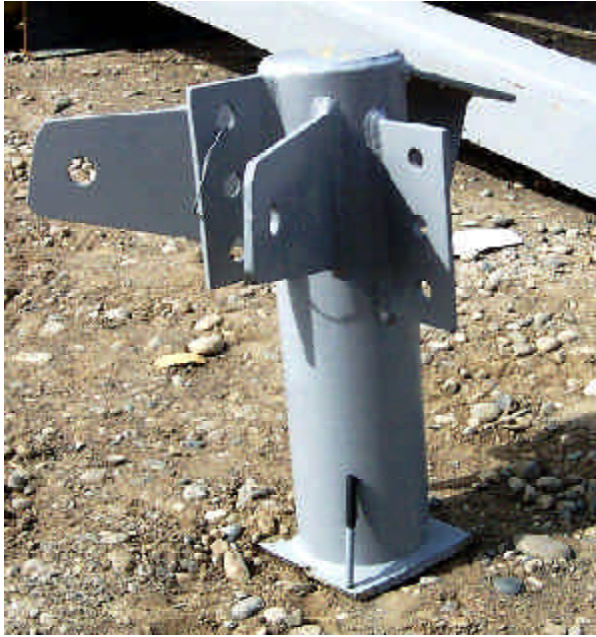
**Figure 1-2. Spider column**

OE Summary 2003-12 reported a near-miss event that occurred on May 21, 2003, at Hanford. An ironworker positioning spider columns (Figure 1-2) on a roof failed to notice that the self-retracting

lanyard on his safety harness had hooked another spider column in an open-faced skiff box next to the roof cutout. The 80-pound spider column fell out of the box, through the roof cutout, and landed 18 inches from an oxyacetylene welding cart 15 feet below. No workers were in the immediate area at the time the spider column fell, and there were no injuries or equipment damage. (ORPS Report RL--BHI-DND-2003-0003)

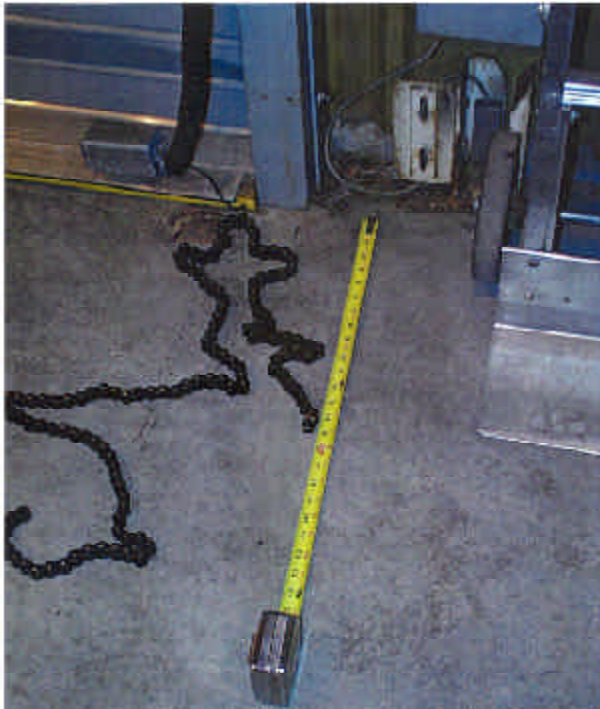
**Figure 2-1. Fallen drive chain  
(Rocky Flats)**

On January 9, 2004, at the Rocky Flats Environmental Technology Site, a roll-up door at an industrial building dropped 10 feet to the floor when the drive chain for the operating mechanism separated. Personnel had heard noise coming from the drive chain prior to the failure. (ORPS Report RFO--KHLL-WSTMGTOPS-2004-0001)

An offsite vendor had replaced the door about a year before it failed. The vendor was contacted and supported the investigation. When the door was checked, inspectors determined that the broken chain was the only failure. Figure 2-1 shows the broken chain on the floor beneath the operating mechanism. Investigators determined that the door had been cycled in excess of its normal expected life cycle and that no preventive maintenance had been performed on it. Since the door failure, the vendor has checked all roll-up doors. The contractor is establishing a preventive maintenance process that will be conducted based on the expected door usage. Figure 2-2 shows the damage to the door on impact.

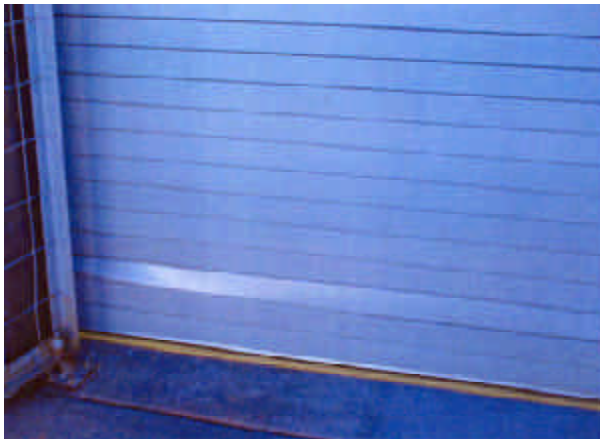
**Figure 2-2. Buckled door slat  
(Rocky Flats)**

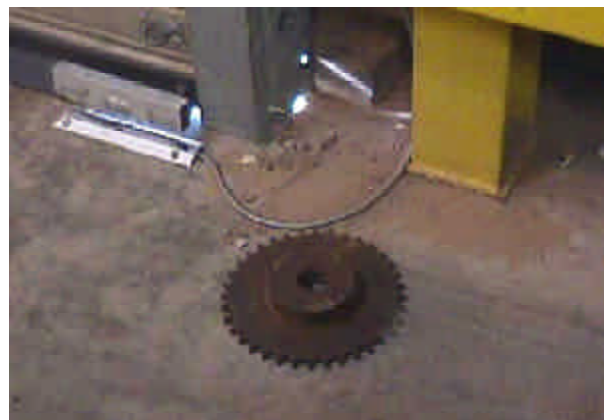
Another event occurred at Pantex in November 2002, when a 5-pound chain sprocket for a roll-up door fell within a foot of a security police officer who was operating the door. Preventive maintenance for roll-up doors had not been established at this facility. Figure 2-3 shows the sprocket.

**Figure 2-3. Fallen drive sprocket  
(Pantex)**

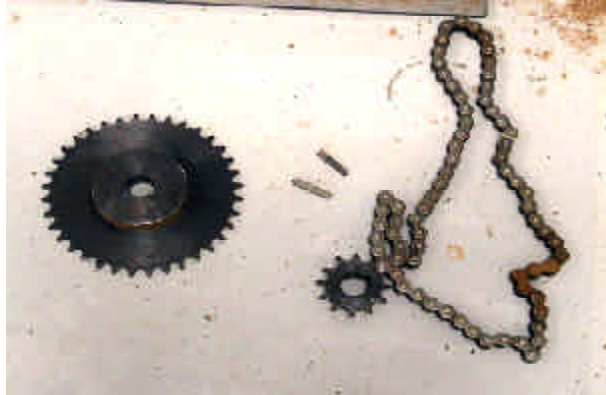
On July 15, 2003, at the Los Alamos Tritium Facility, two sprockets and a drive chain for the

motorized opener on a roll-up door fell as an electrician was closing the door. The door dropped at an uncontrolled rate, and the chain glanced off the electrician's right arm. He was standing below the motorized door opener and in front of the controls. The two sprockets landed within 2 feet of the electrician. (ORPS Report ALO-LA-LANL-TRITFACILS-2003-0003)

The roll-up door was installed in 1997 and is in an annual preventive maintenance program that includes a mechanical component and an electrical component. The electrical component had been completed the day before the failure, but manipulation of the door opener sprockets or chain was not part of this inspection. Figure 2-4 shows the sprockets and chain.

**Figure 2-4. Staged photo of sprockets, keys, and chain (Los Alamos)**

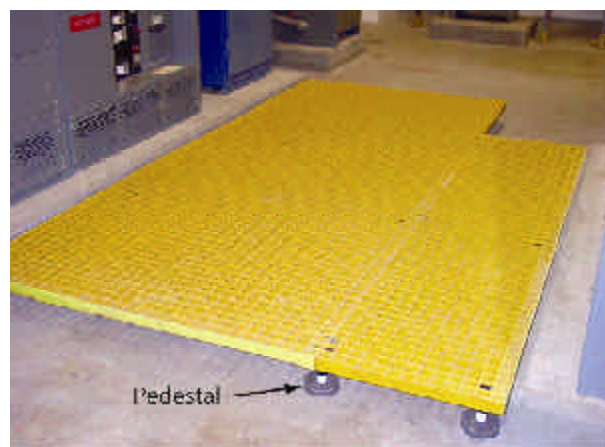
**Figure 3-1. Electrical safety grating**

On May 29, 2004, at the Idaho Advanced Mixed Waste Treatment Facility, an operations technician attempting to retrieve an O-ring underneath an electrical safety grating (Figure 3-1) cut his finger when the grating dropped as he was replacing a pedestal that had fallen. Six stitches were required to close the wound in his finger. Management briefed work crews on using gloves when hand hazards exist and on obtaining shift manager approval before moving guards, flooring, or grating. (Not reported in ORPS)

Investigators determined that retrieving the dropped O-ring necessitated reinstalling the grating—a task the technician performed without first identifying the hazards. He realigned the grating alignment without the proper tools, personal protective equipment, or work instructions to perform the job. The investigation disclosed that the accident could have been avoided by retrieving the fallen item in a different way or by barricading the area and developing work controls for installation of the grating.

Corrective actions included creating and distributing a “Toolbox” (site-specific publication) that outlined integrated safety management areas for improvement and initiating a hand safety information campaign to raise workers’

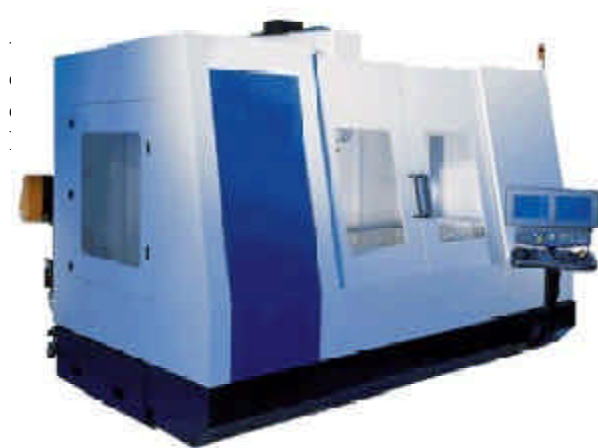
On May 19, 2004, at Lawrence Livermore National Laboratory, a machinist operating a milling machine like the one shown in Figure 3-2 suffered lacerations to his middle and ring fingers when he caught his hand in the conveyor. He needed 20 stitches to close the cuts in his middle finger and 4 stitches in his ring finger. (ORPS Report OAK--LLNL-LLNL-2004-0020; update/final report filed May 27, 2004)

The machinist noticed that the machine's output chute was clogged and cleaned the conveyor system with a metal brush while cycling the machine on and off. After cleaning the conveyor, he noticed that coolant had overflowed from the metal chip discharge chute. He checked the output chute with his right hand to determine the source of the overflow. Unaware that the chip conveyor was running, he entangled his hand in the conveyor system. His fingers were lacerated as he pulled his hand out.

*Figure 3-2. Milling machine similar to the one that cut the machinist*

A window was installed in the output chute so operators could visually confirm that the machine was not operating before cleaning or making adjustments to it. Other milling machines are being inspected and modified using other positive visual means for verifying operational status such as an indicator light or interlock.

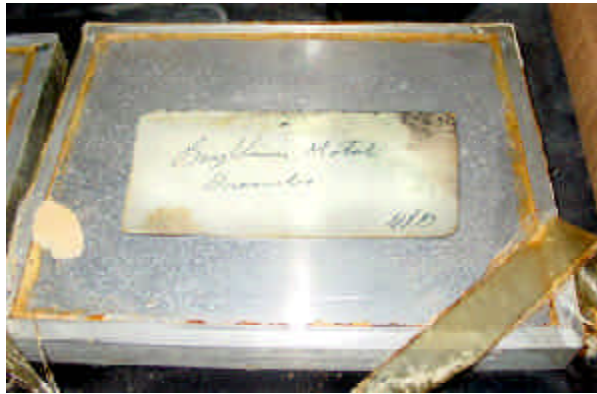
**Figure 4-1. Labeled container**

During a tour of the facility on December 3, 2003, the IH representative found a container with a handwritten label indicating that it contained beryllium metal granules (Figure 4-1). He notified the site D&D managers, who directed workers to lock the building, post it, and barricade the entrances to restrict access. They also ordered the IH representative to obtain follow-up swipes from the immediate area and several other locations in the building as a precaution.

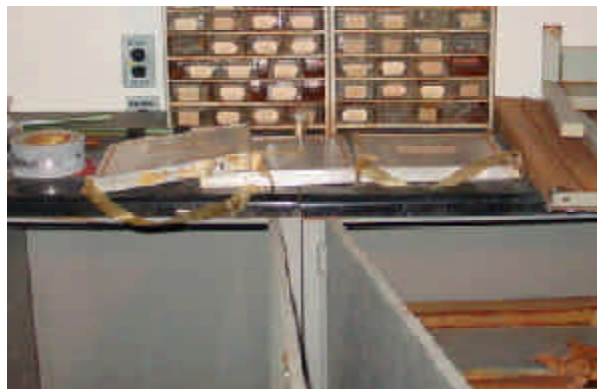
Two months later, in early February 2004, the IH representative took swipe samples from a tabletop where the containers were found (Figure 4-2) and submitted them for analysis. More than a month later, the laboratory returned the

results. Analysis indicated beryllium levels ranging from non-detectable to 11.47 micrograms per 100 cm<sup>2</sup>. Nine out of 24 samples exceeded the 0.2 micrograms/100 cm<sup>2</sup> that the site selected as their criterion for designating an area as a beryllium legacy area.

**Figure 4-2. Area surrounding containers where swipes were taken**
