OPERATING EXPERIENCE SUMMARY

U.S. Department of Energy
Office of Environment, Safety and Health
OE Summary 2004-11
May 31, 2004

1. WORKER INJURED WHEN PERSONNEL HOIST FALLS

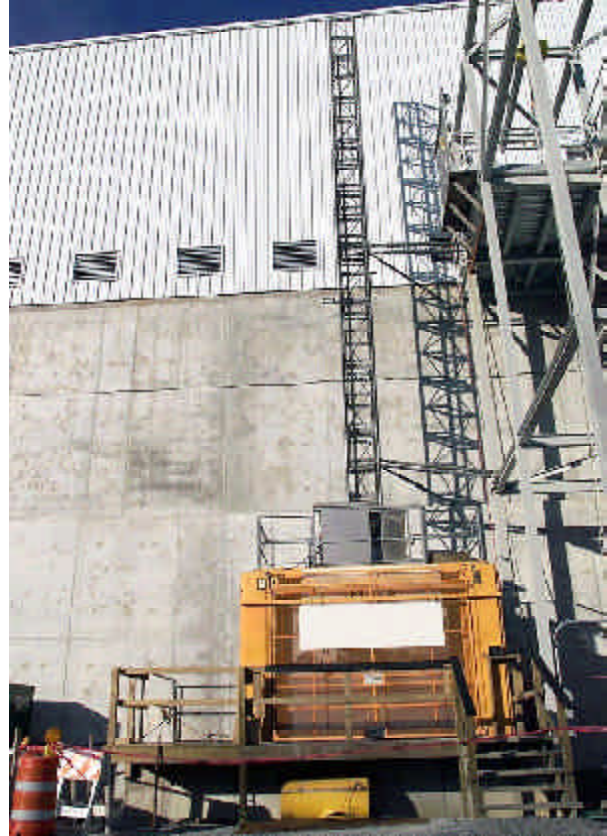
On January 6, 2004, at the Fernald Environmental Management Project, a hoist operator was injured when the car of a personnel hoist dropped approximately 20 feet before a pneumatic safety buffer stopped it. Medical personnel characterized the worker's injury as "soft tissue swelling" in her lower back. Despite a 7-week investigation of the incident, investigators were unable to identify any combination of mechanical or electrical material conditions or personnel errors that caused the incident. (ORPS Report OH-FN-FFI-FEMP-2004-0001, final report filed April 15, 2004)

The rented personnel hoist (one car on a tower) had been in use at the Fernald Silos Project Tank Transfer Area since August 14, 2003. It has a 3-ton capacity and a vertical travel path (lower to upper platform) of 36½ feet. Figure 1-1 shows the hoist involved in the accident. An inspection of the hoist following the incident revealed that the housing for the high speed up/down switch was filled with water. This water probably came from a severe rain storm 2 days

Figure 1-1. Hoist involved in the incident.

before the incident that dropped 3.3 inches of rain. It is possible that the submerged high-speed up/down switch contributed to the occurrence, but investigators could not substantiate this theory. However, they believe the rain may have been the cause of a "squealing" noise heard during hoist operation the day before the incident.

- The manufacturer's manual for the hoist, and a plaque mounted inside the hoist car, state that the hoist is not to be operated with ice on the mast or power cable. The temperature at the time of the incident was 14°F, and there was ice on the mast roller bearings and the power cable.

Because of the lack of conclusive evidence that the hoist failed because of some electrical or mechanical malfunction or personnel action, the reliability of the hoist could not be demonstrated. In accordance with this conclusion, site management decided to dismantle the hoist remove it from the site.

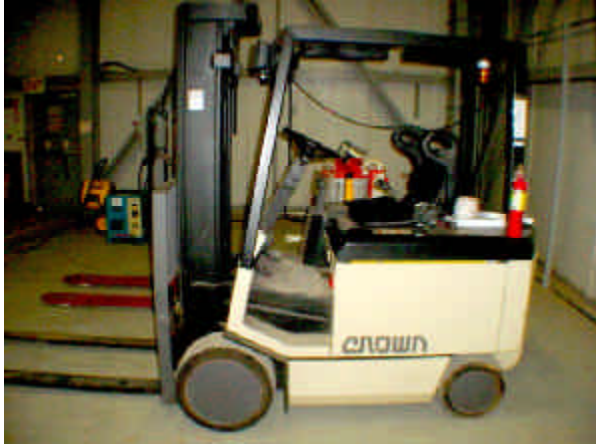
- S/C bolts were discovered in load-bearing areas of the lift systems in CROWN Lift (Figure 3-1) and Allis Chalmers powered industrial trucks. These bolts (Figure 3-2) were marked Grade 5 or Grade 8 and appeared on the DOE Suspect Head Mark List. (ORPS Report RFO--KHLL-D&DOPS-2004-0007)

Figure 3-1. S/C bolts found in this CROWN Lift

In all of these events, the ratchet straps were destroyed, and the trucks were removed from service.

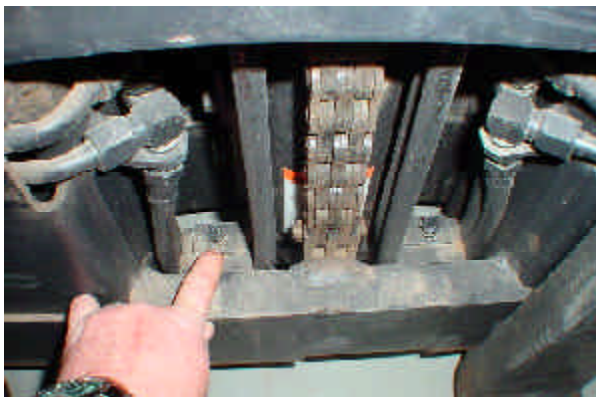
Figure 3-2. Location of S/C bolts in CROWN Lift
