# OPERATING EXPERIENCE SUMMARY

**U.S. Department of Energy**  
**Office of Environment, Safety and Health**  
OE Summary 2004-13  
June 28, 2004

## 1. NEAR MISS — EXPLOSIVE SQUIB FIRES WHILE BEING CONNECTED

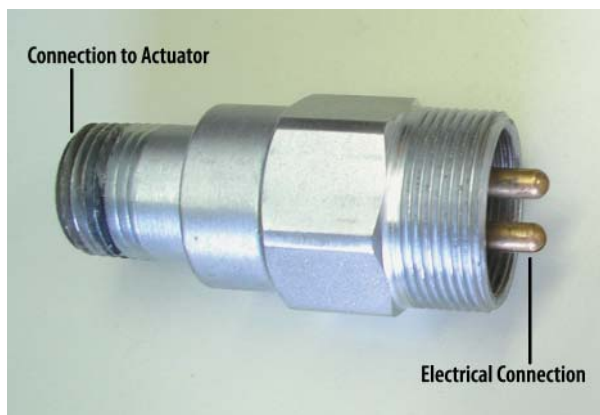
**Figure 1-1. Explosive squib**

Westinghouse Savannah River Company staff was conducting training at the Fire Alarm and Systems Training (FAST) laboratory. The FAST lab is a partnership between Aiken Technical College and the Savannah River Site Fire Protection Engineering Department. The student (from the Savannah River Site) was connecting the squib to an empty Halex AP-7 Halon cylinder when the accident occurred. The Model CDI98J-001 squib (Figure 1-1), manufactured by Cartridge Actuated Devices Inc., contains a 0.875-gram charge of sealed smokeless powder.

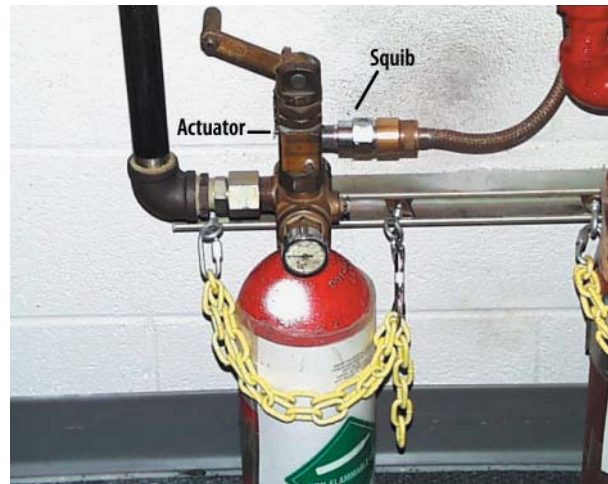
**Figure 1-2. Configuration of cylinder, actuator, squib and electrical connection to squib**

The student verified that the fire alarm panel was not in alarm condition, then connected the squib to the actuator with a grounding disc attached to the connectors. When the squib was threaded to the actuator, the student removed the grounding disc and attached the electrical connector from the fire alarm panel. As he was securing the electrical connection with a threaded retaining nut, the squib fired, causing the electrical plug portion of the squib to fragment and discharge debris (Figure 1-3). The debris struck the student and was scattered over a 20-foot area. The student was wearing only safety glasses; he was not wearing gloves or long sleeves.

The investigation team considered several possible scenarios but could not positively determine the primary cause of the accident. One scenario involved static discharge as an ignition source. During the event, the fire alarm panel indicated several ground-fault trouble alarms that could have been caused by a bare squib conductor coming in contact with ground. The student could have developed a static charge as he moved across the carpet, and the squib could have been ignited through a static discharge between the bare squib conductor and ground. A panel malfunction could also have ignited the squib; however, investigators found no evidence of a malfunction. Also, the team ruled out high temperature because of the large heat sink provided by the actuator. In addition, the student did not sense a high temperature while handling the actuator.

The other issue of concern was the failure of the squib at the electrical connection, which resulted in the flying debris that injured the student. When the Halex actuator was disassembled, investigators found it was difficult to move the plunger and that a large amount of powder residue had collected inside the actuator. Normally the actuator is inspected following a Halon discharge. However, this training system is attached to an empty cylinder, and a program was not established to check the function of the actuator following a squib firing. Therefore, powder residue continued to accumulate after each firing of the squib, and the actuator was never cleaned. Team members believe that inadequate venting through the actuator allowed pressure to build up inside the actuator and squib until failure. The accumulation of powder residue and its ability to degrade the actuator's performance were not recognized as a hazard in the training setup.

Corrective actions included stopping all live firing during training to prevent classroom accidents. The activity hazard analysis and work instructions were revised to require wearing safety glasses, faceshield, and gloves when working on fire protection squib systems.

A precaution to stay clear of the line of fire was also included in the hazard analysis.

In addition, requirements were included to wear electrostatic ground straps when replacing or installing squibs and to perform a hazardous energy control lockout on the fire circuit before installing a squib. No lockout had been required because the connection involved only a 24-volt plug.

The work instructions were also revised to include inspecting and manipulating the Halon actuator movement before replacing a squib. The DOE *Explosives Safety Manual* (DOE M 440.1-1) will be reviewed for guidance on minimum safe distance between radio frequency (RF) transmitters and explosive devices and to determine if these precautions apply to working on fire protection squib circuits. Engineering calculations determined that any RF energy induced on the squib would have been well below the safe "no fire" level.

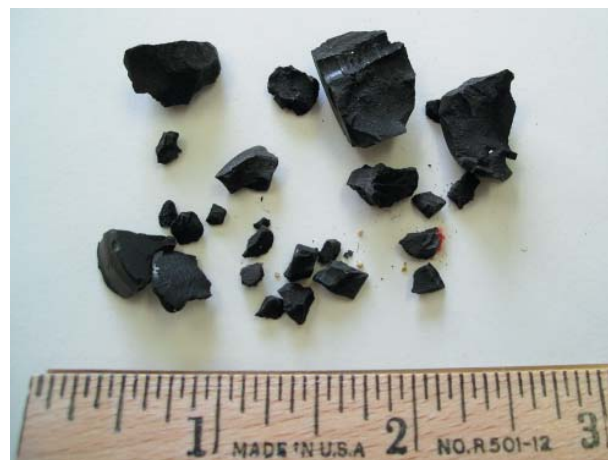
**Figure 1-3. Debris expelled from inside electrical connection on squib**

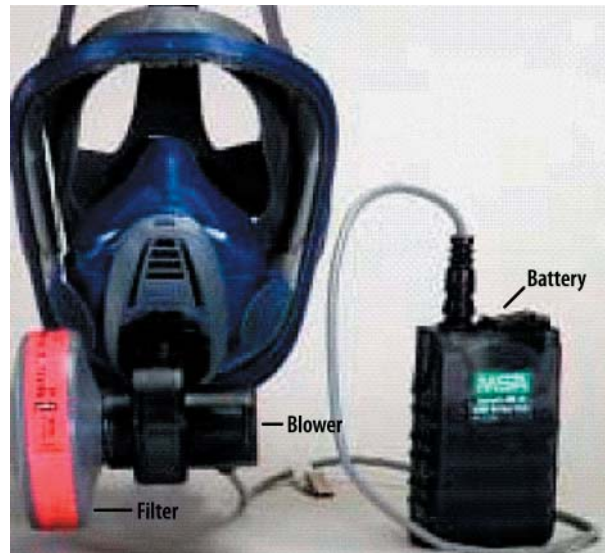
Powered Air-Purifying Respirators (PAPRs) protect workers by filtering particulate contaminants pulled through a filter by a battery-powered blower. If the filter is not in place, the respirator offers no protection. On May 11, 2003, at the Brookhaven National Laboratory (BNL), a worker in an airborne contamination area was potentially exposed to radiological contamination when the Type HE OptiFilter XL® filtering cartridge became dislodged from the blower on a Mine Safety Appliances (MSA) Model OptimAir® MM2K with an Advantage 3000 facepiece (Figure 2-1).

*Figure 2-1. Powered Air-Purifying Respirator unit*

- Mis-threading the filter to the blower unit in a manner that allows the filter to attach without being fully seated is possible if the unit is not properly aligned. In this scenario, the filter can remain on the blower and permit a negative pressure fit check but become dislodged with relatively minor forceful contact of the filter with a surface. Because the worker installed the filter while wearing double gloves, the tactile function to detect improper installation would have been decreased. Because the facepiece was already donned, direct line of sight of the threading of the filter was not possible. BNL investigators concluded that cross-threading of the filter is the most likely scenario to explain the event.

Since this event, an MSA representative has trained BNL workers on how to assemble the respirators and filters, how to properly don the facepiece, and how to prevent common errors in the use of the equipment. A manufacturer's representative for another PAPR used at BNL conducted similar training on their unit.

An outcome of this training and the BNL investigation has been a change in the mechanisms for donning PPE. Before this event, workers donned the facepiece without the filter installed and taped the facepiece to the protective clothing suits to maximize protection from particulate infiltration. The filter was not installed until the last step to minimize breathing resistance for the worker. As a result of training and written instructions from MSA, workers now install the filter before they don the facepiece, and the unit is powered while they complete the dressing-out procedure. By assembling the filter before donning the mask and gloves, workers can ensure that they have maximum visibility and dexterity. This procedure also allows for close inspection of the seating of the filter.

BNL management has instituted an upgrade to its sitewide training program to include detailed instructions on the assembly and points of concern for each respirator style used. The improvements include hands-on training in cartridge assembly and development of practical qualification criteria to verify proficiency.

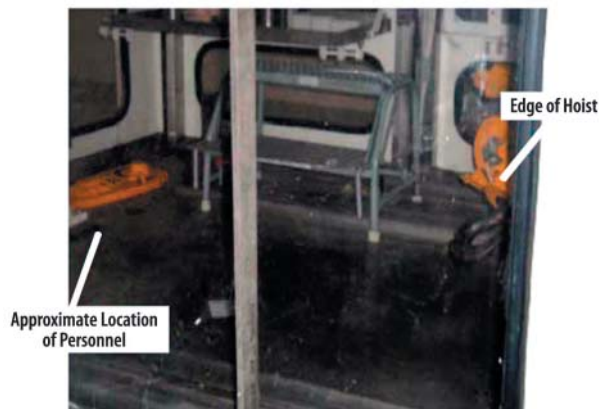
On June 7, 2004, at Oak Ridge National Laboratory, failure to plan work as a critical lift<sup>1</sup> instead of an ordinary one resulted in a load being dropped near two workers. Workers noticed binding of a load, jogged the crane, and successfully cleared the rail from the wedge guide, but the rail began tilting off-horizontal, causing the load to shift. When the 1-ton hoist tilted, and the load shifted, C-clamps and a restraining rope failed. The hoist dropped 12 feet, coming to rest approximately 5 feet from the two workers (Figure 3-1). Neither worker was injured. (ORPS Report ORO--ORNL-X10NUCLEAR-2004-0003)

**Figure 3-1. Location of hoist following dropped load**

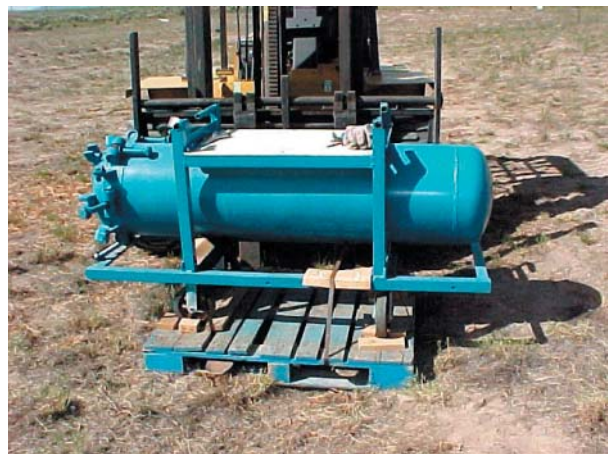
When the workers discovered the leak, they made the necessary notifications, placed the cylinder into a nearby overpack cylinder (Figure 4-1) they had staged for unexpected leaks, performed initial stabilization of the area, and evacuated. About 90 minutes later, the site area emergency was terminated.

**Figure 4-1. Overpack containing the leaking cylinder**
