OPERATING EXPERIENCE SUMMARY

- *Runaway, unattended vehicles result in near misses..... 1*
- *Check sources may leak in some Thermo Electron Detectors..... 3*
- *Too little crane cable on hoist drum results in near miss..... 4*
- *Good practices for safe use of multimeters 5*

U.S. Department of Energy
Office of Environment, Safety and Health
OE Summary 2004-14
July 12, 2004

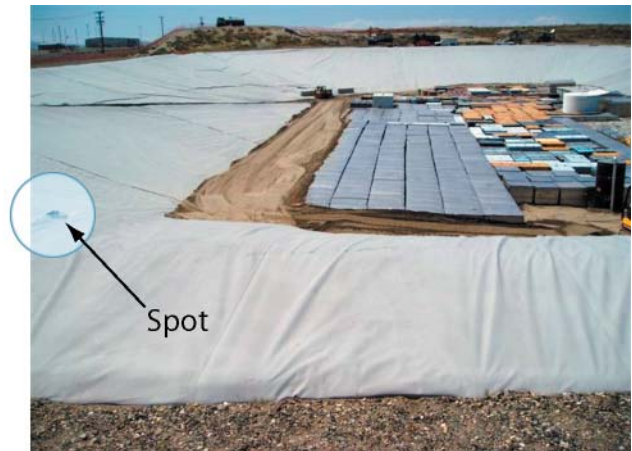
In the Hanford incident, a nuclear chemical operator left his truck to make a phone call, and did not pull on the parking brake. He left the engine running and the transmission in gear, and the idle speed was sufficient to move the truck about 25 feet uphill. Another operator saw the truck heading toward the trench, jumped into it, and managed to stop it just before it went over the edge into the trench (i.e., approximately 3 feet from the edge). Figure 1-1 shows the trench, the rain cover surrounding it, and approximately where the truck stopped. Following this incident, management established a precautionary 20-foot vehicle exclusion zone around the mixed-waste trenches. The accident is still under investigation.

Figure 1-1. Trench, rain cover, and approximate spot where the truck was stopped

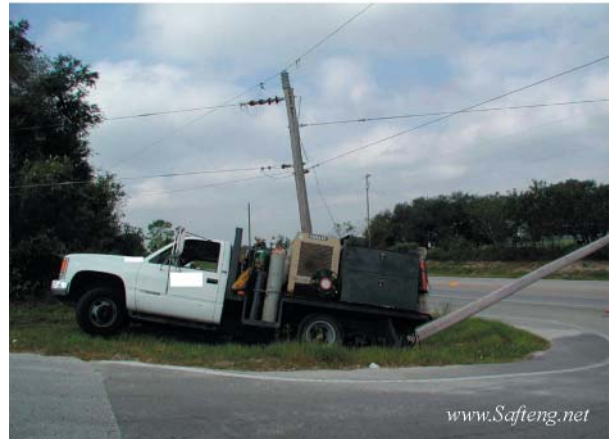
Industry also has had its share of accidents attributed to unattended, runaway vehicles. Figures 1-2 and 1-3 show the results of an accident that occurred when a gas company welding truck rolled backwards 162 feet, hit a utility pole, and snapped it in half. The bottom half of the pole (Figure 1-2) stopped the truck from continuing to roll across a busy state highway.

Figure 1-2. Welding truck after the accident

Each of these accidents resulted in thousands of dollars in damages and could have resulted in injuries or death. If the drivers had simply turned off the engine and set the parking brake when they exited their vehicles, the accidents could have been prevented. At most DOE sites, safety procedures for trucks and similar vehicles direct drivers to set parking brakes and apply chocks when leaving the vehicle unattended. State manuals for commercial driver's licenses provide similar direction. Managers and supervisors should regularly stress the importance of these actions.

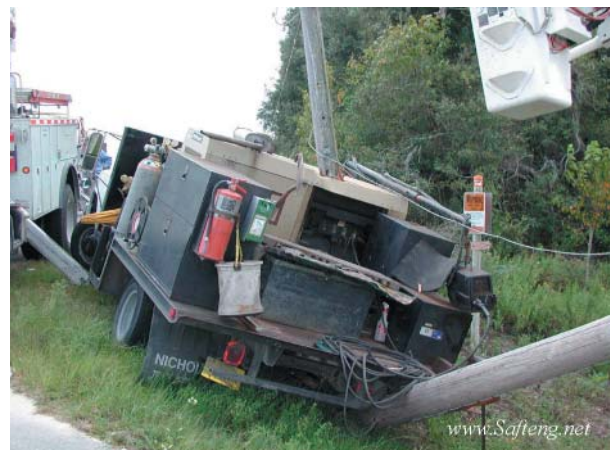
Figure 1-3 shows what remained of the top section of the pole, which fell onto the recently topped-off 200-gallon diesel fuel tank. In this case, an unset parking brake and an unattended vehicle nearly led to a major vehicular accident, downed power lines, and contact with electrical conductors.

Figure 1-3. Truck and top section of utility pole

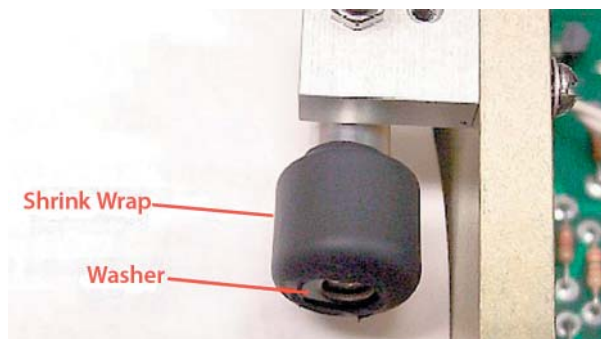
On June 24, 2004, at the Savannah River Site, an inspector found a leaking check source in a Thermo Electron Gamma Remote Detector (Model DA1-6CC). Further investigation revealed that the strontium/yttrium-90 source did not meet original specifications and that heat-shrink tubing (Figure 2-1) and a washer (Figure 2-2) had been installed on the source to reduce the beta dose rate. (ORPS Report SR-WSRC-HPIH-2004-0001; SELLS identifier 2004-SR-WSRC-0034)

The Radiological Protection Services organization at Savannah River, which has purchased 24 of these detectors in the past year, found a total of 4 sources with activity levels up to 10 times higher than similar models. A

Figure 2-1. Modified check source

Thermo Electron investigated and found that a modified process for applying the source material caused the subcontractor it employed for manufacturing certain check sources after August 30, 2000, to inadvertently apply excess material. When Thermo Electron received the assembled sources and detected high source readings, factory workers installed washers and applied heat-shrink tubing to reduce the dose rate. However, heat-treating degraded the Mylar window containing the source material, causing leakage from some sources.

Sites using Models DA1-1, DA1-6, and DA1-8 containing CS-19, CS-19S, and CS-20 check sources manufactured after August 30, 2000, should check them for external contamination. Any contamination should be removed before opening the housings. Personnel should leak-test the check sources. If a source is leaking,

the detector should be treated as potentially internally contaminated. Sources that are not leaking should be checked to see if they were modified using heat-shrink tubing around the check source body. Those with the shrink tubing should be contained and removed from the detector housing. Unmodified sources can be reassembled and returned to service.

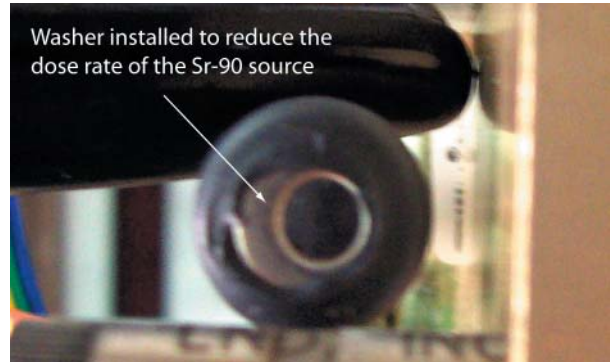
Figure 2-2. Closeup of washer installed in source

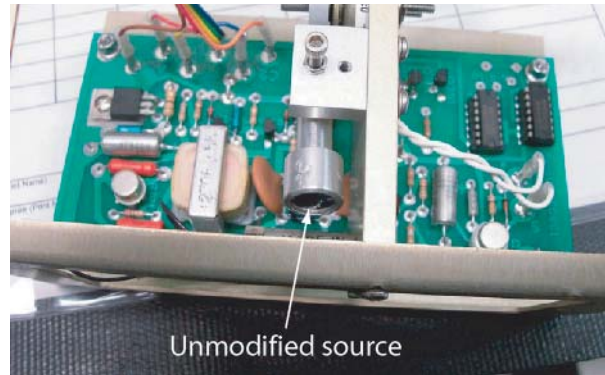
site representative contacted Thermo Electron (formerly Eberline) to determine the reason for the altered configuration. Figure 2-3 shows an unmodified check source.

Figure 2-3. An unmodified source

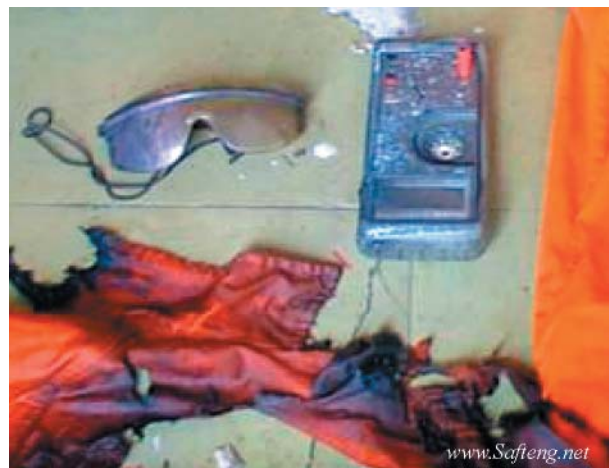
The following event, reported on the Network for Safety Professionals web site (URL <http://www.SAFTENG.net>), illustrates what can happen when a multimeter is used incorrectly. A worker was attempting to take voltage measurements with a multimeter inside a 480-VAC circuit breaker cabinet. He had the meter selected to read voltage but had the test leads plugged into the meter sockets for measuring current. This meter configuration produced a short circuit and electrical arc that burned the worker over 40 percent of his body. Figure 4-1 shows the remains of the multimeter, and Figure 4-2 shows the inside of the electrical cabinet.

Figure 4-1. Accident victim's clothing, destroyed digital multimeter, and damaged safety glasses

The report does not provide any information as to the worker's skill level or experience, but it is clear that this event resulted from the worker's inattention to detail.

These events underscore the need to safely use multimeters and electrical testing equipment on energized circuits. In addition, it is very important to (1) choose a multimeter that is rated for the proper voltage, (2) inspect it for damage, and (3) verify that it operates before use. Users should consider voltage test instruments as part of their personal safety equipment.

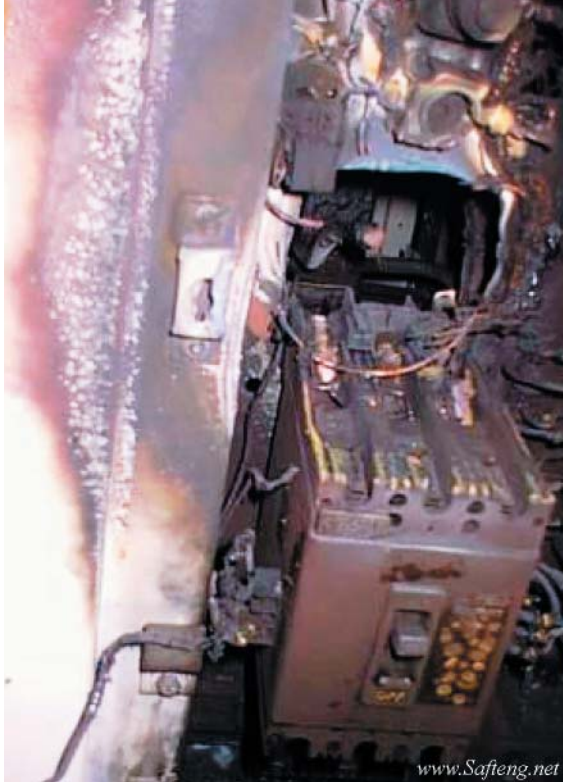
Figure 4-2. Damaged electrical cabinet
