OPERATING EXPERIENCE SUMMARY

U.S. Department of Energy
Office of Environment, Safety and Health

OE Summary 2004-16

August 9, 2004

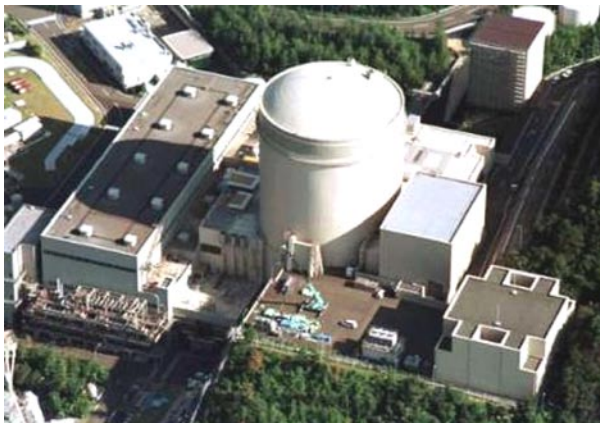
The accident occurred in the turbine building of the pressurized water reactor operated by Kansai Electric Power Company (Figure 1-1). There was no release of radiation because the breached pipe was not part of the reactor primary piping system.

Figure 1-1. Turbine building to the left of the reactor building (center)

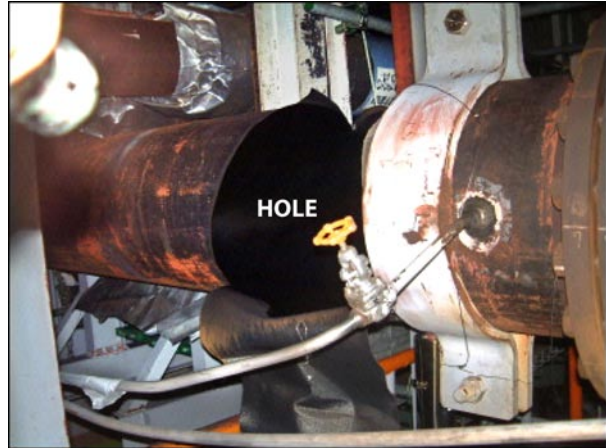
Steam at 518°F blew a 2-foot-wide hole in the carbon steel pipe as shown in Figures 1-2 and 1-3. Initial measurements by investigators showed that the section of piping had thinned from its original thickness of 10 millimeters to 1.4 millimeters at the thinnest section. The minimum thickness to maintain proper safety was reportedly 4.7 millimeters. The plant operator had visually inspected the pipe, but never performed ultrasonic tests or radiography to measure the thickness of the pipe. Japan's nuclear and industrial safety agency ordered four other power companies that operate similar reactors to perform ultrasound inspections on plant piping systems.

Figure 1-2. Breached large-diameter pipe

In both events, wall thinning was caused by erosion/corrosion. Before the Surry event, single-phase carbon steel piping runs were not generally inspected for potential wall thinning because they were not thought to be susceptible to thinning from erosion/corrosion.

The disastrous event in Japan underscores the importance of periodically assessing the integrity of piping systems to reduce the potential for injury and damage to equipment caused by erosion/corrosion.

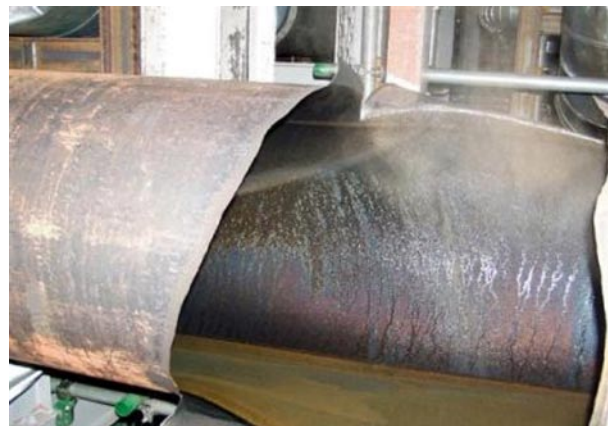
Figure 1-3. Close-up of pipe break

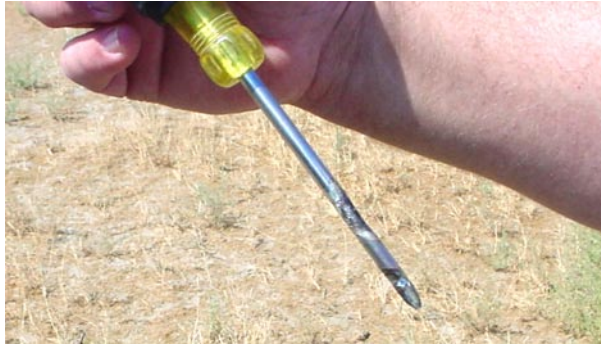
A similar event occurred at the Hanford Cold Test Facility, where a subcontractor electrician received minor flash burns to his left forearm and his neck when an electrical arc occurred while he was installing a circuit breaker in a distribution panel. The 480-volt panel was energized, and neither a lockout/tagout nor an

Figure 2-1 shows the screwdriver after it accidentally made contact between the breaker C-phase, line-side lug and the grounded mounting plate as the electrician attempted to install the lower mounting screw for the circuit breaker. The resulting arc flash burned the electrician and caused him to jump back from the work area.

Figure 2-1. Burned and damaged screwdriver

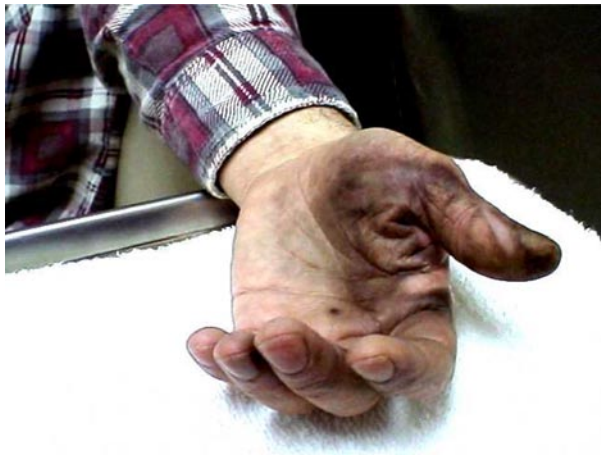
In another event, at Sandia National Laboratory–New Mexico, a maintenance electrician caused a short circuit and received electrical flash burns to his left hand (Figure 2-2) and one finger on his right hand while troubleshooting an energized 120/208-volt power strip. The electrician used a generic work order that did not require a lockout/tagout of the power strip. (ORPS Report ALO-KO-SNL-NMFAC-1999-0002)

Figure 2-2. Flash burns to electrician's hand

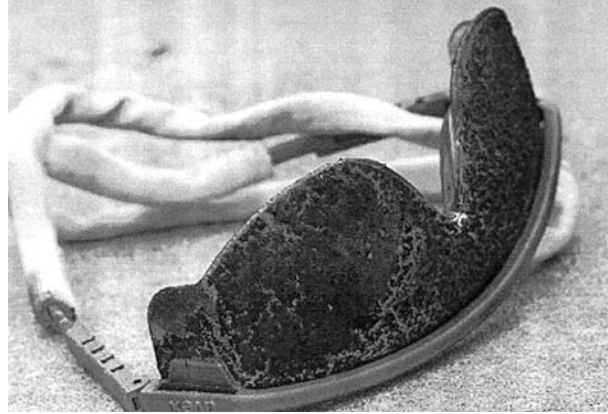
At the Kansas City Plant, an electrician received third-degree burns that required skin grafts to his face, neck, arms, and hand from an electrical flash. Figure 2-3 shows the electrician's scorched

Figure 2-3. Electrician's safety glasses

safety glasses. The electrician was performing preventive maintenance inside a 13.8-kV switchgear cabinet in a substation. He was cleaning out the cabinet with a paintbrush and did not know that surrounding equipment was energized. A Type B Accident Investigation Board was unable to determine the exact event scenario, but they believe that either debris falling onto energized components or the electrician's shirt sleeve contacting energized equipment caused an electrical fault. (ORPS Report ALO-KC-AS-KCP-1998-0010)

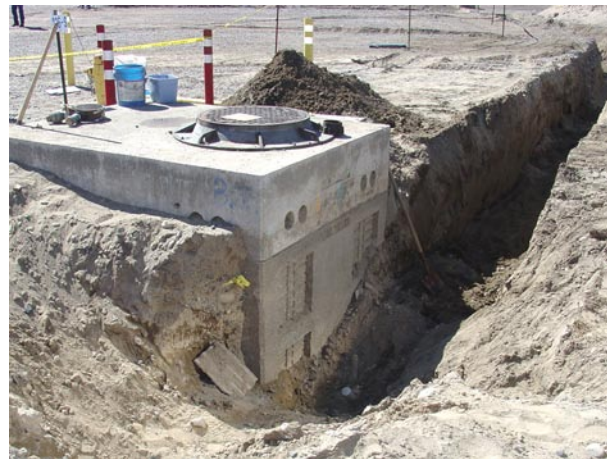
The scope of the excavation work was to expose the water main and measure it for a saddle so a tap could be installed the following day. An excavation permit was in place that required hand-digging within 5 feet of the buried utility. No one was providing oversight for the work because the scope was simply to expose and verify the size and type of pipe. The drawing used when planning the water tap did not show the short length of 2-inch-diameter pipe, which was one of many saddle stubs used to inject chlorine into the pipeline during its construction. Figure 3-1 shows the excavation site.

Figure 3-1. Excavation trench

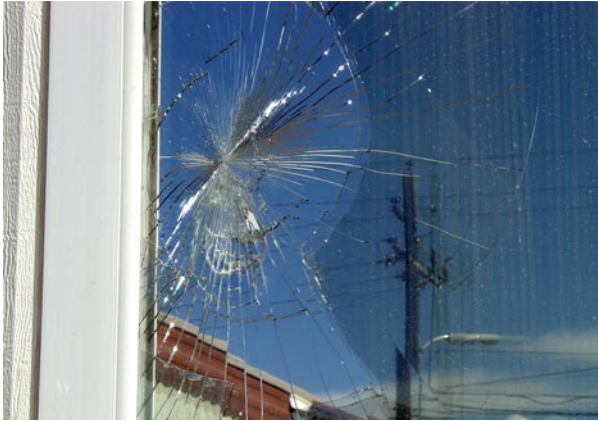
The excavation crew consisted of two construction workers and a radiological control technician (RCT). When the backhoe operator breached the pipe, the two construction workers (one in the backhoe) were near the trench, and the RCT was over 100 feet away. During the initial stage of the water jetting, the building emergency director determined that two people inside one of the trailers were safe and did not need to evacuate. However, about halfway through the event, the backhoe operator lowered the bucket over the water jet, which changed the direction of the water flow causing rocks in the trench bank to become projectiles. The flying debris broke a window in a trailer (Figure 3-2) that was 120 feet from the leak, and rocks fell onto the roof of the occupied trailer.

Figure 3-2. Shattered window on trailer

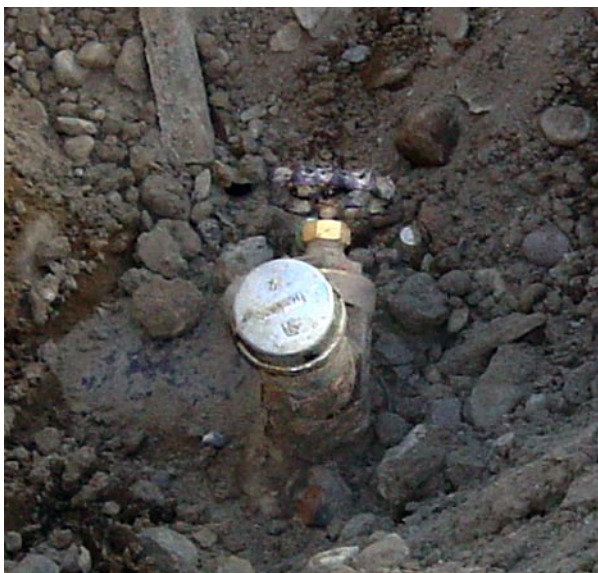
Investigators learned that the chlorination stubs, which are common on water mains at the Hanford site, intentionally were not shown on drawings because there are so many of them. Water utilities personnel knew about the stubs, but the excavation crew did not know they were in the area they were excavating.

Figure 3-3. Chlorination stub attached to water main

The Hanford procedure for excavation, trenching, and shoring will be revised. The new excavation permit form will include special instructions stating that when water utilities are involved, there may be chlorination stubs in the area, even if they are not shown on the drawings.

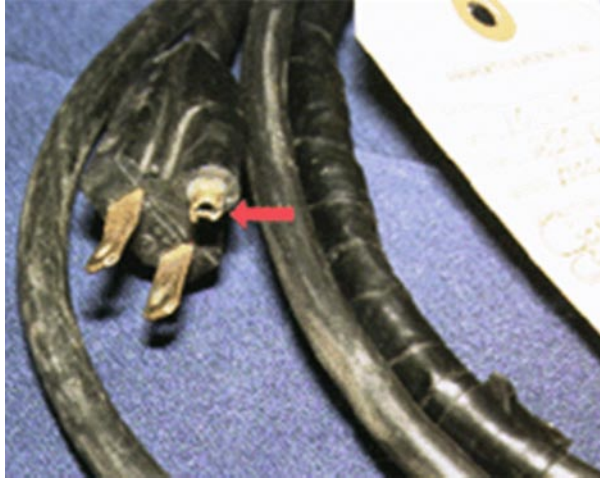
It is important to take precautions to avoid nicking or cutting power cords when working with powered tools such as saws or hydrolances, but it is also essential to check power cords for any sign of damage or breaks in the insulation before using them. Figures 4-1 and 4-2 are examples of damaged cords that should be replaced.

Figure 4-1. Worn cord and damaged grounding prong

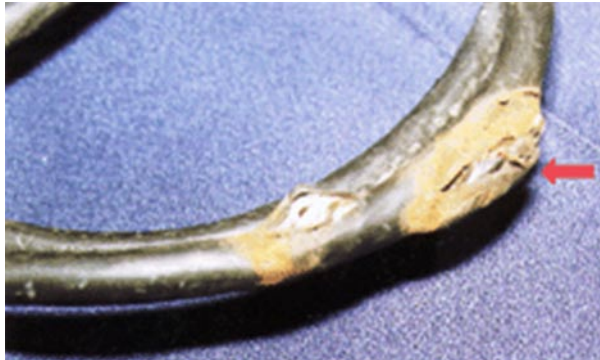
Figure 4-2. Cord with damaged insulation
