OPERATING EXPERIENCE SUMMARY

**U.S. Department of Energy
Office of Environment, Safety and Health
OE Summary 2004-18
September 20, 2004**

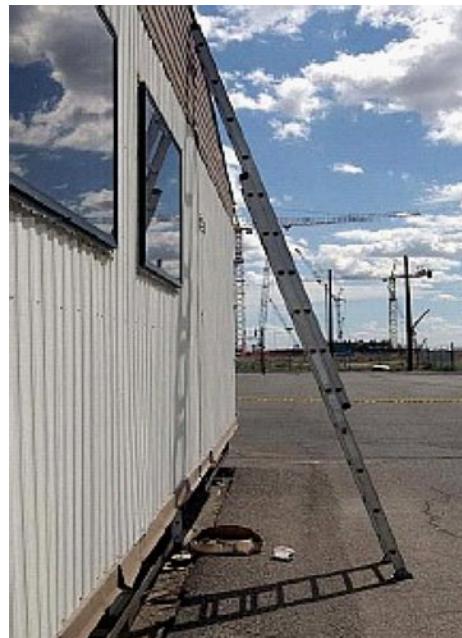
- The worker apparently was standing on the ladder approximately 5 to 6 feet off the ground removing screws from the aluminum trim of an office trailer to prepare it for transport to its new owner. Figure 1-1 shows the ladder propped against the trailer.

Figure 1-1. Ladder and trailer involved in the accident

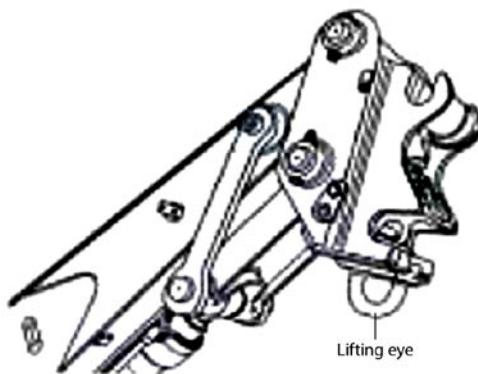
Figure 3-1. Lifting eye

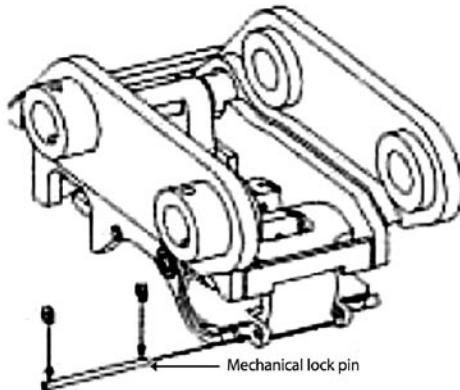
Figure 3-2. Retrofit lock pin

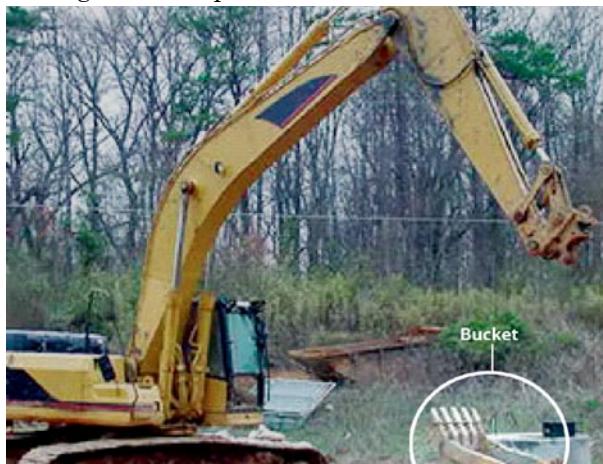
sections onto a truck. The victim was on the ground connecting the sections to the excavator while his co-worker was on the truck waiting to disconnect the sections after loading. The operator positioned the excavator bucket near a manhole section while the victim attached a three-legged bridle to the manhole section to lift it. The bucket unexpectedly disconnected from the excavator stick, struck the victim, and killed him. Figure 3-3 shows the bucket on the ground after it detached from the excavator stick.

Figure 3-3. Excavator and dropped bucket

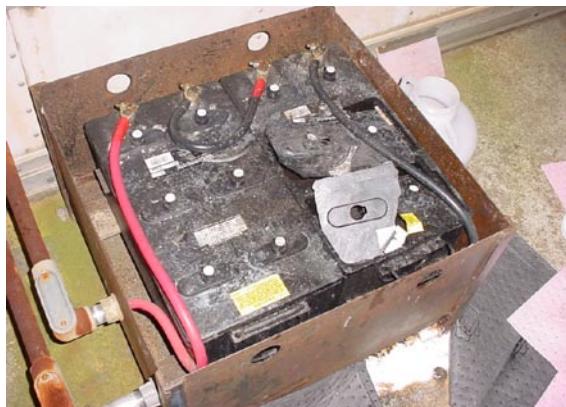
Maintenance workers were in the process of conducting a no-load test of the diesel generator following preventive maintenance on the battery and battery charger. When the diesel start signal was initiated, they heard a loud "bang" at the battery box and saw liquid leaking from the box. Figure 4-1 shows the battery box. A sizzling, electrical noise could be heard coming from the batteries, so they opened the battery disconnect switch to isolate the batteries from the diesel start circuit, and the electrical noise ceased. The workers initiated a spill response, and responders positioned spill control pillows and applied soda ash to the spilled liquid to neutralize the electrolyte.

Figure 4-1. Battery box containing failed battery

Corrective actions included evaluating the adequacy of the preventive maintenance frequency for battery replacement based on the published warranty life. The service life of similar batteries in other systems/plant areas where catastrophic failure is possible will also be evaluated. Consideration will be given to replacing NAPA batteries within 30 months from initial installation. Some systems use Caterpillar batteries, and they will be replaced within 36 months of installation.

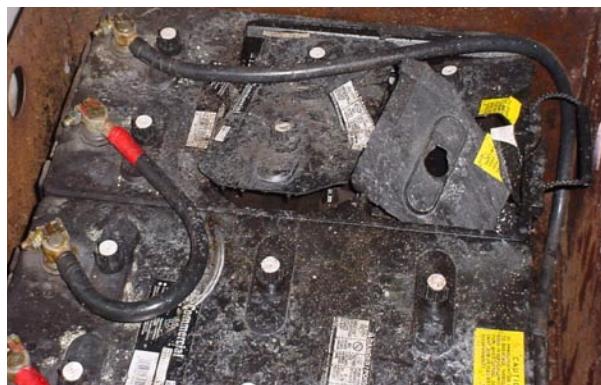
As part of the investigation, the failed battery was shipped to NAPA Batteries/Exide Technologies (manufacturer) for examination. The manufacturer found advanced grid corrosion, positive grid growth, cracked positive grid frames, and open welds; all of which are consistent with batteries that have served their expected life. The 30-month battery had been in service for 38 months. Investigators believe that constant charging current could have contributed to internal component degradation that ignited hydrogen gas inside the battery. Figure 4-2 shows a close-up of the failed battery.

Figure 4-2. Damaged top of failed battery cell

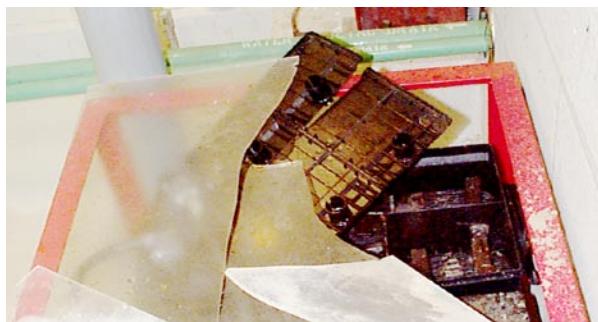
On March 8, 1999, a battery exploded while workers were starting a diesel-driven fire pump for a weekly test run at INEEL. An operator was 20 feet away when the battery ruptured, spilling a quart of acid on the floor. The battery had not been inspected for 18 months and had been in service for 5 years. Figure 4-3 shows the damaged battery bank.

Figure 4-3. Damaged plastic cover over battery bank

An inspection of the battery indicated that the electrolyte levels were low and corrosion had formed around a fractured bus bar inside the battery. The battery manufacturer believes that low electrolyte contributed to lead corrosion and expansion inside the battery case that fractured the bus bar. The fractured bus bar produced an arc that ignited battery gases when the operator attempted to start the diesel fire water pump.
