OPERATING EXPERIENCE SUMMARY

U.S. Department of Energy
Office of Environment, Safety and Health
OE Summary 2004-19
October 4, 2004

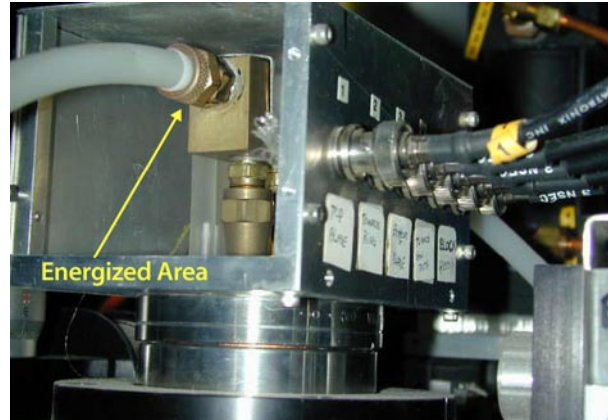
Figure 1-1. Beam position monitor and location of the energized nut

The researcher met with the technician and helped him remove the front plate of the box around the top of the monitor to access the hose connection inside. The researcher told the technician that the beam position monitor motors were off (signal/power cables with bayonet-type [BNC] connectors were disconnected from the motor controller at the time). Believing that area was safe, the technician reached inside with his wrench and made contact with the nut that secured one of the hoses, while his other hand was touching the aluminum foil surrounding the beam pipe, and immediately received an electrical shock. Figure 1-1 shows the hose and connection nut inside the box on the beam position monitor.

A team of experts from the electrical section located the source of power to the beam position monitor, de-energized it, and locked and tagged it out. Later, during controlled testing they determined that the power supply could provide approximately 300 volts DC and 18 milliamperes.

A causal analysis of this incident was conducted and investigators identified six factors that, if corrected, would have prevented this event. The following is a summary of these causal factors.

1. The technician assumed that the system was in a safe configuration to begin work based on the actions and information given by the researcher. He did not seek confirmation that power was off. The technician is lockout/tagout-qualified and should have taken steps to ensure all high voltages were locked and tagged out and verified the absence of energy.

2. The researcher was not aware that the beam position monitor was energized at 300 volts and not aware of the location of the power supply. Although she had used the equipment, the researcher was not knowledgeable about either the hazards or how to safely secure the monitor.

3. A caution sign that clearly warned of hazards (i.e., "300 VDC Power Supply") inside the box was found lying face down near it. The tape holding the sign had degraded over time, and the sign eventually fell off.

4. Previous use of a lockout/tagout to secure the power supply was not documented, resulting in a loss of historical information. In April 2001, the hoses were replaced without incident because a lockout/tagout was used; however, when the job was scheduled again for this year, no one could remember the hazards.

5. Based on the material covered in a safety training module the researcher believed that BNC cables were only used for less than 50 volts AC or DC. Although information in the safety training module limits the use of BNC cables and connectors for new applications to less than 50 volts, there was no mention that older, existing BNC cabling could contain higher voltages.
6. Equipment responsibility was not adequately assigned for the beam position monitor. The department list of equipment and responsible persons was incomplete and did not identify a person responsible for the photon beam position monitor.

DO NOT ASSUME that the system is in a safe configuration to begin work. Always verify that hazards have been isolated.

This event illustrates the importance of conducting a proper hazards identification and use of physical barriers, such as a lockout/tagout, to prevent electrical shock or injury. Subject matter experts should be consulted in this process to ensure that all hazards are addressed and correct isolation points are identified. Work procedures for maintenance activities should include standardized lockout/tagouts and zero-energy checks, which improve job preparation and document important safety information, thus eliminating reliance on recollection or inexperience.

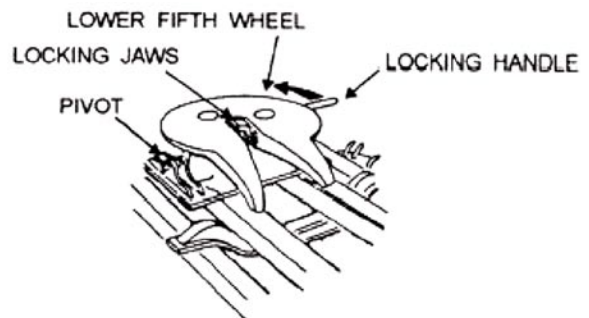
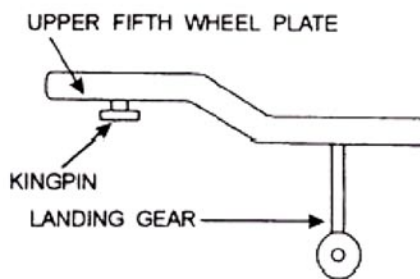
Figure 2-1. Diagrams of lower and upper fifth wheels

A tractor and trailer are joined together by a fifth-wheel coupling, which consists of two metal plates: the lower fifth wheel, which is mounted on the tractor; and the upper fifth wheel, which is mounted on the trailer (Figure 2-1). The upper fifth wheel consists of a flat plate and a kingpin. The lower fifth wheel has locking jaws that lock around the kingpin to connect the tractor and trailer. The two parts, locked together, allow rotational and vertical movement between the tractor and trailer.

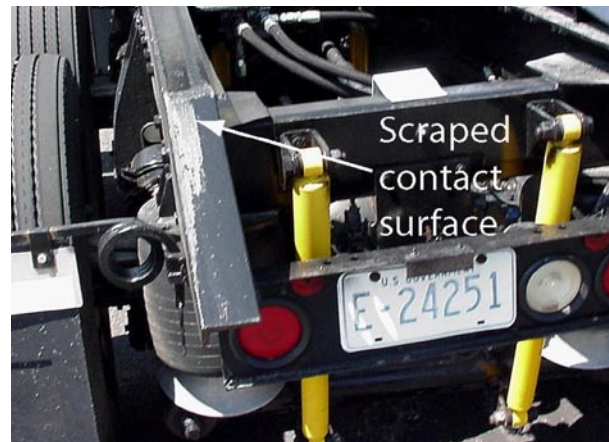
Figure 2-2. Upper fifth-wheel plate

Investigators determined that the kingpin (shown in Figure 2-2) was probably not fully engaged and locked during the coupling procedure. They believed that the trailer was likely too high when the coupling procedure was initiated. This allowed the fifth wheel latch to engage but not completely grasp the kingpin. In effect, the kingpin was resting on a lip within the fifth-wheel latch and was not completely secured. This condition allowed the operator to think that the coupling was completed. When the operator accelerated from a dead stop, the trailer kingpin lifted out of the fifth-wheel latch and the trailer slid off the tractor and fell to the pavement.

As a result of this event, the following corrective actions have been completed:

- The drivers and independent verifiers were trained to visually check the coupling and sign off per procedure that a positive coupling had been made before any movement of a trailer.
- Complete vehicle inspection checklists and coupling charts with [pictures](#) (courtesy of the Holland Group, Inc.) are provided to the driver and independent verifier so that they know exactly what to look for to ensure a positive hookup to the trailer. This information is available on each tractor.
- After verification of positive coupling, a pull test is performed to verify positive hookup.
- Lights have been installed on the tractors to assist in coupling verification.

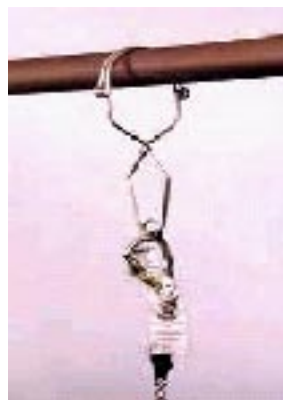
Figure 3-1. A spring-loaded wire form anchorage connector

The Occupational Safety and Health Administration (OSHA) recently issued a safety and health bulletin on the hazards of misusing wire form anchorage connectors (Figure 3-1) for fall protection. These are used as portable and temporary connectors for fall-arrest systems and to position equipment.

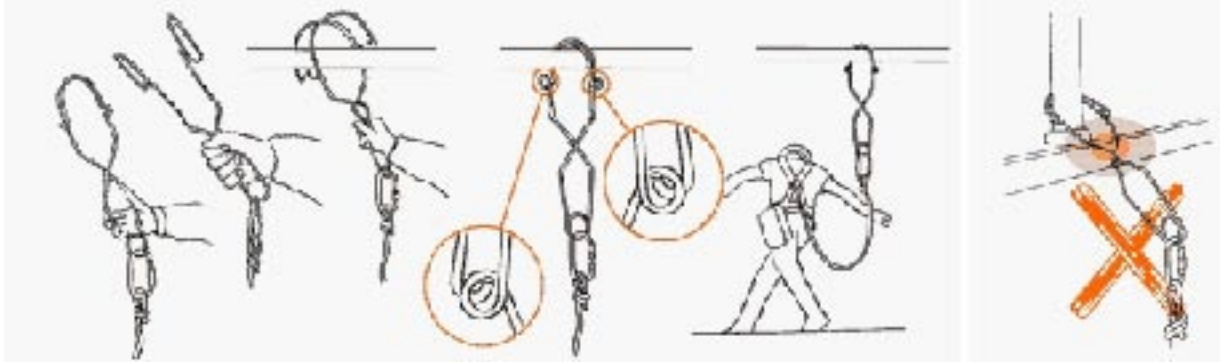
Figure 3-2. Correct (left) and incorrect (right) way to connect to an anchorage

OSHA issued the bulletin following a fatal accident in North Dakota that occurred when a worker used a spring-loaded wire form anchorage connector as part of a fall-protection device while upgrading the structural members of a tower. The worker fell approximately 75 feet when the device failed.

The worker apparently attached the wire form anchorage connector to a diagonal tower member instead of connecting his fall arrest system directly to an anchorage, as the manufacturer recommends. Figure 3-2 illustrates the difference. This positioned the anchorage connector so that the worker's weight exerted a significant side load on the connector. These connectors are designed to be used vertically by being hooked to an anchorage directly above the worker — they are not designed to hold side loads.

The OSHA bulletin included requirements for the use of personal fall-arrest systems and positioning device systems for construction, which are given in 29 CFR 1926.502 9(d) and (e). In addition, the bulletin advises:

- Employers must only use personal fall-arrest system connectors and positioning device system connectors that meet applicable OSHA regulations.
- Employers must train employees on the appropriate use of personal fall-arrest systems and positioning device systems and ensure that such systems are connected only to compatible components.

- Contractors and other employers should review manufacturer instructions and markings and must ensure that the wire form anchorage connector is the appropriate anchorage connector for the situation and work environment in which it will be used.
