OPERATING EXPERIENCE SUMMARY

U.S. Department of Energy
Office of Environment, Safety and Health
OE Summary 2004-21
November 1, 2004

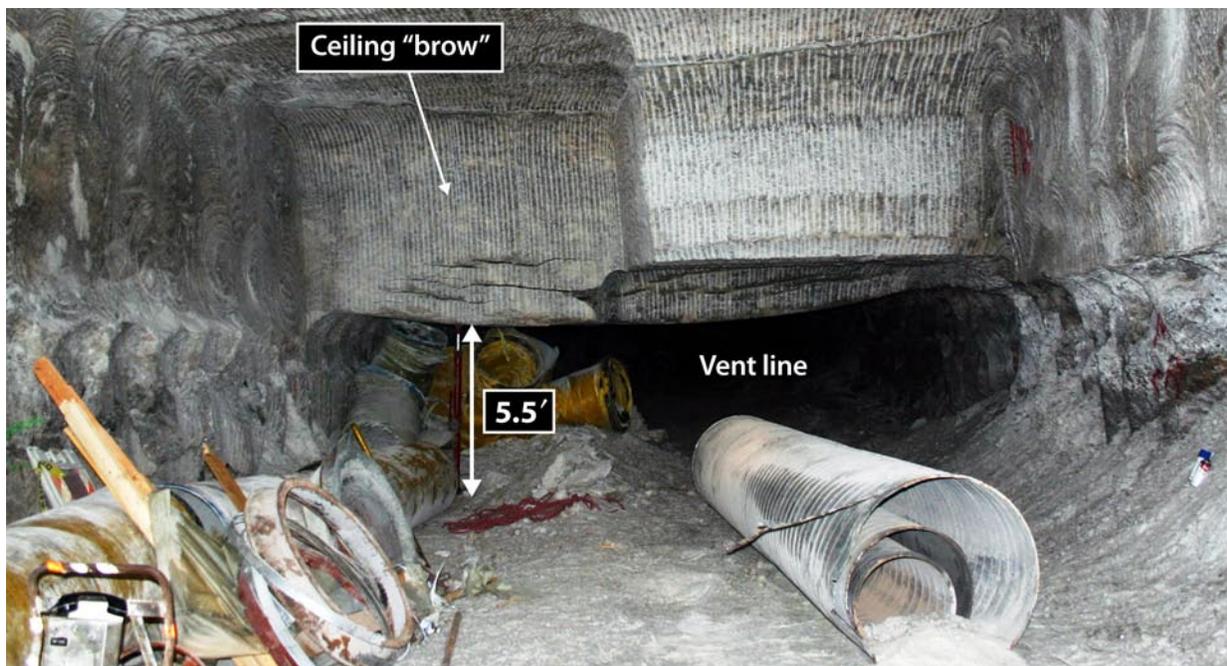
The injured worker was part of a team that was tasked with cleaning out the drift (shown in Figure 2-1), which had been unused for 10 years. The work scope included removing stockpiled muck, ventilating the drift, evaluating and repairing roof beams, and retrieving abandoned materials and equipment.

Figure 2-1. Vent pipe in the drift

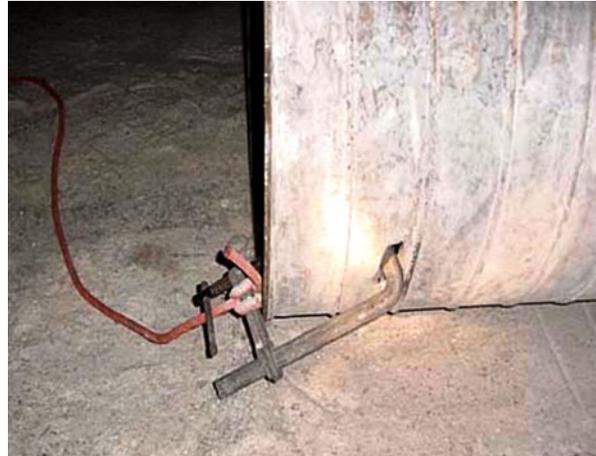
Figure 2-2. C-clamp attached to vent line

As the hauler pulled the vent line, one of the workers noticed that the clamp was tearing the line and called to the hauler operator to stop. The operator, however, was moving in reverse and did not see the worker. The 5½-pound C-clamp pulled out of the line with sufficient force to fracture the hard hat and safety glasses of the worker, who was 65 feet away, and to propel the clamp another 85 feet behind him.

- Establish a program to provide a formal Person-In-Charge or equivalent to ensure that safe work practices accomplish work package objectives.
- Strengthen the integrated safety management program to identify the scope of work, analyze the hazards, plan, control, and conduct work safely, and effectively address improvement opportunities when developing work packages.
- Better communicate work scopes that involve multiple work groups.
- Focus management attention on identifying hazards and evaluating work performance at the activity level.
- Assess the effectiveness of hazard recognition and accident prevention training.
- Ensure that training requirements comply with 30 CFR 49.8, *Training for Mine Rescue Teams*, as prescribed by MSHA.

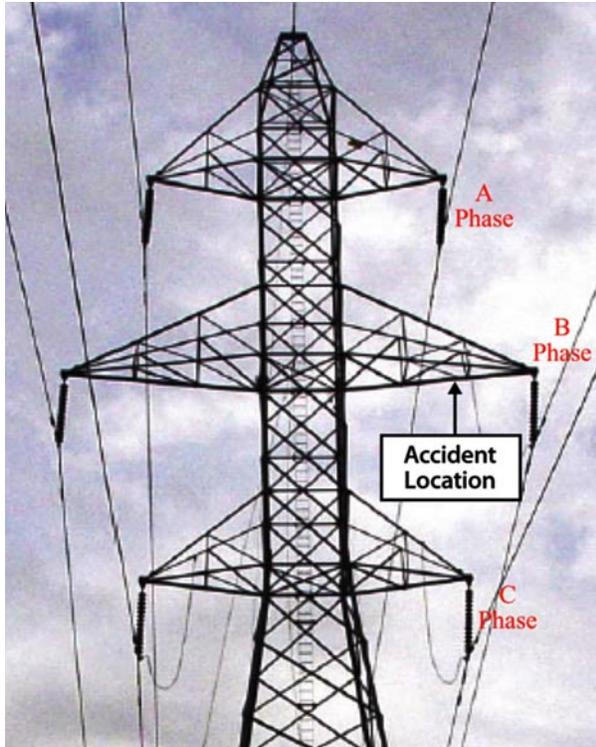
The Board determined that removing the cold end of the protective ground while the "hot" end of the ground was still connected to the "A" phase conductor was the direct cause of the accident. This condition placed the apprentice lineman in series with a circuit that was energized by induction. The current on the ground cable was calculated at 1,400 milliamps, well above lethal levels (50 milliamps or greater).

Figure 3-1. Transmission tower involved in the accident

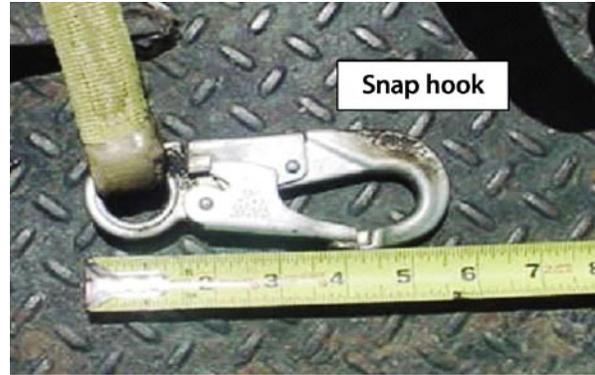
Figure 3-2. Lanyard snap hook showing burn marks

The apprentice proceeded to remove grounds without communicating with the journeyman, and he disregarded proper fall protection requirements by using the lanyard snap hook as a tool to remove the ground end.

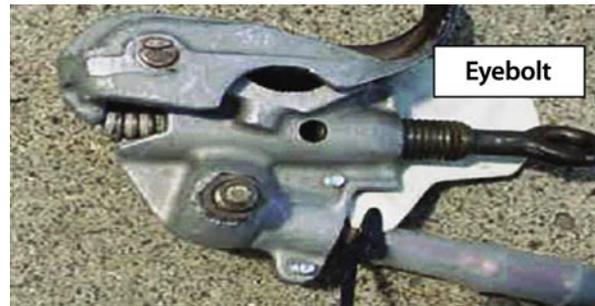
Figure 3-3. "Cold-end" clamp of the ground cable that was attached to the tower

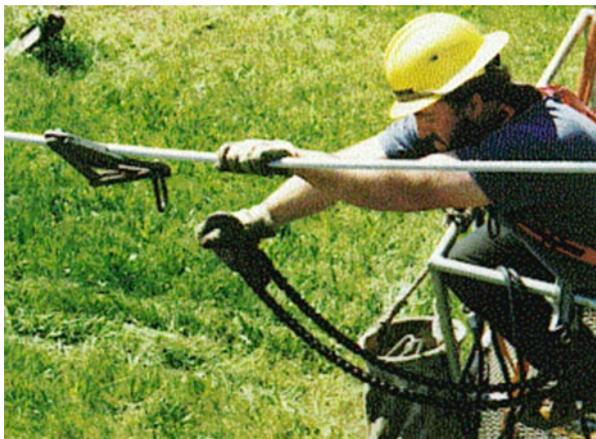
A similar event occurred on April 25, 1997, when a Bonneville Power Authority subcontract lineman was electrocuted when he came in direct contact with a de-energized 230-kV transmission line conductor that contained induced voltage. A 287-kV line operating at 300 kV ran parallel to the line on which the fatal accident occurred. Accident investigators determined that the conductor may have had an induced voltage of 4 kV from coupling with the energized line. When the lineman attached the ground to the conductor, over 125 milliamps flowed through his body. The accident occurred while the lineman was attempting to remove a gripper from the conductor while standing in a lift basket. A reenactment of the accident is shown in Figure 3-4.

Investigators found that the portable protective grounds were not properly secured at the ground clamp end and that the lineman's

Figure 3-4. Reenactment of lineman removing gripper from conductor
