Operating Experience Summary

U.S. Department of Energy
Office of Environment, Safety and Health
OE Summary 2005-13
September 6, 2005

Transformer Energized with Protective Grounds Still Installed

Operator Errors and Design Flaws Cited for Leak at British Reprocessing Plant

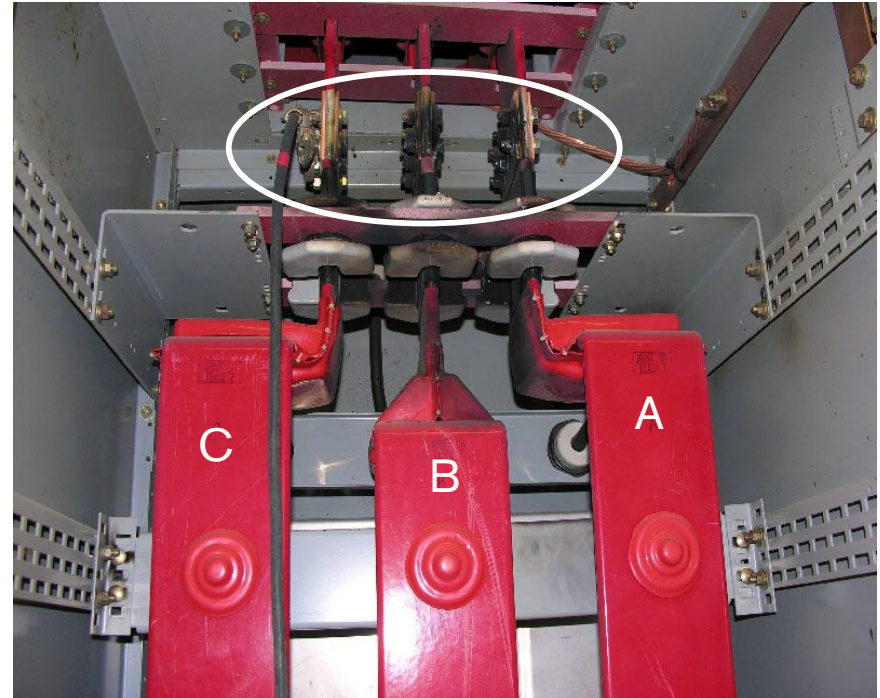
When the electricians completed the installation, the Clearance was removed. The electricians verified removal of two sets of personnel protective grounds; however, they overlooked the remaining set of grounds located inside a closed switchgear cabinet. Figure 1-1 shows the inside of the cabinet and the grounding attachment point. Figure 1-2 shows a closeup of the remaining ground, still connected to the “C” phase.

Figure 1-1. Grounding attachment point (circled)

These events underscore the importance of maintaining positive control over the use of personnel protective grounds. Organizations responsible for installation and maintenance of electrical distribution equipment must ensure that a process is in place for tagging and tracking these grounding devices. Never authorize equipment to be energized unless you can account for every safety ground. Don't allow a safety device to become a safety hazard.

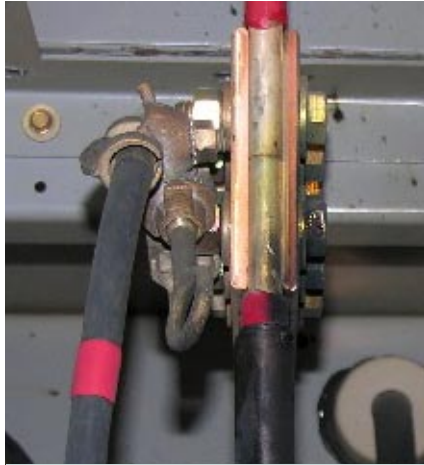
Figure 1-2. Protective ground clamped to phase “C”

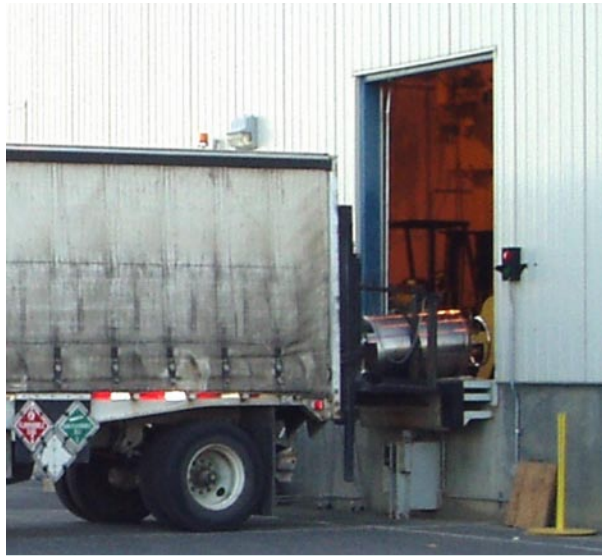
Figure 2-1. Truck at loading dock with fallen Dewar

Investigators believe that the ramp flexed under the load of the 700-pound Dewar, causing the Dewar to tip to the side, and that once the Dewar started to fall, there was no way to stop it. Fortunately, the Dewar fell in a way that it did not hit anyone. The teamster and operator placed the work area in a safe condition and strapped the Dewar to the truck rail and ramp until a rigging crew could right the cylinder and move it into the facility. Figure 2-2 shows the Dewar strapped in place.

Investigators determined that the apparent cause of this event was that neither management nor the work teams considered that the high center of gravity and the design of the wheel base would create a tipping hazard when the Dewar was pushed or pulled on an incline. Contributing factors included flexing of

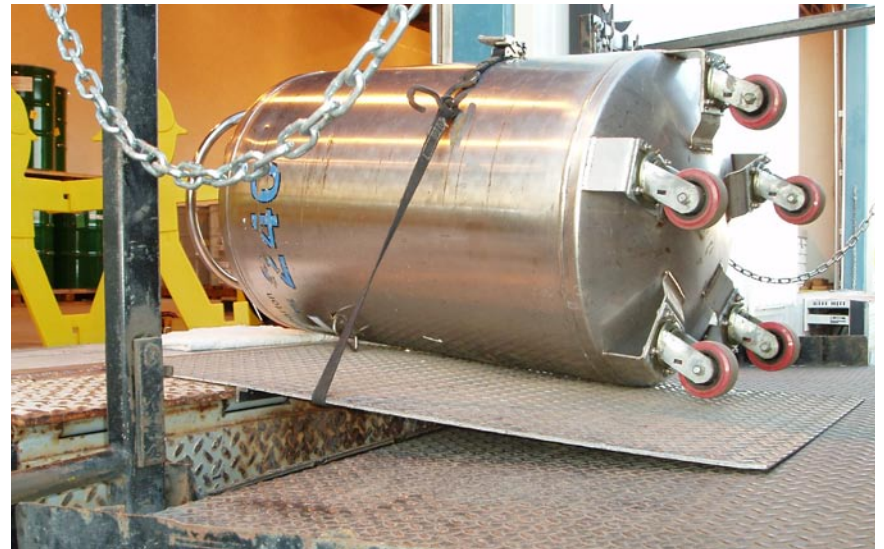
Figure 2-2. Dewar strapped to truck rail and ramp

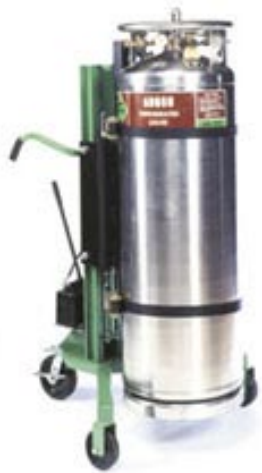
never formalized. Also, an engineering analysis of the stability of the cart was never performed. Figure 2-3 shows a similarly configured three-wheeled cart carrying a Dewar.

Figure 2-3. Three-wheeled cart and cryogenic cylinder

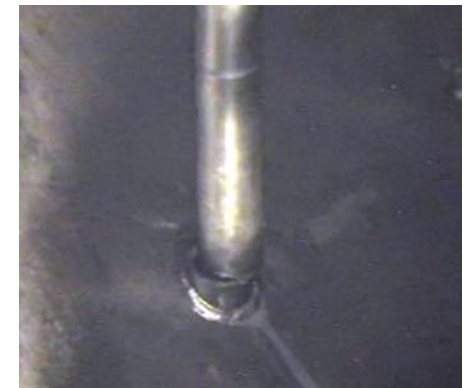
The clarification cell is a stainless-steel-lined space measuring 60 meters long, 20 meters wide, and 20 meters high. The camera inspection was initiated because of calculated discrepancies in the nuclear material balance and indications of leakage into one of the sumps within the cell. Investigators determined that the dissolver solution had been leaking into the cell for many months, possibly since July 2004. It is believed the pipe, which provides feed to an accountancy vessel (tank), suffered a major break on or around January 15, 2005, based on a rapid increase in sump level and rising temperature. Figure 4-2 shows the failed feed pipe to the accountancy vessel.

Figure 4-2. Failed pipe nozzle on tank head

Investigators believe the pipe failed because of fatigue stresses induced by excessive movement of the vessel. Operators had seen problems with vessel vibration as evidenced in their shift logs and video footage showing significant movement of the vessel during agitation and emptying cycles.

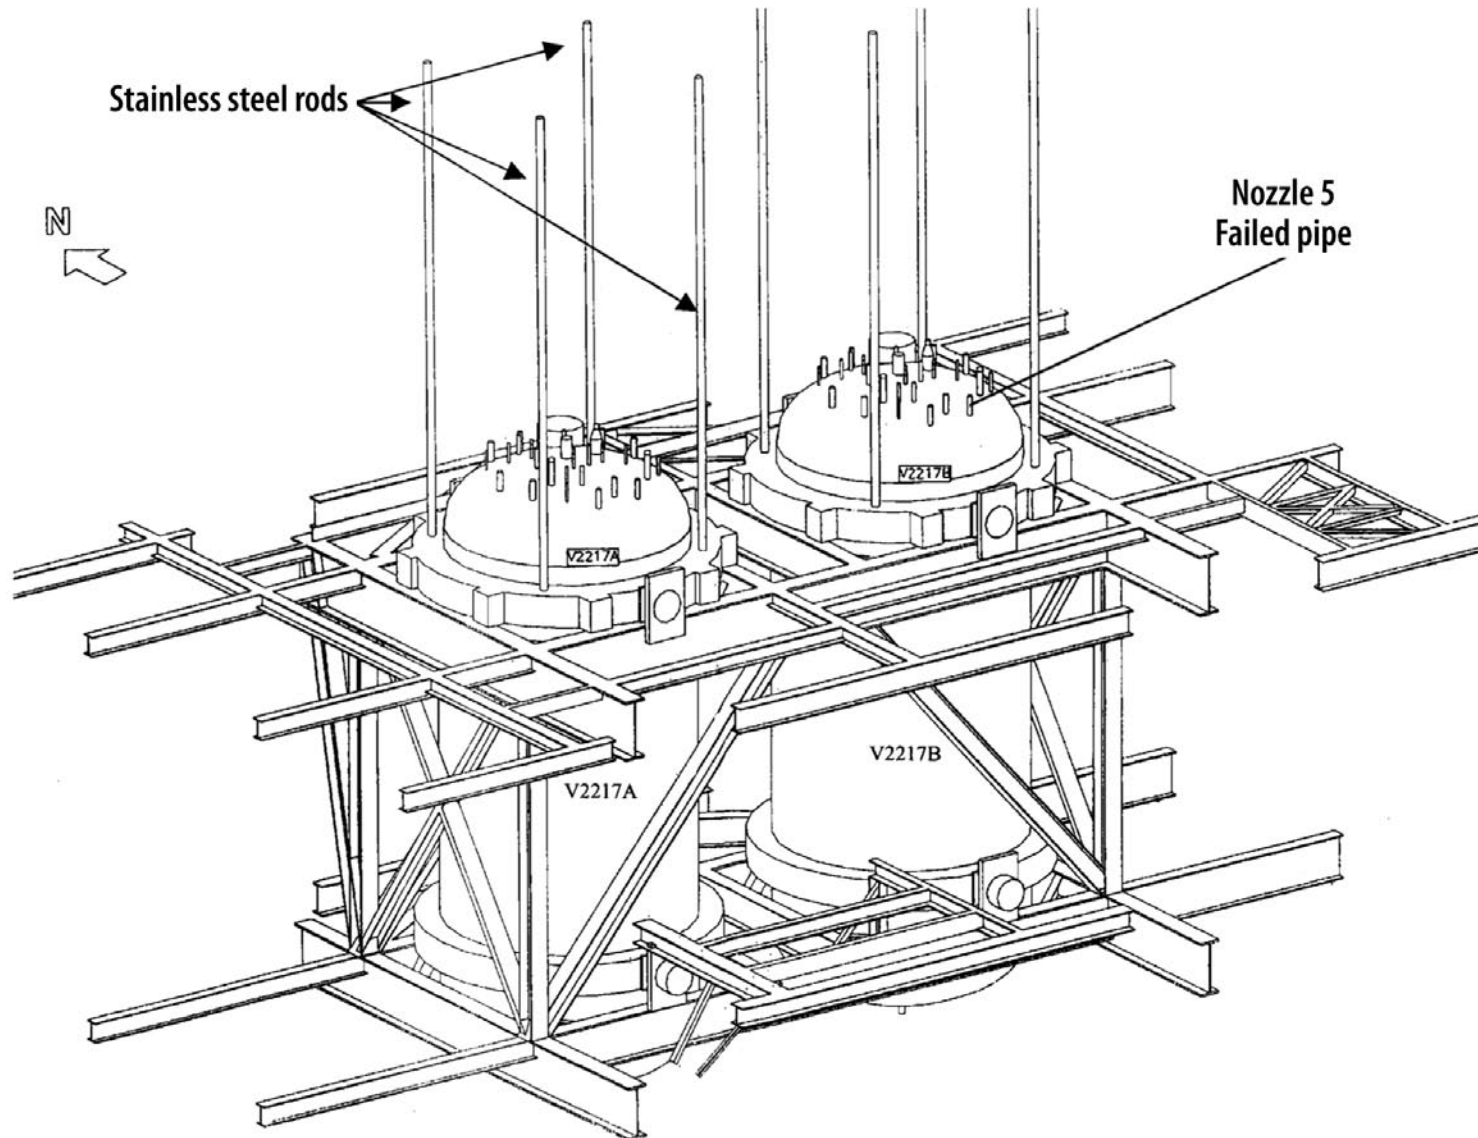
The accountancy vessels are suspended from the cell roof to allow weighing of the vessel and contents and determining material balance. To achieve this, the vessels are supported by four rods that pass through the roof to a weigh mechanism. The vessels are normally operated suspended, except for brief periods to establish a datum or for calibration, at which time they are lowered to rest on a steel frame in the cell (Figure 4-3).

The original design of the accountancy vessels provided for seismic restraints to prevent lateral movement and induced stresses from pumping devices. However, the installed configuration was modified and did not include the restraint blocks. The Board of Inquiry has no evidence that the design was reviewed to consider fatigue stresses following modification that eliminated the restraints.

Figure 4-3. Accountancy vessel showing suspension rods and support frame
