OPERATING EXPERIENCE SUMMARY

U.S. Department of Energy
Office of Environment, Safety and Health
OE Summary 2005-02
January 24, 2005

1. USE THE RIGHT FILTER WITH YOUR RESPIRATOR

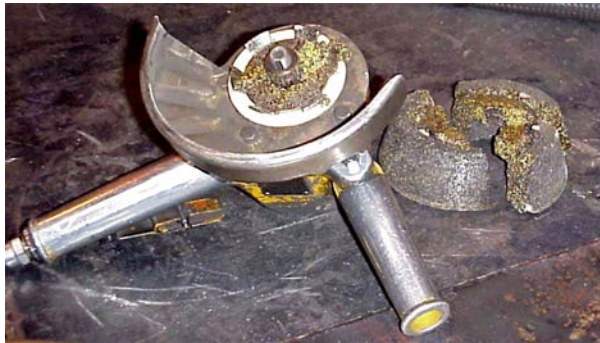
OE Weekly Summary 1999-05 reported a similar event that occurred on January 26, 1999, at the Hanford Site. A pipefitter was grinding slag from the flame-cut edge of a 3/8-inch-thick metal plate when the grinding wheel disintegrated. The guard protected the pipefitter and deflected the broken pieces away and down to the floor. The largest piece traveled approximately 15 feet and struck a metal garbage can, penetrating one side of the can and propelling it approximately 15 feet. Other fragments were distributed over an area within a 12-foot radius. Figure 2-3 shows the grinder and pieces of the cup stone. There were no injuries. (ORPS Report RL--PHMC-FSS-1999-0006)

Figure 2-3. Damaged grinder and cup stone

The pipefitter stopped work and notified his immediate supervisor. The facility manager directed all grinding operations to stop until personnel had inspected all grinding wheels for visible damage and verified that no wheels were mounted in grinders with a greater speed rating.

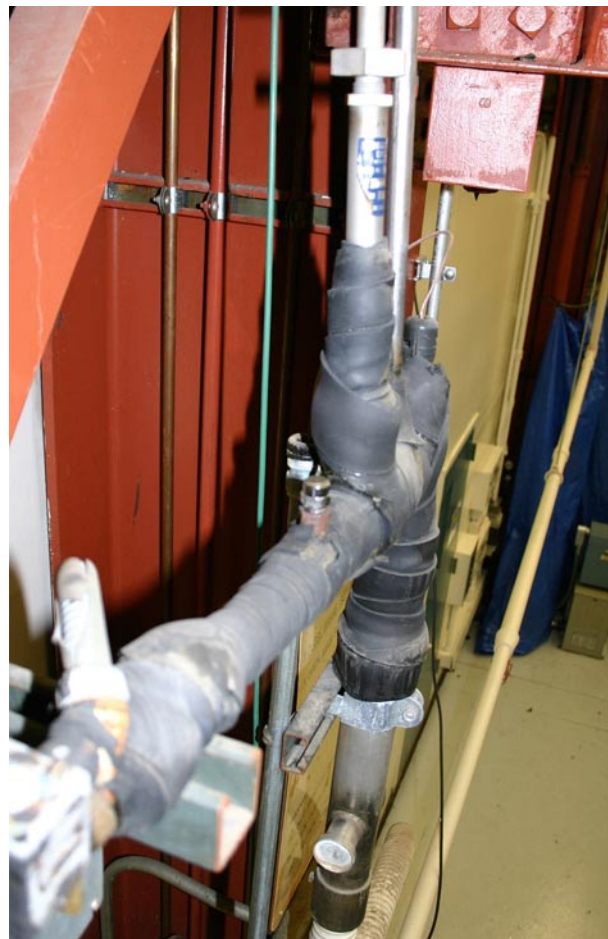
- Design engineers were unable to find the original design documents and drawings for the old tank when planning the tank replacement project. As a result, facility personnel did not know the exact settings to use for the new tank. After the leak was found, original drawings were finally located. The drawings showed that the old system was designed to operate at 35 psig with a final delivery relief valve pressure of 50 psig.
- The pressure setting for relief valves (illustrated in Figure 3-1) on the liquid line coming into the building was 150 psig.

Figure 3-1. Pressure relief valve

However, several other smaller relief valves inside the building, which were untagged and difficult to find and read, were set at 50 psig, the same as the operating pressure. This, in effect, created a series of small distributed gas leaks that made it difficult to detect any single leak until liquid finally flowed from one of them.

1. Facility personnel should thoroughly research proposed changes to any pressure system, even if they seem to be insignificant. It is especially important to locate the original documentation, inspect the entire existing system, and compare it to the as-built drawings, noting the original design intent.

2. Design engineers should always conduct a system design review before replacing components with those of different specifications, especially when replacing an aging system where identical components may not be available and compatibility issues may exist between replaced and new components. This is particularly important when installing new cryogenic delivery systems.

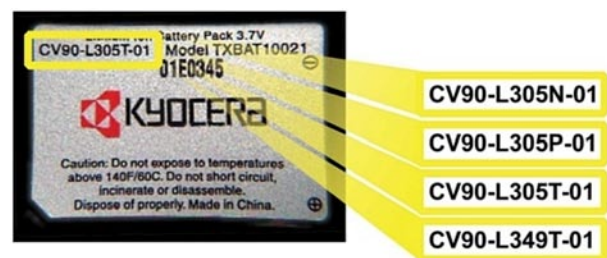
Hazard: Some of the cell phone batteries supplied by the battery manufacturer may be counterfeit. This can cause the batteries to short-circuit, overheat, and pose a burn hazard to consumers.

Figure 4-2. Slider series product codes

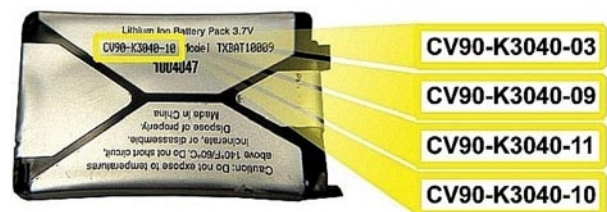
Figure 4-3. 3200/K400 series product codes
