## OPERATING EXPERIENCE SUMMARY

U.S. Department of Energy Office of Environment, Safety and Health OE Summary 2005-03 February 7, 2005 The Office of Environment, Safety and Health, Office of Corporate Performance Assessment publishes the Operating Experience Summary to promote safety throughout the Department of Energy complex by encouraging the exchange of lessons-learned information among DOE facilities.

#### 1. WORKER SCALDED WHEN HOT-WATER HOSE FAILS

#### 2. DON'T USE CHEATER BARS TO TIGHTEN CHAIN BINDERS

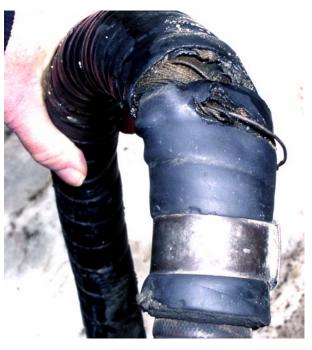
Investigators determined that the accident resulted from deterioration of the hose from constant wear where the hose attached to the nozzle (Figure 1-2) and where it rides on the truck after it is rolled up on the reel. The deteriorated condition of the hose was noticed by the workers but never reported and repaired.

Figure 1-2. Damaged hose at nozzle connection

As a result of this event, a team of operators evaluated inspection forms to ensure that all pieces of equipment are addressed in the inspection. Regular inspections will be performed on all heavy equipment, and a complete inspection of hot-water-hauling vehicles will be performed monthly.

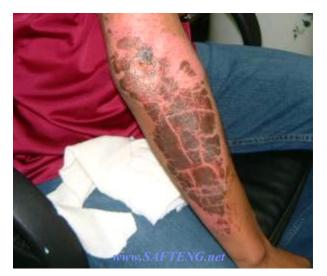
The worker was not wearing long-sleeved coveralls, and the burns were much more severe to the arm (Figure 1-4) than to the thigh, which was protected by the layer of clothing.

Figure 1-4. Burns to right arm from hot water

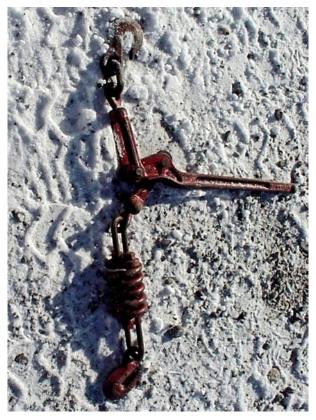
diameter that they were using as a cheater bar or handle extender (illustrated in Figure 2-2) to close a lever-type, spring-load binder (Figure 2-3). Thinking the binder had closed, two of the laborers walked away. The third laborer was in a lower position holding the cheater bar.

Although the investigation is not yet complete, several factors are known that likely contributed to the accident. Investigators believe that the cheater bar prevented the latching mechanism from fully engaging. The ambient temperature, which was at or near 0°F, also might have played a part in the bar's failure to engage. In addition, there was no Standard Work Plan or procedure because this task was considered skill-of-thecraft.

Figure 2-3. Spring-loaded chain binder

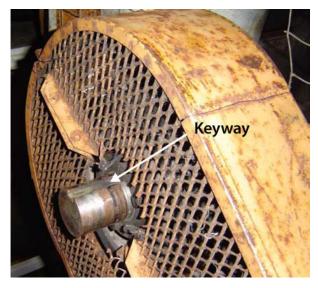
When the accident occurred, the worker and a co-worker had just finished repairing a water leak on a Heating, Ventilation, and Air Conditioning (HVAC) unit that was located in a limited space. Investigators determined that the direct cause of the accident was lack of a guard on the exposed rotating shaft, which protruded beyond the existing machine guard (Figure 4-2). They also determined that the work activity was deficient in that it did not include plans for mitigating hazards. The work area was not normally an occupied space and therefore the rotating shaft hazard was not common knowledge. Safeguarding the HVAC equipment in an enclosed location did not prevent exposure to unguarded hazards within the enclosure.

Figure 4-2. Exposed rotating shaft and keyway

- The worker wore a loose fitting sweatshirt around rotating machinery.
- The workspace was difficult to access and maneuver in.
- The rotating shaft was difficult to see because of poor lighting.

Following the incident, a team conducted a site-wide survey of rotating equipment at LLNL. Using a master equipment list, the team surveyed similar equipment and identified a small population that was unguarded. The Safety Manager generated job orders to immediately repair the equipment or install machine guarding.

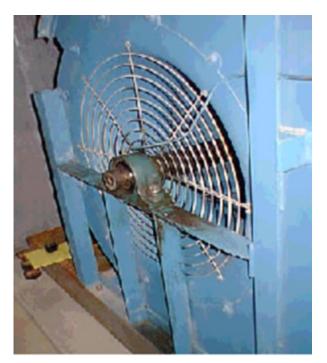
The electrician and a co-worker were evaluating a smoke detector located inside a supply fan room. They had turned off the fan at a control panel outside the room and entered while the fan was coasting down. The injured electrician was carrying a ladder near the shaft end when his jacket came in contact with the rotating shaft (Figure 4-3) and became entangled.

Figure 4-3. Exposed shaft end of the fan unit

A Type B Accident Investigation Board determined that the Laboratory's corrective actions for machine guarding deficiencies identified during previous assessments failed to prevent recurrence. Other causal factors included the following.

Based on the Board findings, Ames Laboratory personnel installed protective guards over fan shafts (Figure 4-4) and inspected other fan units for similar conditions.

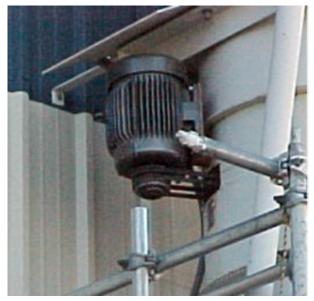
On August 30, 1999, at the Idaho Nuclear Technology and Engineering Center, a carpenter was exposed to an unguarded blower motor fan belt while working on a scaffold railing near the motor. Because the power transmission belt was unguarded (Figure 4-5), the carpenter should have placed his lock on the motor power supply to ensure his safety. However, he did not recognize that the transmission belt was a potential hazard. (ORPS Report ID--LITC-LANDLORD-1999-0012)

Figure 4-5. Blower motor with unguarded fan belt
