OPERATING EXPERIENCE SUMMARY

U.S. Department of Energy
Office of Environment, Safety and Health
OE Summary 2005-04
February 22, 2005

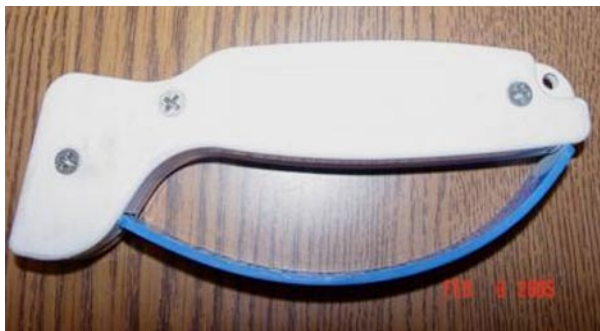
On February 9, 2005, at the Hanford Site Waste Treatment Plant (WTP), an insulator craft person accidentally cut his hand, severing two tendons, while sharpening his knife. The worker was wearing leather gloves while using a hand-held AccuSharp® knife sharpener (Figure 1-1), but he was using the sharpener incorrectly. (ORPS Report RP--BNRP-RPPWTP-2005-0005)

Figure 1-1. AccuSharp® knife sharpener

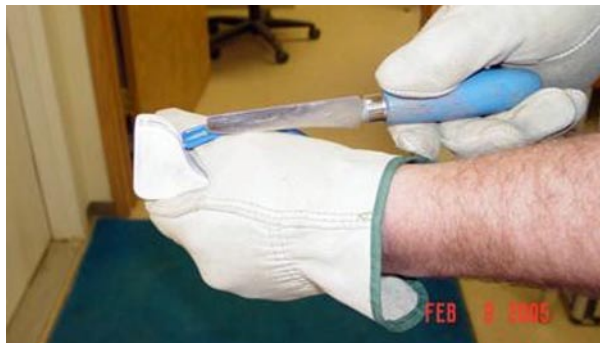
The worker's knife was about 3¾-inches long and very sharp. He held the sharpener upside down and pulled the knife through the sharpener (Figure 1-2), towards himself and through and over his left thumb, leaving a hairline cut in the thumb.

Figure 1-2. How the worker used the sharpener

attending physician determined that two extensor tendons on the top of the thumb had been severed and would require approximately 6 months to heal.

The worker stated that he had used AccuSharp® knife sharpeners for over 10 years but he was unaware of the manufacturer's instructions on the back of the package. This particular sharpener, along with instructions for use, was issued to the worker approximately 2 months before the accident. Inspection of the tool revealed marks on the plastic finger guard indicating that the knife had slipped off the sharpener many times before and cut into the guard. These marks indicate that the worker had narrowly missed being cut in the past but failed to recognize the hazard posed by incorrect use of the sharpener.

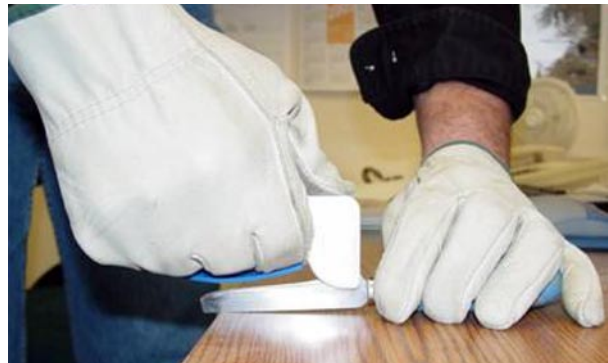
Proper use of this sharpening tool is important for the user's safety and the manufacturer's instructions for correct use were included with the tool. Figure 1-3 demonstrates how the sharpening tool should have been held and used in accordance with the manufacturer's instructions.

Figure 1-3. Correct use of the knife sharpener

These occurrences illustrate the importance of reading, understanding, and following the manufacturer's instructions. Manufacturers are responsible for providing directions for safe use of their products and for warning of hazards that could arise from misuse. It is therefore the user's responsibility to follow these directions and observe all caution and hazard warnings to ensure their own safety and the safety of others.

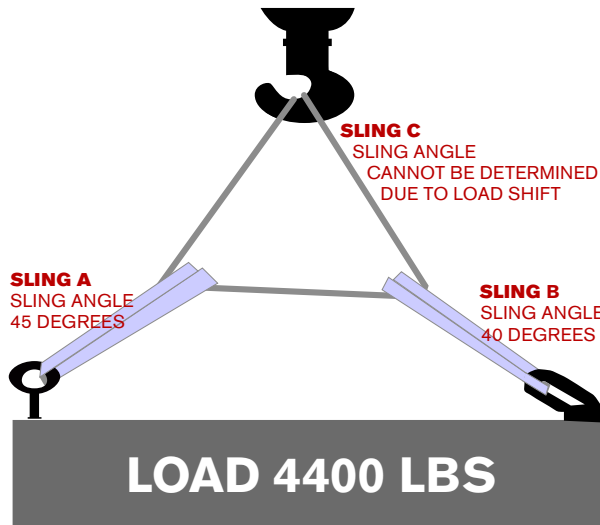
On September 30, 2004, at the Stanford Linear Accelerator Center (SLAC), an improperly rigged 4,400-pound steel corner block that was being lifted with a 50-ton overhead bridge crane fell 8 inches to the floor when two of the slings supporting it broke. No injuries resulted, but the block was slightly damaged. (ORPS Report OAK--SU-SLAC-2004-0009)

Figure 3-1. Rigging diagram

The rigger folded two 6-foot, 6,400-pound-capacity endless slings in half (shown in the figure as slings A and B), believing that doing so increased their weight capacity, but in actuality, it *decreased* their capacity. He folded sling A around the eyebolt and sling B around the swivel hoist ring. In this configuration, neither sling was long enough to reach the hook, so the operator joined them to the hook using sling C. This put slings A and B at angles of 40 and 45 degrees, which increased the stress on them by up to 1½ times. This additional stress meant that the slings were effectively sharing a 6,800-pound load, while their 6,400-pound weight capacity had been reduced.

Because the load's center of gravity was not in line with the lifting hook, sling C offered no load stability and could have allowed the load to shift or slide through it, even if slings A and B had not failed.

The load could have been lifted safely using a special lifting fixture designed for moving the block. The following corrective actions were taken.

- Revising facility hoisting procedures to include engineering oversight of all lifts and guidance on using special lifting devices for moving irregularly shaped loads such as the steel blocks.
- Comparing facility hoisting procedures to the SLAC hoisting and rigging policy.
- Revising hoisting and rigging training to include a refresher training course and hands-on-rigging practice.

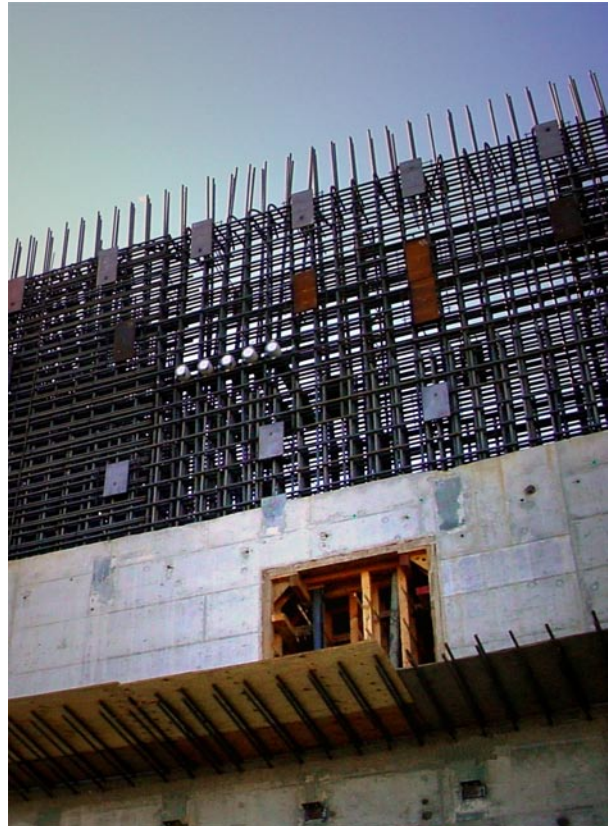
On January 25, 2005, at the River Protection Waste Treatment Plant construction project, an electrician slipped and fell about 3 feet from a height of 55 feet before his fall protection equipment (a harness and double lanyard) caught him. Because he correctly maintained tie-off points above his body, he was not injured. The electrician was descending a rebar wall like the one shown in Figure 4-1 when his foot slipped and he fell. He continued his descent down the wall and reported the incident to his supervisor. (ORPS Report RP--BNRP-RPPWTP-2005-0002)

Figure 4-1. Rebar wall
