OPERATING EXPERIENCE SUMMARY

- *Insulated tools:
a barrier against
electrical hazards..... 1*
- *Light fixture installed
in path of overhead
crane 2*
- *Not segregating
incompatible
chemical wastes
can be hazardous..... 3*
- *Safety interlocks
should never be
defeated, modified,
or ignored 5*

U.S. Department of Energy
Office of Environment, Safety and Health
OE Summary 2005-05
March 7, 2005

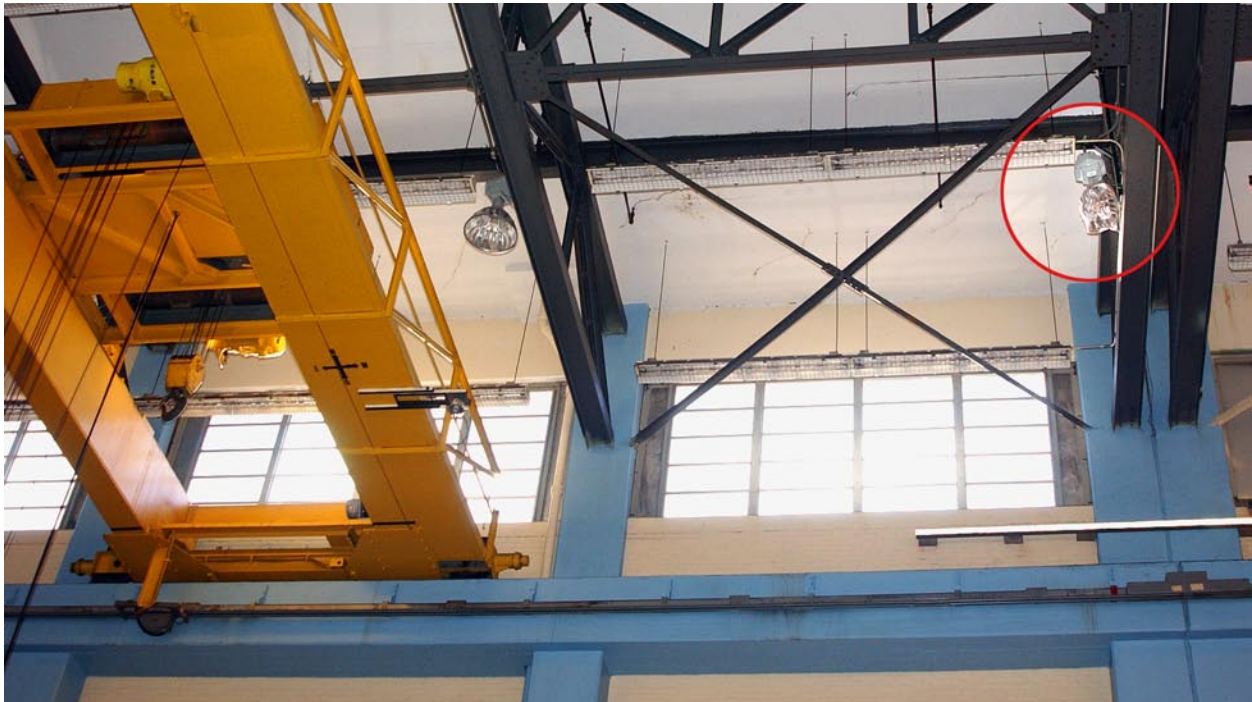
Figure 2-1. Broken light fixture

On December 27, 2004, at the Y-12 National Security Complex, the trolley of a moving overhead crane struck a light fixture causing the lens to detach and fall 35 feet to the floor (the broken fixture is shown in Figure 2-1). The fixture was one of 16 that had recently been replaced, and the ballasts were approximately 4 inches longer than those in the original fixtures. The 4-inch change affected the vertical length of the fixture, and consequently, the clearance requirement for the crane traveling beneath it. No injuries resulted, and the only damage was to the fixture. (ORPS Report ORYS-YSO-BWXT-Y12SITE-2004-0023)

After installation, the new fixtures hung down into the travel path of the crane, but installers did not consider the change in length either during or after the installation. Following the incident, investigators found additional fixtures, which were not replacements, also were hanging down into the crane's travel path. Following an inspection, the fixture hit by the crane, as well as 10 other fixtures, were raised to the proper height, and inspectors verified that the necessary clearance had been taken into account.

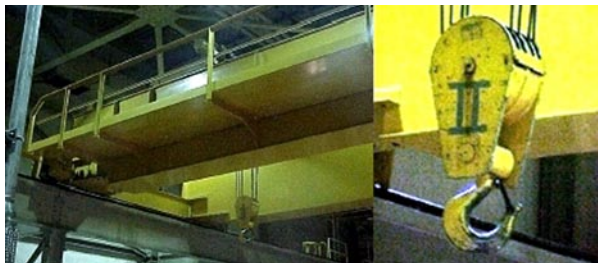
Figure 2-2. Overhead crane and crane hook

On April 29, 2003, at the Thomas Jefferson National Accelerator, an overhead crane was being used to replace lighting in the Test Lab high bay (ORO--SURA-TJNAF-2003-0001). The crane hook contacted an equipment cabinet and damaged two conduits, one of which contained a 120-volt power circuit, creating a near miss situation. The crane and crane hook are shown in Figure 2-2.

Causal analysis revealed that workers had not evaluated the location of the crane hook before the operation began. They had been using the same crane for a period of weeks without incident, and they had consistently found the crane in the same configuration in which they had left it. Because of complacency, they did not check the position of the crane hook.

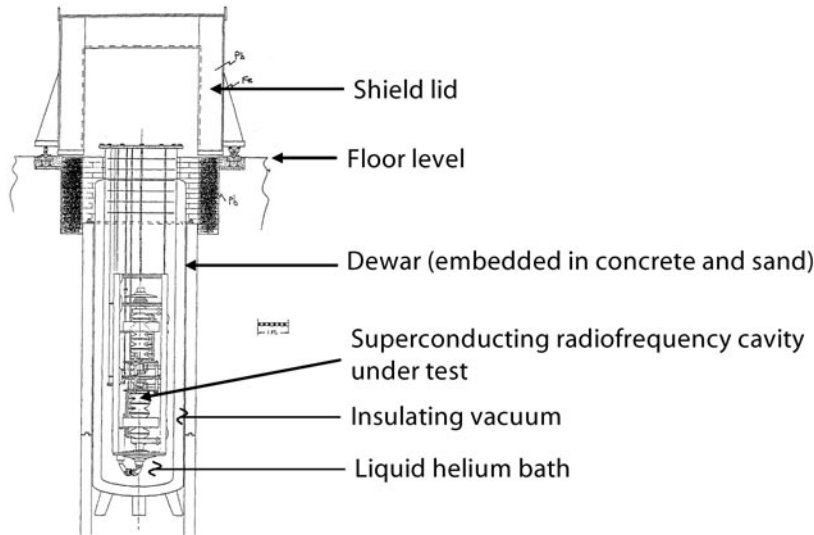
Figure 4-1. Dewar shield

On May 5, 2004, at the Thomas Jefferson National Accelerator Facility's Vertical Test Area, a worker preparing to run a test in a dewar (schematic shown in Figure 4-1) noticed that a metal plate had been attached to a safety interlock switch actuator in an effort to ensure the switch operated when the lid was closed. Two dewars in the facility were found to have been modified in this way. (ORPS Report ORTJ-TJNA-SURA-TJNAF-2004-0003)

The actuator contains a pair of switches and is attached to the inside of the shield lid. When the lid is closed, the switches send a signal that the safety interlock system must detect before allowing the high-power radiofrequency amplifier to operate.

The physicist who made the unauthorized interlock modification told investigators that he had made the modification to the two dewars about 6 months earlier to force the switches to function properly. He should have informed the Safety Systems Group of the intermittent

malfunction of the switches instead of trying to fix them himself. All personnel were monitored for radiation exposures and none was detected.

- The facility reported the event to the Noncompliance Tracking System, where the DOE Office of Enforcement could track it to closure.
- Facility management briefed personnel on the event and on the need to maintain configuration control of safety interlocks.
- The safety systems group replaced all switches and tested the interlocking functions.
- Maintenance plans and procedures were revised to ensure that lids and switches are operating as designed and that Safety Systems Group personnel inspect and recertify facility equipment after maintenance has been performed on it.
- Vertical Test Area personnel are required to notify the Safety Systems Group whenever safety-significant equipment is found damaged or nonfunctioning.
- Shield interlock switches were reconfigured to make them more reliable and less likely to become misaligned.
