OPERATING EXPERIENCE SUMMARY

U.S. Department of Energy
Office of Environment, Safety and Health
OE Summary 2005-06
March 21, 2005

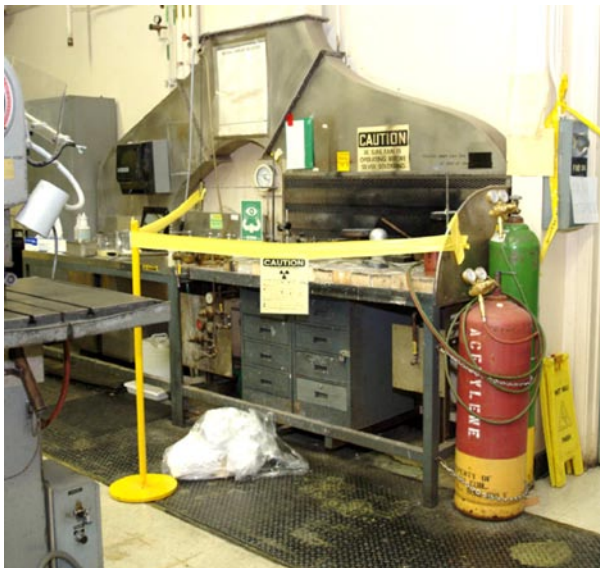
Figure 2-1. Contaminated work area and the gas bottles for the torch used to heat the collimator

The researcher needed to remove the source from the collimator to replace it with a new cobalt-57 source. He tried to remove the source by hitting the assembly with his hand and then with a rubber hammer. He even tried to extract it with tape. After these attempts failed, he took the assembly to the machine shop to try to remove it there. Figure 2-1 shows the ventilated worktable in the machine shop.

source. The technician then suggested using differential thermal expansion to remove the source. He placed the collimator on a block of graphite and heated the back of the collimator with an oxyacetylene torch. After it cooled, he picked up the collimator with tongs and discovered the powder that had been released from the source on the graphite block.

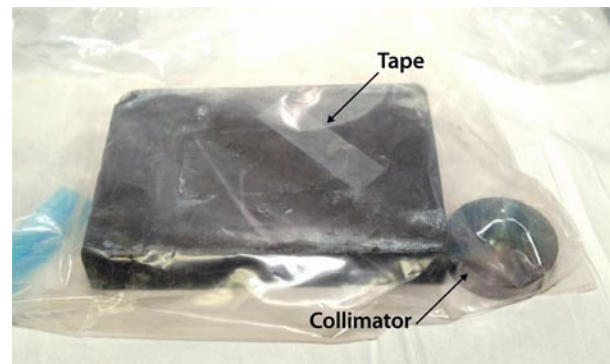
Figure 2-2. Graphite block with tape to fix the cobalt-57 powder and the collimator that held the source

Neither the researcher nor the technician understood the construction of the source. They incorrectly believed it was a solid matrix of material embedded in aluminum, when it actually was a ceramic source covered by a thin metal window. Investigators believe that the hammering initially breached the source and applying heat ultimately resulted in the source failure and release of radioactive material.

A health and safety technician monitored the workbench area for contamination. A direct survey of the graphite block indicated 2,000,000 dpm/100 cm² beta-gamma. Figure 2-2 shows the contaminated graphite block and the collimator in a plastic bag to contain the spill. A survey of the workbench showed 500,000 dpm/100 cm² beta-gamma and a swipe survey of the tongs showed 50 dpm. The researcher and technician did not have any contamination on their clothing, and whole body scans were negative.
