OPERATING EXPERIENCE SUMMARY

U.S. Department of Energy
Office of Environment, Safety and Health
OE Summary 2005-11
July 25, 2005

Operating Experience Summary 2005-11

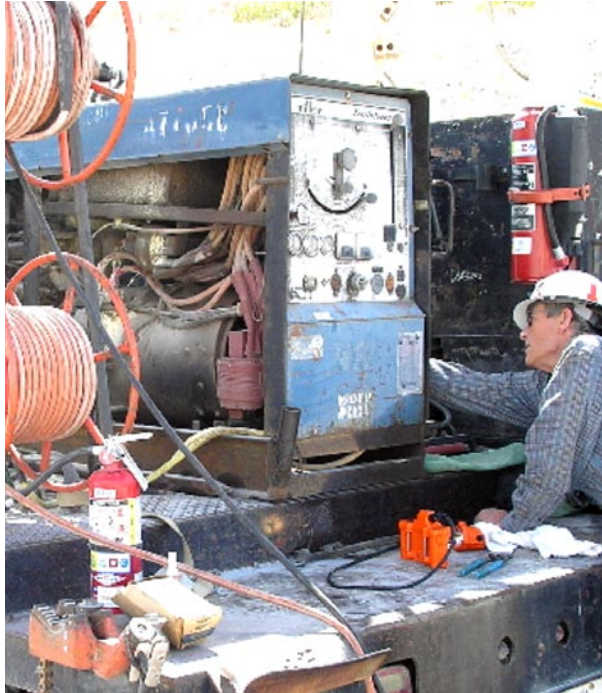
The welder/generator, a Trailblazer model manufactured by Miller, was originally purchased in October 1997. In February 2003, preventive maintenance on welding machines was cancelled. Based on an inspection of the equipment, it appears that an electrical short

Figure 2-1. Welder/generator (blue) on bed of mechanic truck

from damaged low-voltage wires started the fire. The age of the welder/generator and the lack of maintenance were contributing factors.

welding equipment in good working condition. To meet this requirement, the manufacturer's maintenance guidelines should be followed. As a corrective action, facility management will re-establish preventive maintenance programs for all electric arc-welding equipment based on manufacturer recommendations. This effort should be completed in the near term for existing in-service welding equipment and will be applied to new welders added in the future.

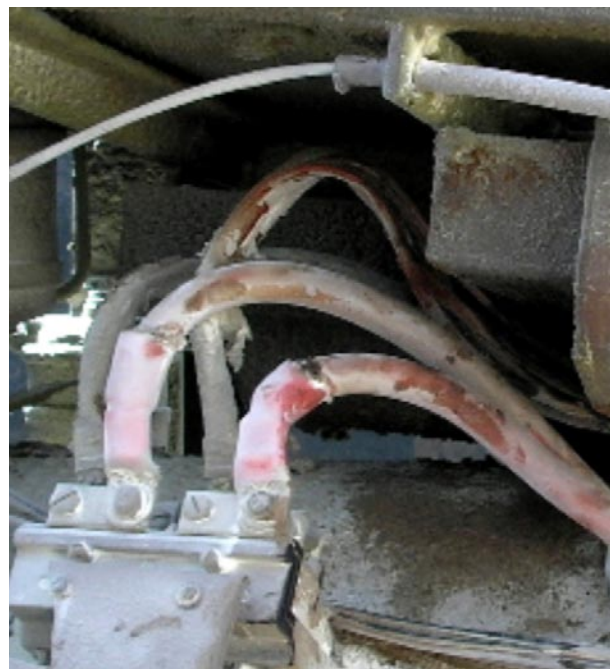
Investigators found several bare, small-gauge wires that appeared to have been abraded through normal use and equipment transportation. The insulation on the heavy-gauge power leads was severely cracked and flaked off when the cable was handled (Figure 2-2). The damage appeared to be from exposure and use over the lifetime of the equipment. It is unlikely that anyone would have discovered the damaged wiring during normal use, which underscores the importance of performing regular maintenance and equipment inspections.

Figure 2-2. Cracked insulation on cables

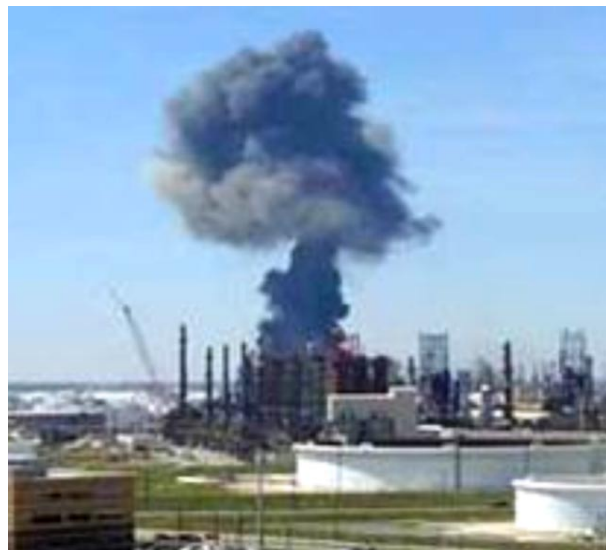
On March 23, 2005, a tremendous explosion (Figure 3-1) occurred at the BP Texas City Refinery, killing 15 workers and injuring more than 100 others on the refinery site. The refinery operator, BP Products North America, Inc., immediately established a team to investigate the cause of this tragedy. The cause is thought to be the ignition of a hydrocarbon vapor cloud that was accidentally released from a fractionating column. Members from the U.S. Chemical Safety and Hazard Investigation Board and OSHA are conducting separate investigations.

Figure 3-1. Photograph of initial explosion

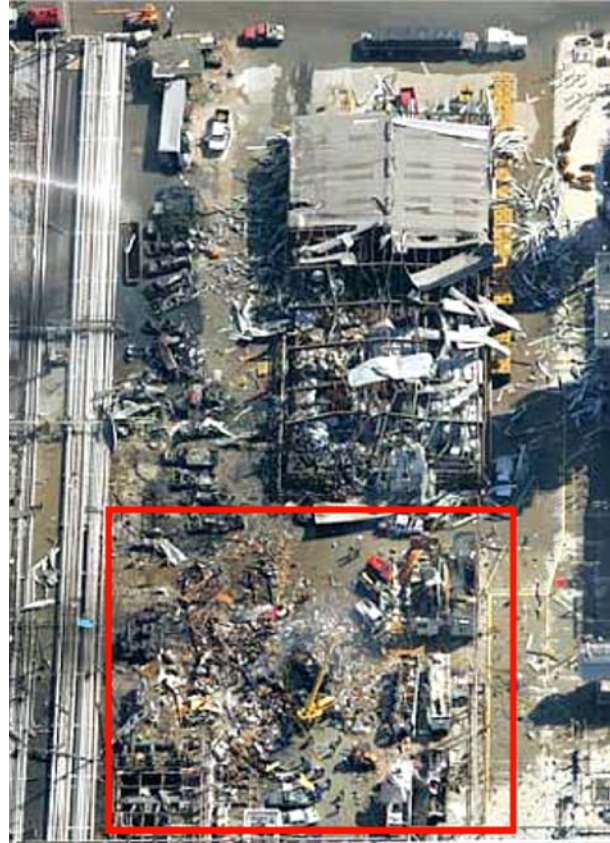
Many of the injured or killed were congregated in or around temporary trailers used to support turnaround work on a nearby ultra-cracker unit. Figure 3-2 is an aerial view showing the destroyed temporary office trailers at the bottom and a heavily damaged catalyst warehouse at the top.

Figure 3-2. Destroyed temporary trailers (red box)

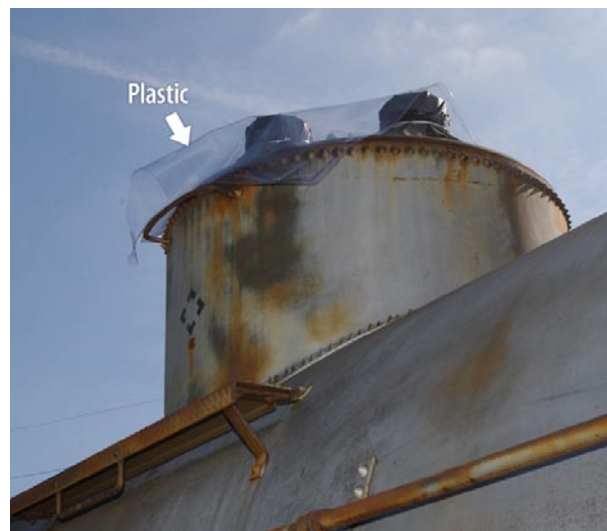
The electrician and his co-worker cut the plastic sheeting on the ground before climbing to the upper platform. The co-worker climbed up to the platform first, and the electrician followed him after placing a segment of rope on the platform for use during their descent. The co-worker placed the plastic over the hatch, as planned, just before the electrician fell (see Figure 4-1).

Figure 4-1. Plastic on rail tank car hatch

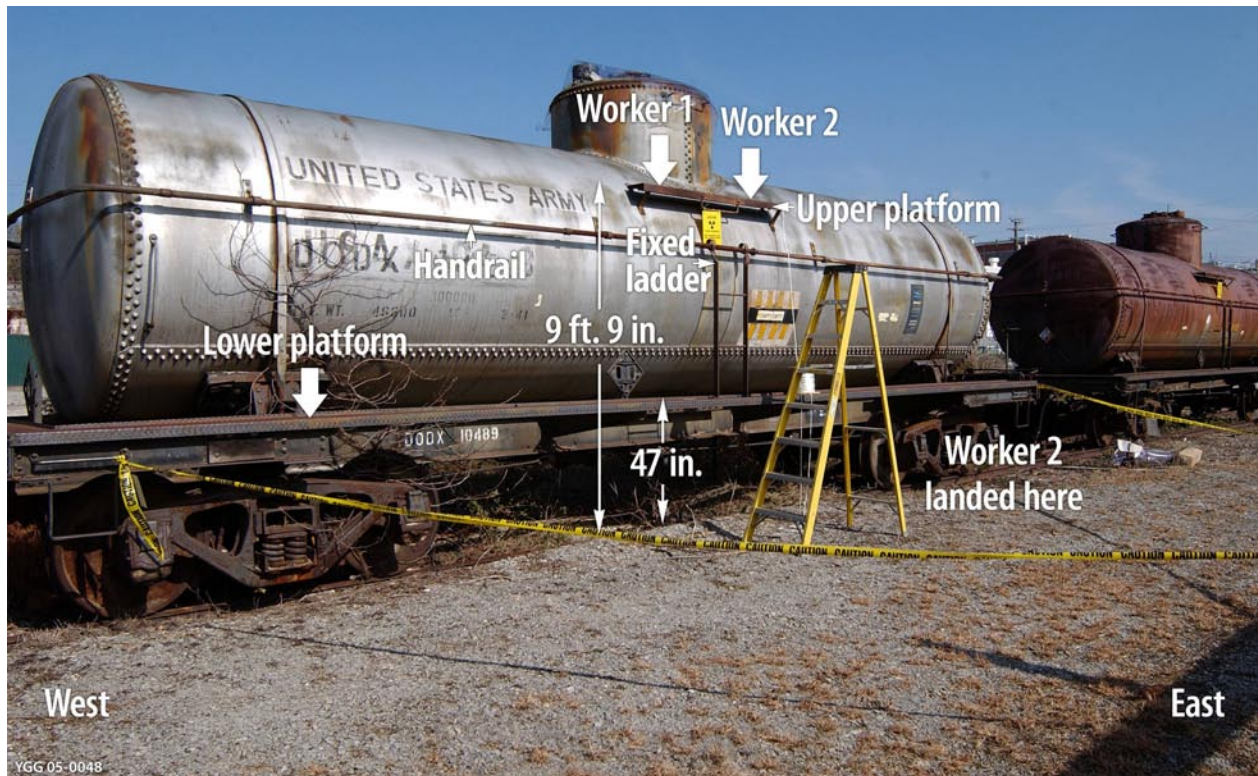
Figure 4-2 shows the tank car following the accident. A stepladder was placed next to the tank car for access to the lower platform, and the car has fixed ladders to access the upper platform. As shown in the figure, there is a

handrail around the midpoint of the tank car that provides stability when workers are on the lower platform, as well as a rung at the top of the access hatch. The upper platform also has a climbing rung, which is approximately 10 feet above the ground.

Figure 4-2. Rail tank car accident scene

1. Evaluate whether to continue using the site requirement that permits three-point contact when working on tanker trucks.
2. Require a hierarchy of fall-protection options that includes (a) elimination of the hazard (i.e., work from the ground), (b) use of fixed or portable engineered fall protection, (c) use of PPE, and (d) administrative controls (e.g., procedures).
3. Ensure that procedures and training for elevated work address ladder safety. Topics should include using three points of contact as a control, selecting and using ladders, transitioning on and off ladders, and using dual-purpose equipment (i.e., platforms that also serve as a ladder rung).
