Operating Experience Summary

U.S. Department of Energy
Office of Environment, Safety and Health
OE Summary 2005-14
November 16, 2005

1. *BE AWARE OF OVERHEAD ELECTRICAL LINES WHEN OPERATING DUMP TRUCKS*

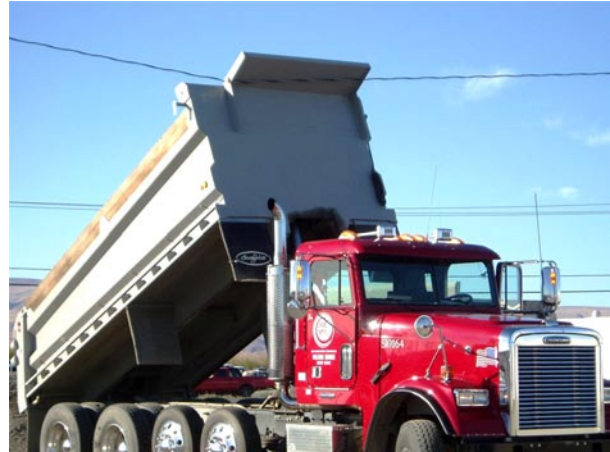
After the first truck departed, the PIC left the work site to determine where the other loads of gravel should be dumped. While he was gone, the second truck arrived. In the absence of the PIC, the second driver communicated with the first driver and was told to dump in the same area. Because the PIC was not at the scene and was unaware of the second truck, the driver received no additional instructions. He dumped his load with the truck facing toward the overhead power line, rather than away from it. An Operations Lead, who was driving by, saw that the raised bed was about to hit the overhead power line and signaled the driver to stop, but the line was hit before the truck stopped. Figure 1-1 shows the raised bed of the truck in contact with the power line. Figure 1-2 shows a closeup of the contact point and burn mark left by the arc when the line was severed.

Figure 1-1. Raised bed in contact with power line

the power line had been de-energized. Neither the driver nor the Operations Lead recognized that this was not a safe practice or realized the potential for electrocution. Electrical Utilities personnel de-energized and repaired the power line after the truck was moved away.

If the bed of your truck makes contact with an overhead power line, attempt to lower the bed or move the vehicle to break contact. If you cannot do either of these things, remain in the vehicle until electrical personnel indicate that it is safe to exit. If you must get out because of a fire, jump clear as far as possible with both feet together, ensuring that you do not make contact with the vehicle and the ground at the same time. Shuffle away or hop with both feet together. If you step, you could become a conductor because your feet will move from higher electrical potential to lower potential as the electrical energy dissipates radially while you move away from the source.

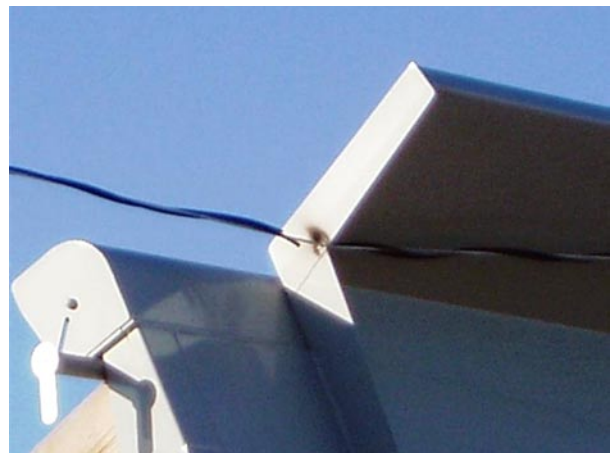
Figure 1-2. Severed power line held in place by support cable

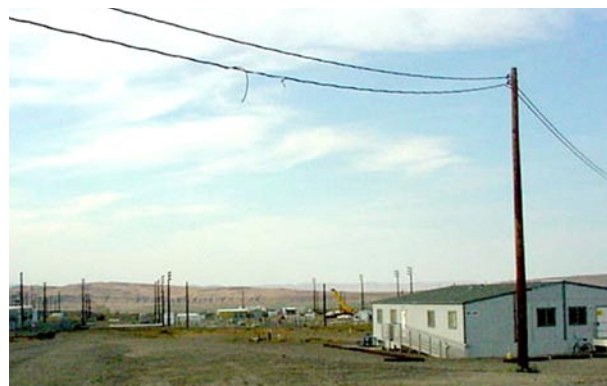
Figure 1-3. Cut power line running diagonally across the road bed

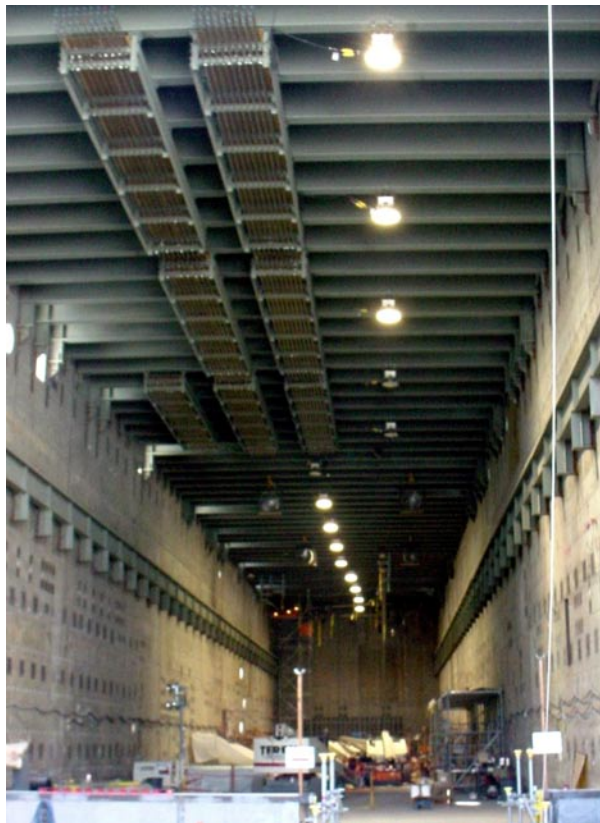
The floodlight was one of a series that are attached to the ceiling beams (Figure 2-1) 45 feet above the floor of the facility. The 480-volt floodlight was manufactured by Hubbell and rated for 1,000 watts.

Figure 2-1. Facility lighting

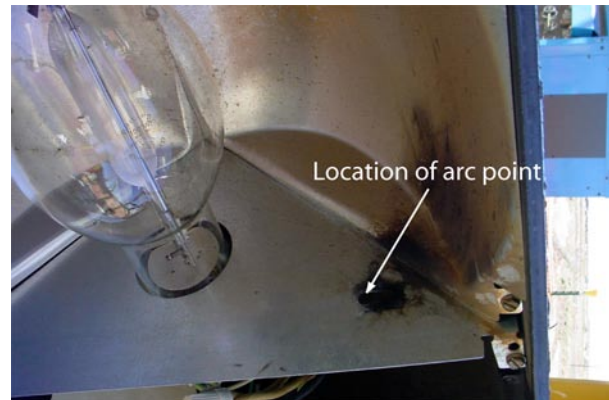
The label on the back of the unit specified the use of supply wire rated to 90°C (194°F). The electricians used wiring and wire nuts that were properly rated; however, the components inside the fixture are rated for 150°C (302°F). One of the lower-rated wire nuts inside the lamp melted, and the wire grounded to the bulb reflector, resulting in an arc (Figure 2-2) that blew out the lamp lens. Figure 2-3 shows the floodlight after the lens broke. Inspectors later found other floodlights with discolored wire nuts and brittle wire insulation.

Figure 2-2. Arc point

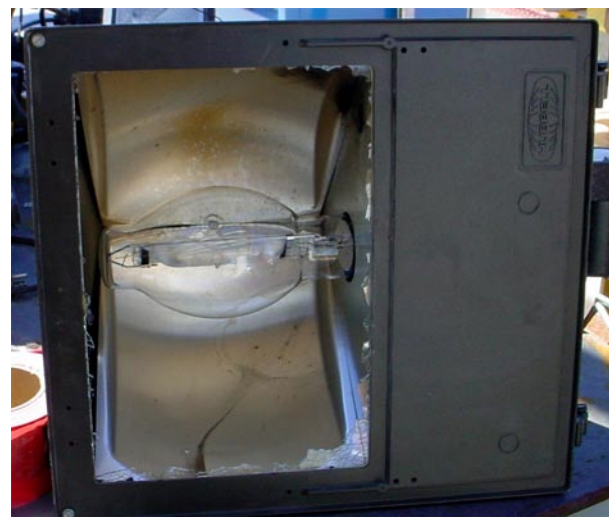
On September 6, 2005, at the Office of River Protection at Hanford, an electrician found a floodlight with the lens glass broken. Broken glass from the lens could be seen on top of a tarp that covered a pit opening. No one witnessed this event, and no one was injured. (Not reported in ORPS)

Figure 2-3. Floodlight with broken lens

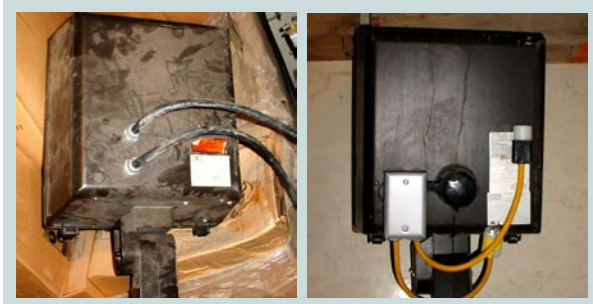
Figure 2-4. Back of previously modified (left) light unit and corrected modification (right)

The electricians should have attached a junction box to the outside of the floodlight and made the connections inside the junction box to prevent the wiring components from overheating. Figure 2-4 shows the original modification and the corrected modification.

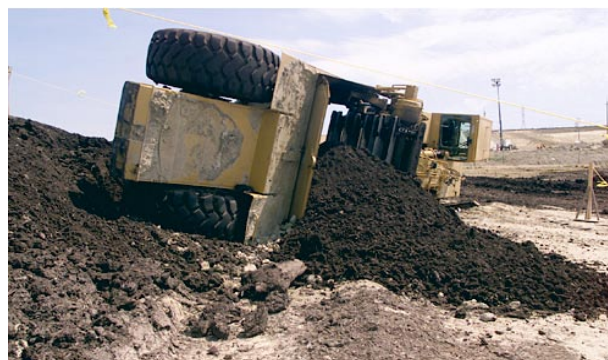
compost material (about 14 feet high) that had an 80-foot-wide entrance ramp and a 40-foot-wide exit ramp. Because of the soft nature of the compost, the rubber-tired, belly-pan scraper was pushed up the stockpile by a bulldozer until it reached the downward slope, then the operator left the stockpile via the exit ramp to spread the compost. When the operator was about 6 feet from the edge of the exit ramp, the right rear corner of the scraper began to slide sideways down the side of the ramp, and he braced himself for the inevitable rollover. After the scraper came to rest on its right side, the operator turned off the engine, removed his seatbelt, and safely climbed out of the scraper and down to the ground. Figure 3-1 shows the scraper following the rollover.

Investigators determined that the hazards associated with using this type of scraper on a large compost pile were not analyzed. The work authorization document identified hazards associated with stockpiles consisting of soil, stone, and rock materials, but did not take into account that the stockpile being spread was compost and a scraper was going to be driven across the top of it. Stockpiles of soil, stone, or rock are much more stable than those of compost, and a track-mounted excavator or bulldozer (which are much more stable on stockpiled materials) is usually used.

Figure 3-1. Scraper following rollover

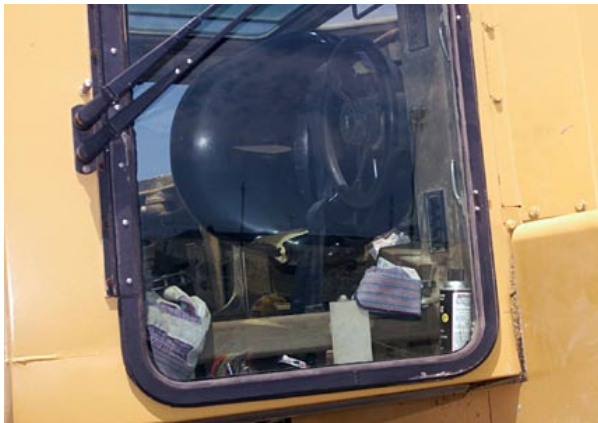
Figure 3-2. Scraper cab, post-accident

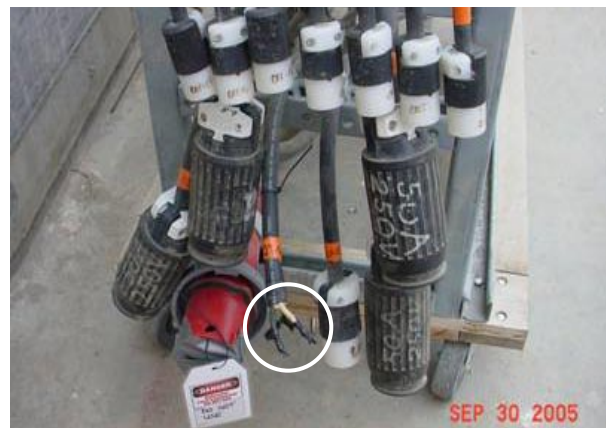
On September 29, 2005, at the River Protection Project Waste Treatment Plant, an electrician removed a plug to install a missing weather-protection cap, and the bare ends of an energized 240-volt power cord came together, causing an electrical arc. The electrician, who was not injured, had deviated from work instructions for de-energizing the circuit. (ORPS Report EM-RP--BNRP-RPPWTP-2005-0026)

The electrician was assigned to test power cords for assured grounding and to install missing weather-protection cord caps on the pigtails of a mini load center (Figure 4-1). The electrician was not given written work instructions, but was orally instructed to remove electrical power to the load center by disconnecting the 480-volt power cord (red plug in Figure 4-1) supplying the load center before he began to work. Instead, the electrician decided to keep the load center energized and open the circuit breaker for the specific cord he planned to work on. However, he opened the wrong circuit breaker so the cord he intended to work on remained energized.

Figure 4-1. Pigtails on the back of the mini load center and the exposed wires that arced (circled)

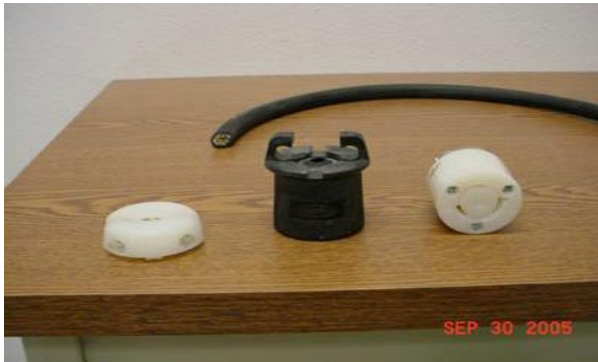
After opening the circuit breaker, the electrician used a tic tracer to check for the absence of energy. The tic tracer failed to indicate the presence of voltage, even though the wires remained energized. The electrician removed the plug attachment clip, slid the cap cover up the cord, loosened the plug wire connection, and removed the plug from the pigtail. When he slid the cap cover down the cord to remove it, the energized wires touched, producing the arc. Figure 4-2 shows the disassembled plug, and Figure 4-3 shows the weather-protection cap.

Figure 4-2. Plug attachment clip, cap cover, and plug (left to right)

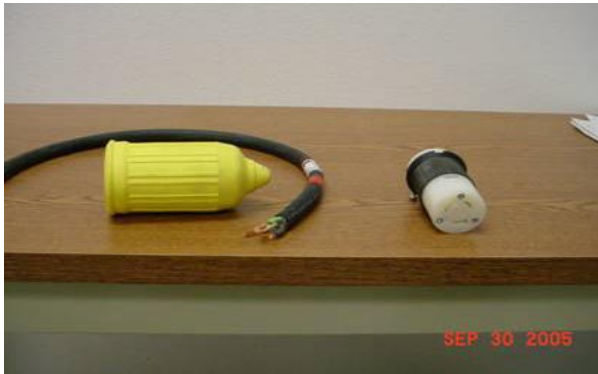
Figure 4-3. Weather protection cord cap (yellow) next to assembled plug
