OPERATING EXPERIENCE SUMMARY

U.S. Department of Energy
Office of Health, Safety and Security
OE Summary 2006-13
November 17, 2006

Failure to Wear Proper Personal Protective Equipment Results in Arc Flash Injury

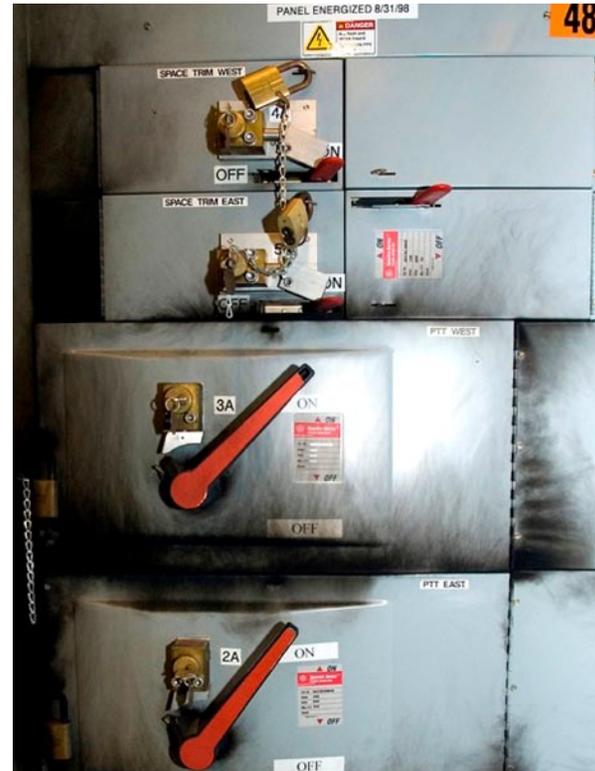
Figure 1-1. Electrical panel PB-1 with switch 3A in the center with signs of arc flash (soot)

A Type B Accident Investigation Board was established to investigate the cause of this accident. The Board believes the arc flash was caused by an overvoltage condition tied to a ground fault on an underground cable, which resulted in the initial arc between the grounded steel frame and phase B bus on the back of switch

The two 400-amp switches (2A and 3A) were coated on the inside with a layer of black soot. The left end of both switches was partially

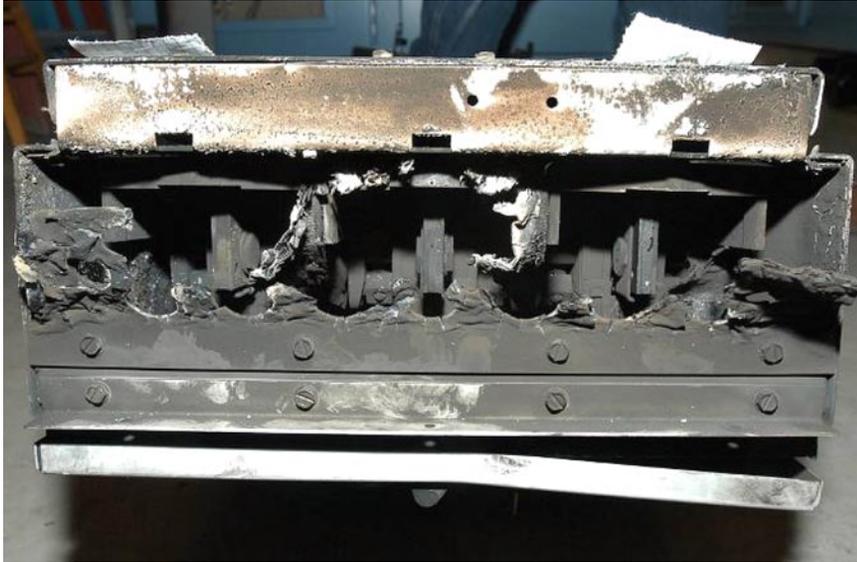
blown out, and adjacent wiring insulation was melted from the heat of the arc flash. The vent panels on the ends of the switches were seared and completely blown off, and the front covers were deformed (Figure 1-2).

Figure 1-2. Bowed cover on switch 3A

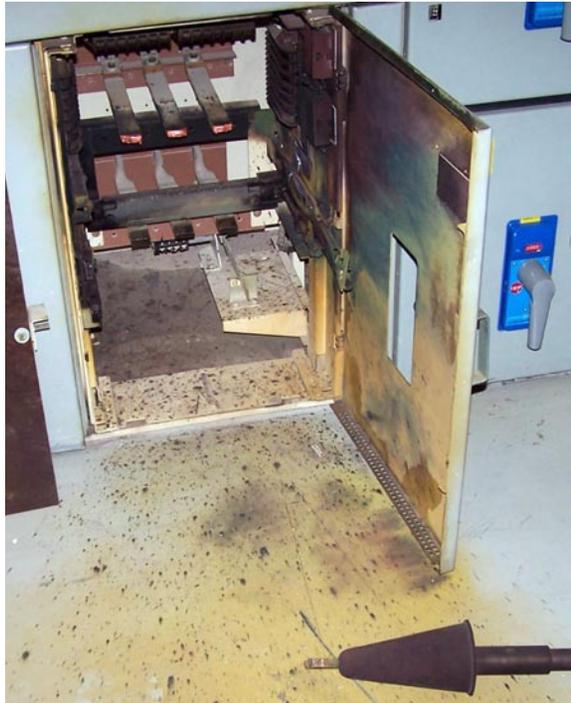
On August 26, 2006, an experienced electrician suffered serious flash burns to his hands, arms, face, and torso from a 480-volt arc flash. The arc flash occurred when the electrician decided to test a high-voltage detection device (hot stick) in a spare circuit breaker cubicle (Figure 1-3). His action caused a phase-to-phase short circuit and electrical arc. The electrician was sent to a regional burn center because of his injuries. He did not don the required PPE for accessing the circuit breaker cubicle

Figure 1-3. The damaged spare 480-volt circuit breaker cubicle and hot stick on scorched floor

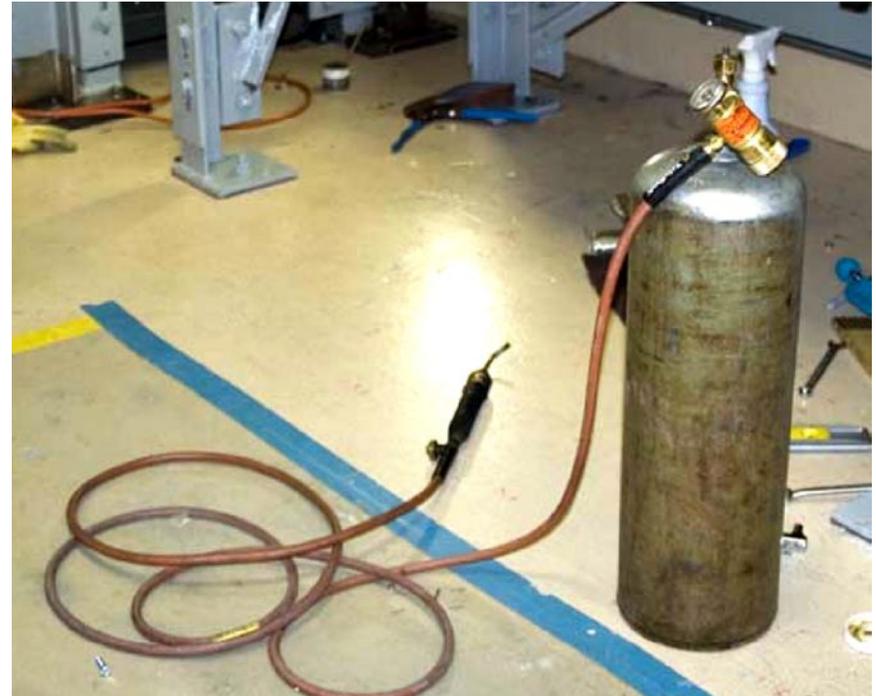
Figure 2-1. Acetylene bottle, regulator, hose, and torch head

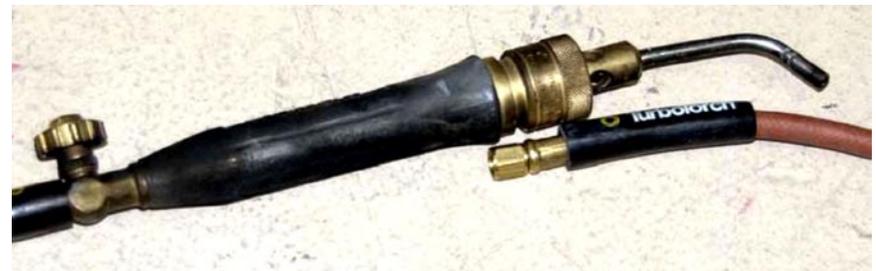
Figure 2-2. Torch head and hose connection to the acetylene bottle

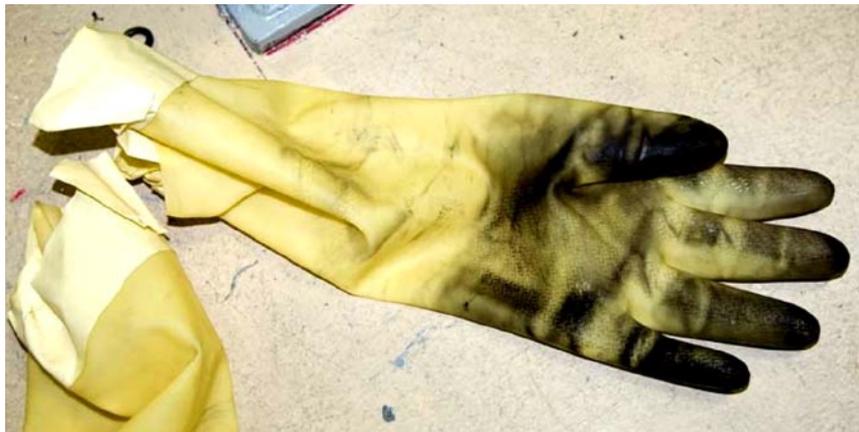
When the pipefitter pulled off his surgeon's gloves, he saw that the left glove was blackened, but had not failed (Figure 2-3), and the right glove was not significantly marked. Investigators believe the burns on the thumb, middle, and little finger of the pipefitter's left hand were caused by sweat in the glove that was turned to steam by the heat of the flames.

Figure 2-3. Pipefitter's blackened left glove

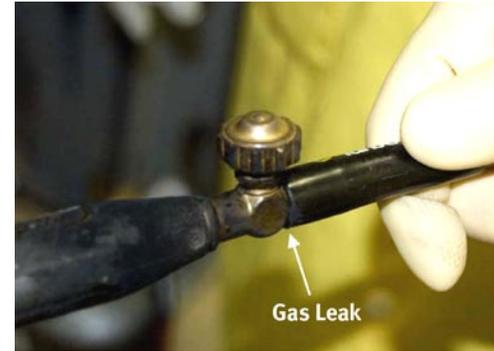
KSL management appointed a team to investigate the incident. They determined that the incident was caused by a loose hose connection on the torch head that allowed acetylene gas to escape and ignite (Figure 2-4). The hose connection did not have an engineered locking device to ensure the integrity of the connection.

Figure 2-4. Closeup of hose connection at torch valve torch

The KSL general manager directed that all torches of this design (i.e., single-hose, air-acetylene) be removed from service. Two-hose oxyacetylene or disposable propane bottle torches will be used instead.

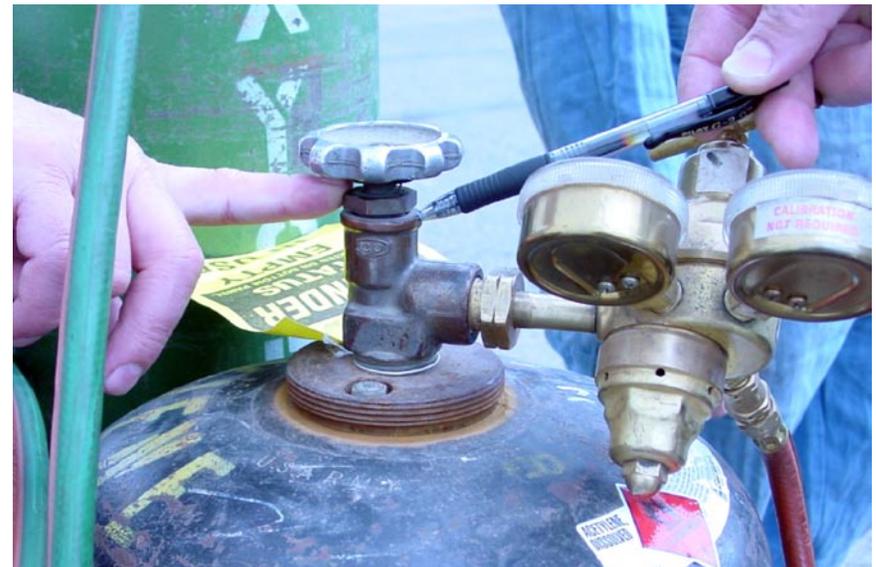
- On April 6, 2004, at the Idaho National Laboratory, a worker felt heat through his glove and noticed a small flame as he attempted to close the isolation valve on an acetylene bottle following oxy-acetylene cutting. The flame originated between the valve stem and the packing nut (Figure 2-5). Investigators identified several other oxy-acetylene torch systems that leaked either at the valve-stem packing nut or at the regulator threads. The gas-bottle vendor stated that occasional packing-nut leaks on acetylene bottles can be expected. Investigators recommended testing the systems for leaks. (ORPS Report NE-ID--BBWI-SMC-2004-0003)

Figure 2-5. Fire originated between the isolation valve and packing nut

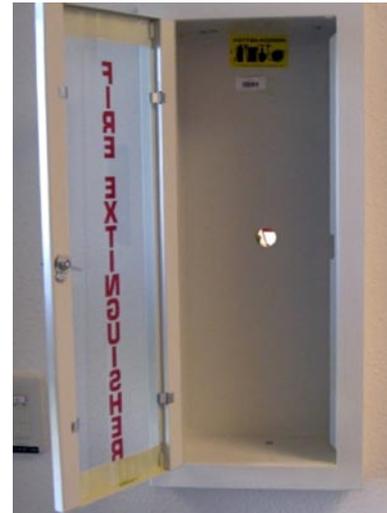
The worker drilled an inspection hole through the 5/8-inch sheetrock wall, then used a flashlight to look for any obstructions. When he saw no obstruction, he started drilling holes for thermostat wires and the 1/4-inch diameter center guide using a 1-inch hole saw. As the worker began to drill the holes for the center guide, he penetrated the fire extinguisher, which released its contents into the cabinet and into the room where it was located. Figure 3-1 shows the hole that was drilled through the sheetrock into the back of the recessed fire extinguisher cabinet, and Figure 3-2 shows the hole in the fire extinguisher.

Figure 3-1. Hole drilled through back of fire extinguisher cabinet

This event would not have occurred if the worker had simply checked the other side of the wall before drilling. However, the procedure that was used for this work has been changed as a result of the event, and exploratory penetrations must now be performed with a non-powered tool. The revised procedure also does not permit workers to use a power tool before they have made absolutely certain that there is no interference inside the wall.

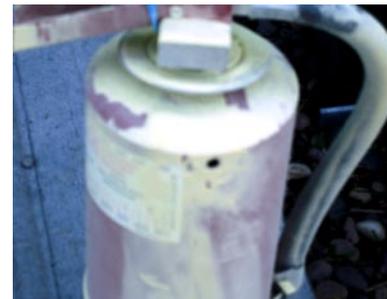
Figure 3-2. Hole in fire extinguisher

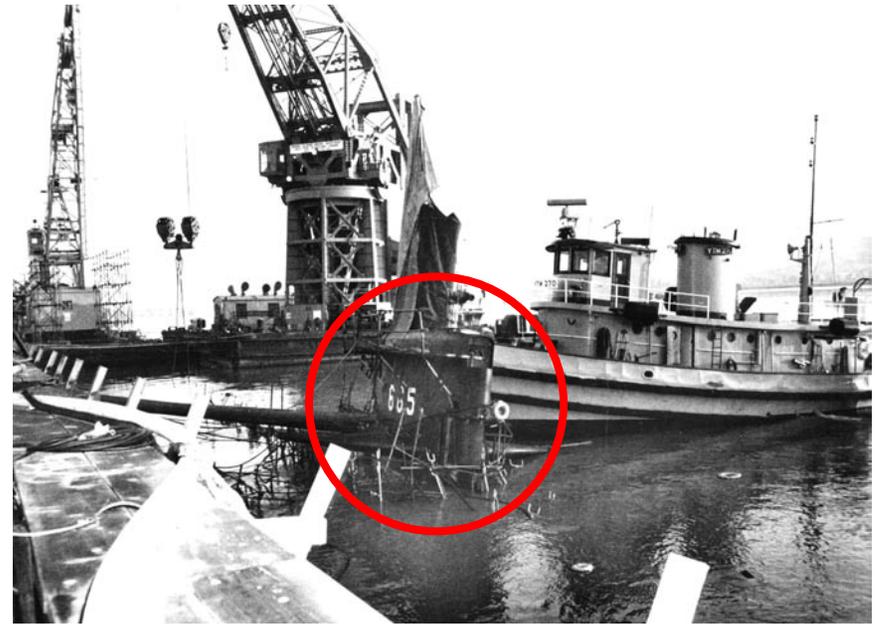
On May 19, 1969, at the Mare Island Naval Shipyard in the San Francisco Bay Area, the nuclear-powered attack submarine *Guitarro* (SSN-665) sank in 35 feet of water (while tied up next to the dock) when the forward part of the ship suffered uncontrolled flooding (Figure 4-1).

Figure 4-1. USS Guitarro resting on the river bottom as a tugboat prevents it from capsizing. All that is visible above the water is the ship's sail (circled).

As investigators would learn, the submarine's Achilles heel in this accident was the unprotected open manhole for the sonar dome, which is located close to the ship's waterline. When the bolted cover plate is removed, the opening is normally protected by a 3½-foot-tall cofferdam, and is designed to prevent water from entering the sonar dome. Investigators discovered that in March workers had removed the manhole cover and cofferdam to facilitate replacement of faulty sonar transducers inside the dome. The cover plate was later located on the dock, and the cofferdam was found in a warehouse.
