Operating Experience Summary

U.S. Department of Energy
Office of Environment, Safety and Health
OE Summary 2006-09
July 21, 2006

Accidental Activation of Golf Cart Results in Near Miss

Near Miss to Serious Injury When Crane Outrigger Float Falls and Hits Worker

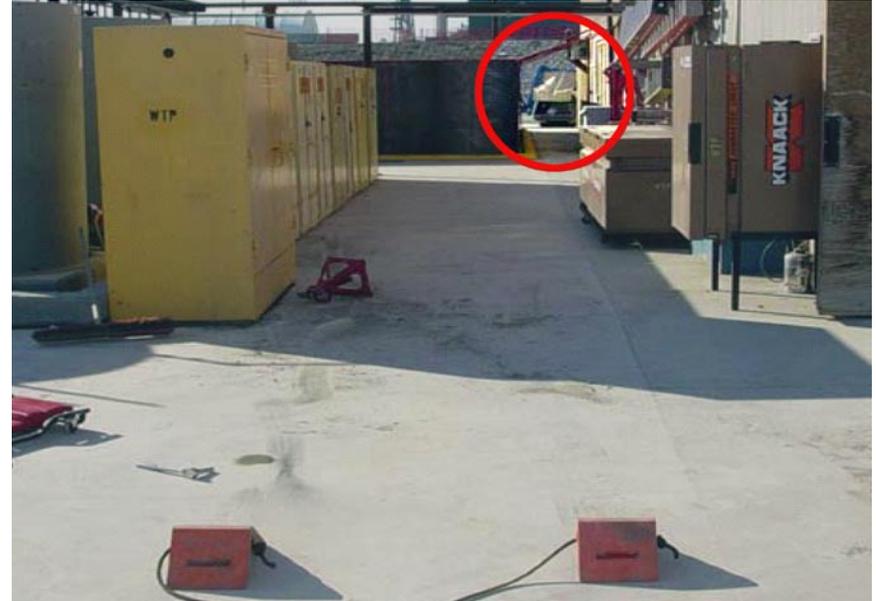
On March 21, 2006, a WTP mechanic was assigned to inspect a parking brake on a site golf cart. While he was underneath the cart, the accelerator engaged, the tires began spinning rapidly, and the 815-pound golf cart started moving. The cart traveled about 120 feet (see Figure 1-1), sideswiped several flammable material storage cabinets, and did not stop until it struck a parked articulating boom lift (Figure 1-2). The mechanic had not turned off the ignition or removed the batteries from the cart before he began working on it. Fortunately, he was not injured when the cart began to move. (ORPS Report EM-RP--BNRP-RPPWTP-2006-0010; final report filed April 20, 2006)

Figure 1-1. Path of cart (note cart at far right, rear)

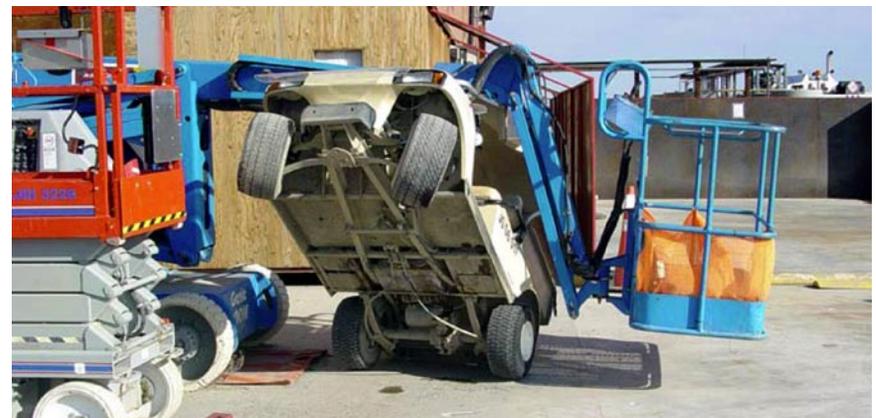
Figure 1-2. Golf cart stopped by the arm of the manlift

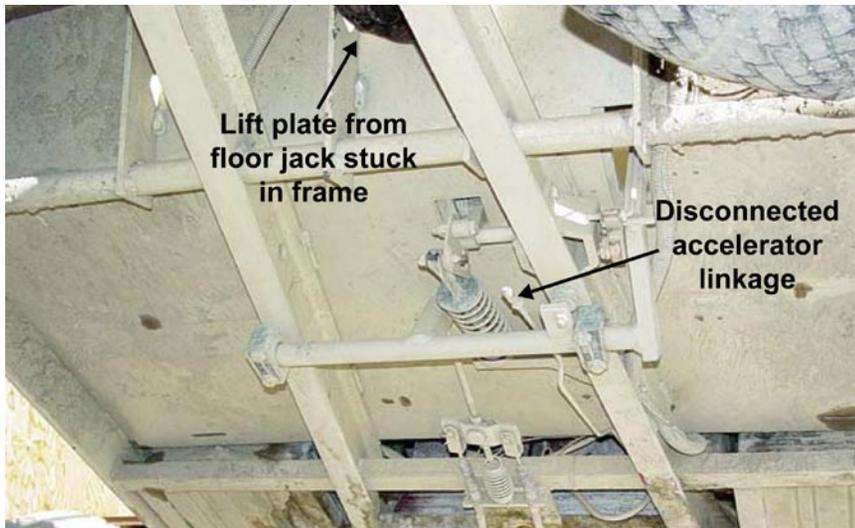
The mechanic had to access the undercarriage of the golf cart to inspect the parking brake. He raised the front of the cart about 20 inches with a hydraulic jack, placed jack stands under each front corner to ensure stability, and chocked the rear tires from behind. The mechanic then crawled underneath the cart and, lying on his back, accessed the undercarriage and disconnected the accelerator linkage. As he pushed the linkage to his right and toward the back of the cart, the movement engaged the cart, causing the tires to spin rapidly, and the cart began moving. Figure 1-3 shows the disconnected accelerator linkage on the undercarriage and the lift plate from the jack, which was carried along by the golf cart, stuck in the frame of the cart.

Investigators interviewed the mechanic, who told them that he thought he had turned off the ignition, but he did not remove the key or disconnect the battery. He also had not tagged the cart out of service or put it in neutral. Investigators determined that the mechanic did not follow the site equipment maintenance procedure, which states:

Figure 1-3. Cart undercarriage (note disconnected linkage and lift plate)

- Control work on hazardous energy sources using either a lockout/tagout or a Hazardous Work Permit.
- Eliminate the distinction between temporary power and permanent power when applying work controls.
- Provide specific instructions for work on hazardous energy sources.

- During pre-job planning, provide guidance describing actions to take when a change in condition is encountered.
- Establish a centralized work control and planning center to control work on or adjacent to operating systems and hazardous energy sources.

- Before work begins, the foreman must specifically address all hazardous energy sources that could affect the assigned work.
- When a work task that requires hazardous energy controls is assigned, a superintendent must document a release to perform work.
- Before a supervisor releases a work crew to leave the work area, barriers must be placed to prevent anyone from being exposed to the hazardous energy source.

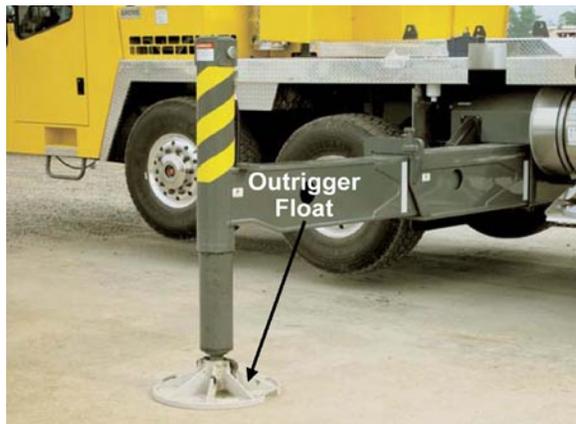
The HPT was performing release surveys on the 90-ton Grove mobile crane. As part of the survey, he needed to survey the bottom of the floats, which, when deployed, are in contact with the ground, as shown in Figure 2-1. When the HPT pivoted the float to facilitate the surveying task, it unlatched and fell.

Figure 2-1. Outrigger and float shown deployed

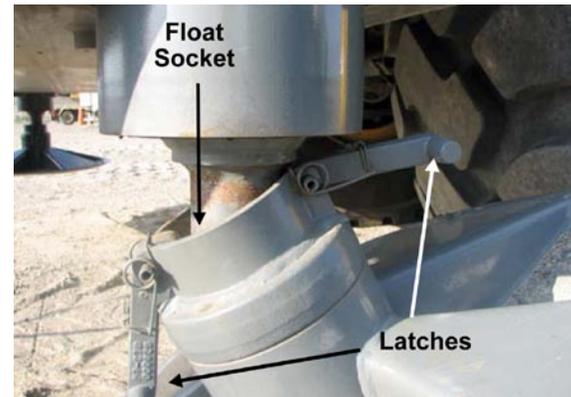
Figure 2-2. Quick-release float showing latches

transit. Removing the floats was a new task of the HPT. Previously, riggers removed the floats, but that assignment was changed because of reported HPT back strains. Figure 2-2 shows the float, as well as the latches on the Grove mobile crane. The latches on this crane have springs that are held in place by roll pins for quick release.

Quick-release floats allow for removal and stowage of the floats during transport. If left in place, the latches disengage when the float is pivoted 30 to 40 degrees from the horizontal plane. There is a warning label on the floats that reads “No Step.”

Investigators determined that the float socket was slightly enlarged, which could have contributed to the unexpected release of the float. Repairs were made to the correct this condition as directed by the manufacturer’s representative.

- Position your body such that detachable parts will not strike or pinch you if they fall.
- Use extension tools to reach under detachable parts.
- Brief personnel so they are aware of the operation and design of the equipment before use.
- Consider installation of positive retaining devices on detachable parts.
- Provide additional warning labels on the outrigger floats to remind personnel “Do Not Tilt or Lift.”
- Seek assistance from crane and rigging personnel when working with a crane.

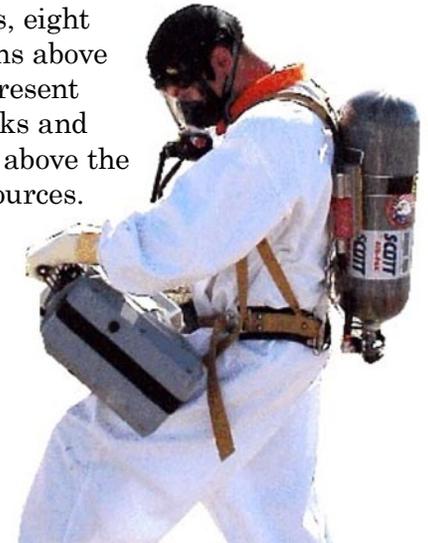
When the process was complete, a conservative exposure limit of 10 percent of the occupational exposure limit was set for chemical vapor concentrations inside the tanks. Of the 1,500 chemicals present in the tanks, 58 were found to be present above the 10 percent exposure limit. Industrial hygienists then sampled work areas to measure vapor concentrations (Figure 3-1). In the first

area that was sampled outside the tanks, eight chemicals were detected at concentrations above the exposure limit, but they were only present near vapor sources such as exhaust stacks and breather filters. No vapors were present above the exposure limit 0.5 feet from the vapor sources.

**Figure 3-1. Tank Farms
vapor monitoring**

Barriers were placed around the vapor sources, and workers were required to use supplied-air respiratory protection inside the vapor control zones. Outside the zones, respiratory protection is not required, but is available to those who wish to use it. Engineered controls are being evaluated for the vapor control zones.

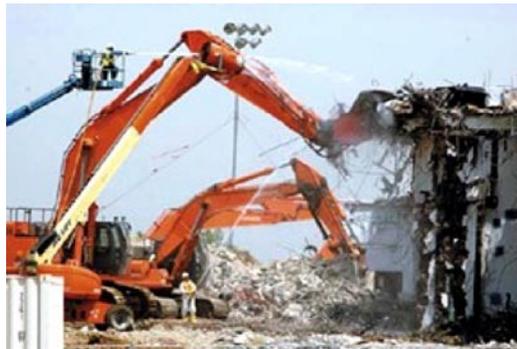
Figure 3-2. Dust control during demolition

with or cut concrete products such as roofing tiles are at greatest risk because of the dust. Large structures that are torn down (Figure 3-2) can release huge amounts of silica dust to the atmosphere. Respirators must be worn at the work or exposure site; once the

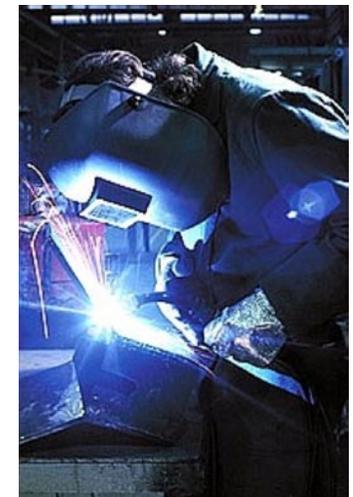
Hexavalent chromium is generated during arc welding (Figure 3-3) using stainless steel. The following summarizes one of two occupational exposures to hexavalent chromium fumes that occurred at the Hanford Waste Treatment Plant construction site.

Figure 3-3. Welding can produce hexavalent chromium
