# Operating Experience Summary

U.S. Department of Energy  
Office of Environment, Safety and Health  
OE Summary 2006-10  
August 25, 2006

## Equipment Labeling Error and Inadequate Zero-Energy Check Result in Electrical Arc Flash

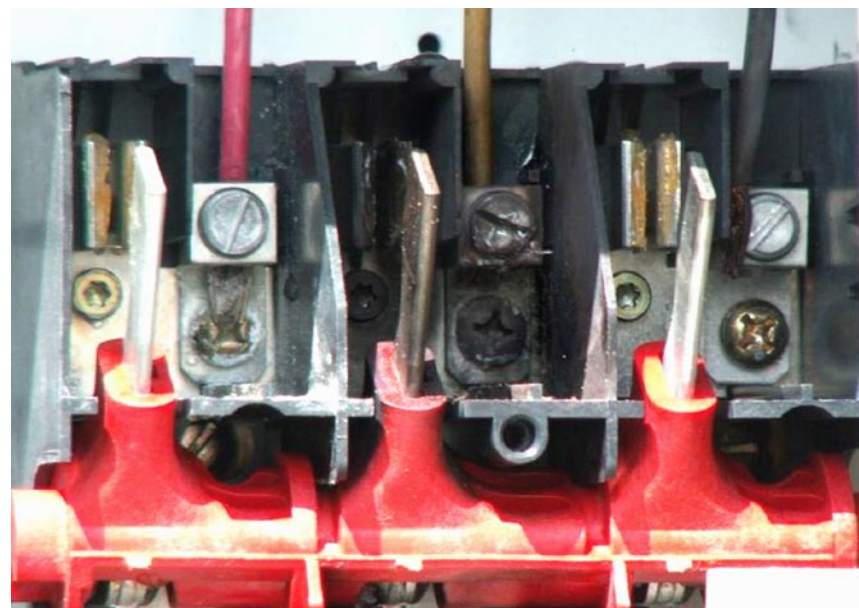
The electricians determined that a control power transformer had failed. They removed a mounting plate holding the transformer and then removed the transformer. The first electrician had to leave, and the second electrician obtained a replacement transformer. While repositioning the mounting plate with the new transformer attached, the line-side C-phase conductor came out of its lug and contacted the B-phase lug resulting in an arc flash. Figure 1-2 shows the burned B-phase lug.

An investigation team was formed to identify causal factors. They determined that the labeling error dated from the time of system construction in the summer of 2000. The labeling on the 25-amp circuit breakers at the distribution panel for the two chilled water pumps was reversed. They also determined that

the design of the arc suppressor on the line-side disconnects restricted access and visibility of the phase lugs during zero-energy checks.

**Figure 1-2. Closeup of the burned B-phase lug (center)**

Recommendations included revising the following procedures:

- Engineering and operations procedures that address new or modified electrical systems need to include verification of correct component labeling and confirmation that the labeled isolation point correctly isolates the identified component; and
- Electrical safety and LOTO procedures and personnel training, which need to include verifying electrically de-energized conditions by 1) observing the test meter probe as it contacts the component to be tested; and 2) observing test meter indications falling when the component is de-energized.

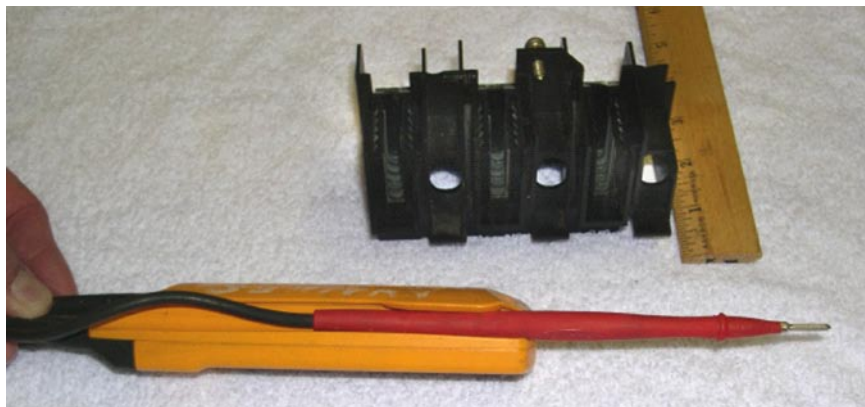
1. Use of the probe holder on the meter while positioning the test probe could have resulted in failure of the probe to contact the phase lug. If the probe was not positioned in the meter probe holder correctly, or if it slid back in the holder, the probe might not have reached far enough through the arc suppressor to make contact with the phase lug. (Figure 1-3 shows the meter and test probe.)

**Figure 1-3. Fluke T-2 meter with test probe in holder (arc suppressor shown above)**

2. The electricians could have mistaken contact with the arc suppressor as being contact with the phase lug without any distinct indication on the meter.
3. Corrosion on the phase lugs could have prevented adequate contact between the meter probe and the lug.

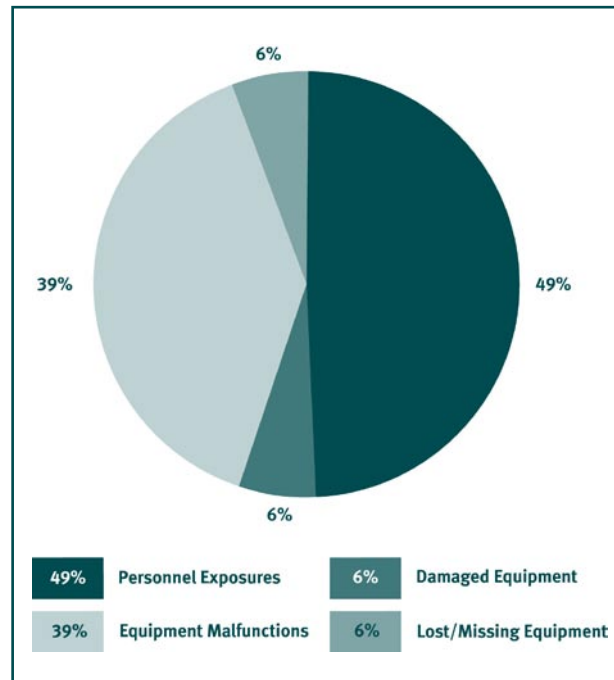
A review of the NRC event notification database showed 18 reported events involving radiography so far in 2006 (Figure 2-2). Almost half of these events resulted in personnel exposures, followed closely by events involving radiographic equipment malfunctions.

Figure 2-2. NRC-reported radiography events (2006)

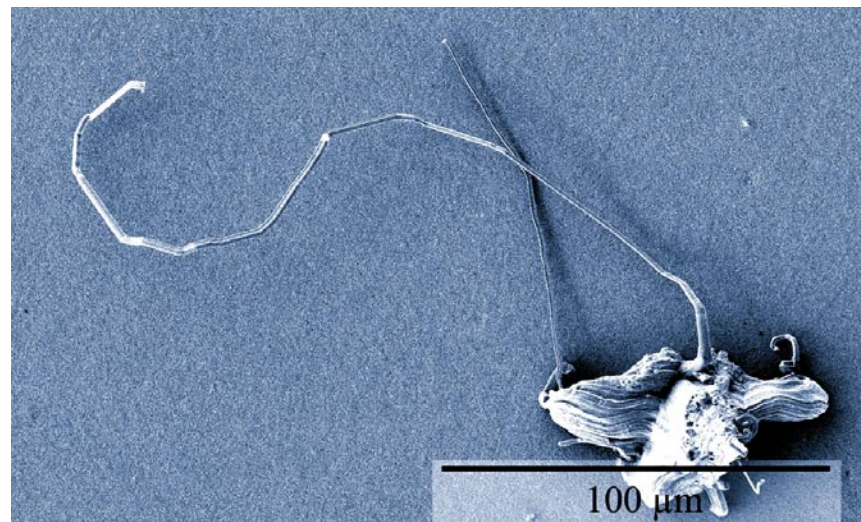
Figure 3-1 is a scanning electron micrograph of a whisker growing from a tin-copper alloy surface. Figure 3-2 shows a less-hazardous “hillock” developing from a pure tin surface. These electrically conductive growths can reach several millimeters in length; infrequently, whiskers as long as 10 mm have been reported. The most serious hazard posed by metal whiskers is a metal vapor arc, in which the whisker vaporizes into a cluster of

**Figure 3-1. Metal whisker on a tin-copper surface**

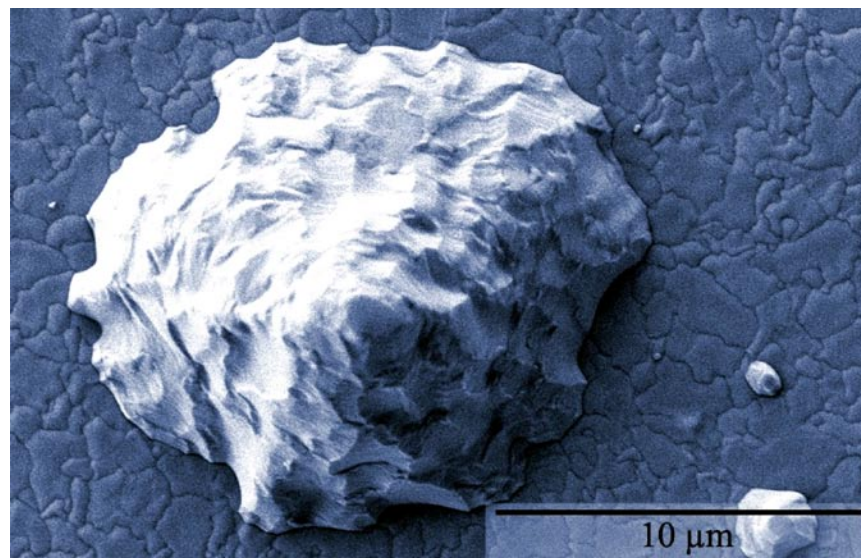
**Figure 3-2. A hillock growing from an electroplated tin surface**

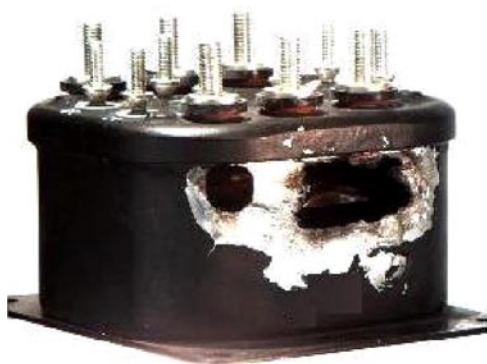
extremely conductive metal ions capable of carrying hundreds of amperes of current. Figure 3-3 illustrates the damage that can occur from such an arc.

**Figure 3-3. Damage from metal vapor arc**

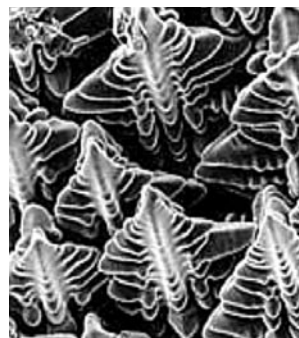
Metal whiskers differ from the more commonly known dendrites (from the Greek word for "tree"), not only by their shape and orientation, as shown in Figure 3-4, but also by the mechanism that forms them.

**Figure 3-4. Dendrites**

Dendrites form in damp environments when metal ions dissolve and are then redistributed in the presence of an electromagnetic field. Although the precise mechanism for metal whisker formation remains unknown, it is known that whisker formation requires neither metal dissolution nor the presence of an electromagnetic field.
