OPERATING EXPERIENCE SUMMARY

U.S. Department of Energy
Office of Health, Safety and Security
OE Summary 2007-05
July 16, 2007

Inside This Issue

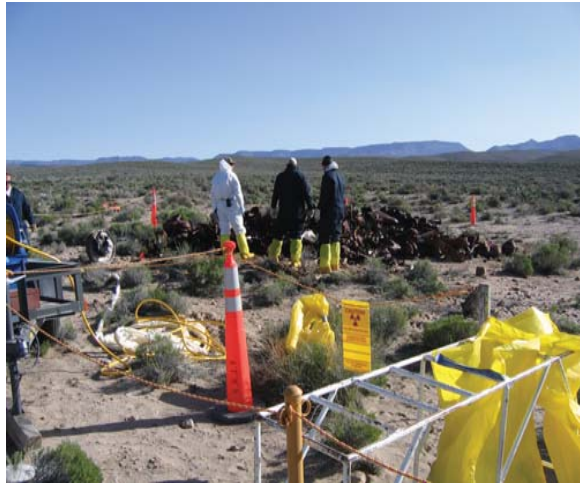
The standard description of hot weather clothing is "lightweight, light-colored and loose-fitting," and 100% cotton clothing has been shown to help prevent heat rash. While this is a good guideline for most outdoor work, in many cases that description does not meet the requirements for DOE work. The most important clothing factors are reflective ability and permeability. Much of DOE work typically requires varying levels of protection up to and including multi-layered Personal Protective Equipment (PPE) which, while blocking most of the radiant heat, adds weight, increases energy consumption, and may not allow for evaporative cooling (Figure 1-1).

Figure 1-1. Working outside in the sun while wearing PPE

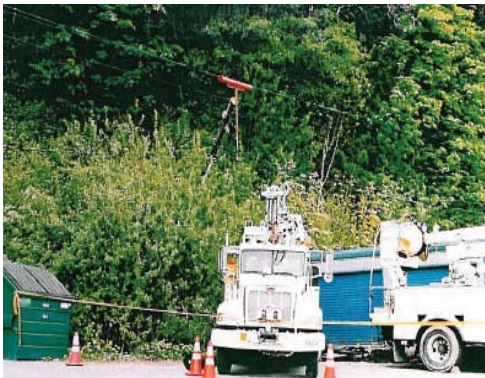
Figure 2-1. Work area showing the pole in the brush

The crew assigned to replace the pole consisted of one foreman, one journeyman lineman, and the apprentice, who had joined the crew a month before. The replacement pole was loaded on the line truck with the butt over the cab so that it could be moved and set in an area of brush on a hillside (Figure 2-1).

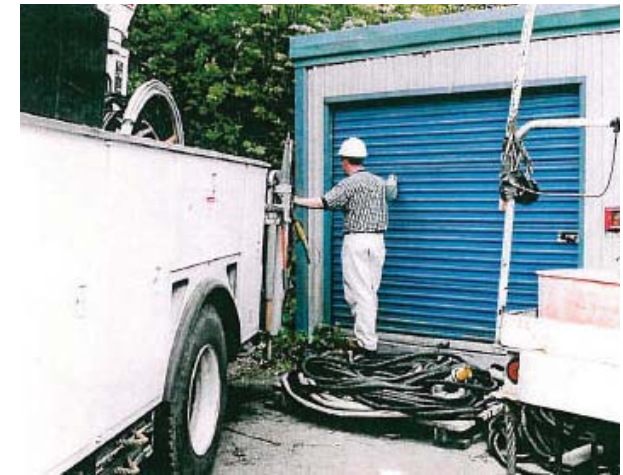
Figure 2-2. Incident reenactment (touching the energized truck and the grounded metal building)

apprentice placed one hand on the truck and one hand on the metal building as he stepped over a pallet of electrical cables. Current flow passed through the chest and heart of the apprentice (Figure 2-2). At the same time, the foreman heard an arching sound and immediately swung the boom away from the primary phase.

- The job should have been engineered, planned, and made ready for the work crew. The work was performed as a favor in exchange for materials and the site was congested and filled with obstacles.
- The job briefing should have focused on the line truck boom being in close proximity to the primary zone because the energized overhead power lines were 26 feet above the ground. Also, not touching the line truck while the boom is in the primary zone should have been discussed with the crew.
- The crew should have used protective line barriers, rubber gloves, and grounded the line truck. The apprentice was not wearing rubber electrical gloves.
- Additional manpower could have been used so the foreman would be able to focus his entire attention on the job as a safety watch and spotter.

- The crew did not have an Automated External Defibrillator (AED) with them, which could have changed the outcome of the accident if employed quickly.

These events underscore the importance of adequate planning when work is to be performed around overhead electrical hazards. Adequate resources need to be assigned to support the safe operation of equipment near these types of hazards. In addition, job planning should address work area issues such as congestion or obstacles that could jeopardize worker safety. Pre-job briefings need to thoroughly address all potential hazards and stress the use of proper protective equipment and PPE. It is important that your workers are knowledgeable of the dangers imposed by overhead electrical hazards and that your organization's safety policies regarding proximity to high-voltage power lines are consistent with the requirements of [29CFR1910.333](#), Electrical – Selection and Use of Work Practices.

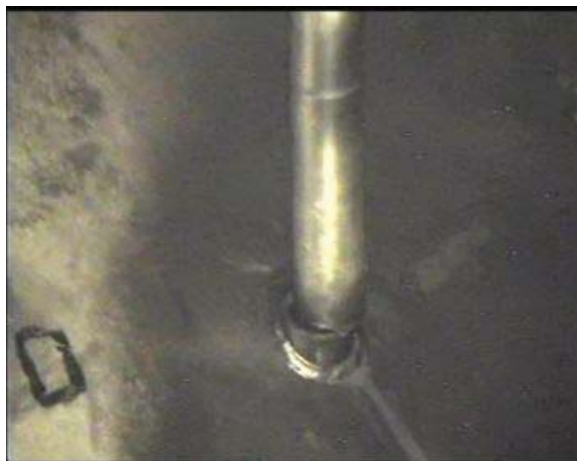
On April 20, 2005, a camera inspection of a feed clarification cell revealed that a pipe carrying highly radioactive dissolver solution to an accountancy tank had severed (Figure 3-3) and leaked 83,000 liters of nitric acid solution containing approximately 20 metric tons of uranium and plutonium onto the floor of the cell and into a sump. There were no injuries and the highly radioactive solution was contained within the cell. The leaking pipe had gone undetected for a period of 9 months. The camera inspection was initiated because of calculated discrepancies in the nuclear material balance.

Figure 3-3. Failed pipe nozzle on tank head

Investigators determined that the nozzle failed from fatigue caused by the motion of the accountancy tank during certain conditions of operation. The initial breach would have been small and would have grown to a complete failure in later stages over a period of months.

The tank is suspended from the cell roof by four rods to allow it and its contents to be weighed for material balance determination. Operators had seen problems with tank vibration during agitation and emptying cycles. Although agitation of a full tank showed imperceptible movement, very visible large movements occurred when the tank was half full. Operator guidance had always been to agitate a full tank just before sampling. However, in 1997, the requirements changed from agitating a full tank to allowing agitation of less than a full tank for prolonged periods. Investigators could not find any procedures for auditing how these decisions were made. Also, the original design of the accountancy tank provided for seismic restraints to prevent lateral movement and induced stresses during pumping and agitation; however, the installed configuration had been modified and the restraint blocks were not installed.

- The technical origins of the leak lay in the design inconsistencies in the later stages of the design process and during construction, together with a modification to the operational mode of the tank that inadequately considered the impact on the piping. The incident has again highlighted the experience in the major hazards industries across the world where ill conceived or inadequately executed changes to design, plant, procedures, process or organizational arrangements have resulted in incidents. It is essential that changes, even those that are apparently minor, are carried out with the appropriate assessment of their potential impact by people who understand their safety significance in relation to the original design intent of the plant or processes to be changed.
