# OPERATING EXPERIENCE SUMMARY

U.S. Department of Energy  
Office of Health, Safety and Security  
OE Summary 2007-06  
September 14, 2007

## Damaged Powered Air Purifying Respirator Hoses

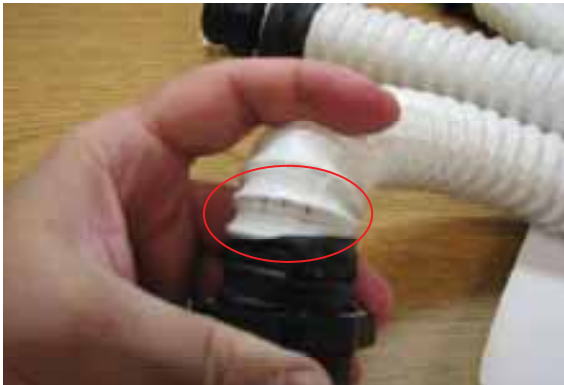
On August 2, 2007, at the Hanford K-Basins, a cut in a breathing air tube for a powered air purifying respirator (PAPR) was identified at a mask issuing station. The air supply tube on the PAPR, manufactured by Bullard, was damaged by the sharp edges of the tube connector. (Lesson Learned 2007-RL-HNF-0029)

The Bullard PAPR hood uses a breathing air tube (PN# PA1BT) that connects to a plastic fitting that has a sharp outer edge. This can cause small holes to develop in the composite plastic breathing air tube that supplies air to the hood. The holes can be difficult to see and may be partially covered by a black outer wrap around the hose (Figure 1-1).

*Figure 1-1. Small holes in white plastic breathing air tube (red circle)*

Once the problem of the damaged air hose was identified, respiratory protection personnel inspected a sample of 50 hoses of which 12 were found to have the same problem. Most of these hoses had been used daily for more than a month. They also inspected 100 new hoses and found no holes. The manufacturer has been contacted and is working with the Hanford Respiratory Protection Program to eliminate the occurrence of this type of damage.

*The identification of the damaged air purifying respirator hoses underscores the importance of inspecting respirator equipment and verifying its integrity before it is issued to the user. It is also extremely important to ensure that personnel who wear respirators understand and implement the correct methods for checking, wearing, and operating their respirators.*

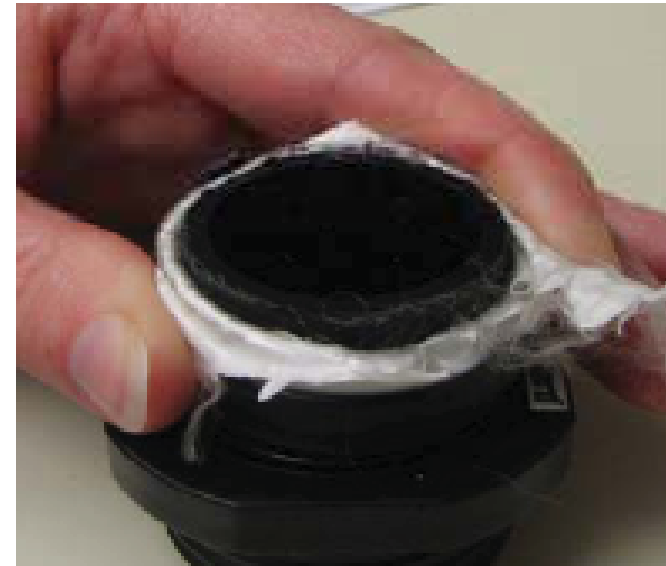
The outer edge of the plastic fitting, which inserts into the hose, can score the composite plastic hose and cause a line of small cuts penetrating the hose around its perimeter near where the hose

contacts the top of the fitting. After cutting apart one of the hoses, investigators observed that the outer edge of the fitting against the hose was sharp and rough in some spots (Figure 1-2). The normal action of assembling the hose to the blower unit and normal movement could score the hose and then exacerbate the cutting effect. These cuts can be single or multiple. The observed multiple cuts appear to lie in a straight line around the perimeter where they contact the inner fitting.

*Figure 1-2. The rough and sharp edge can be seen around the edge of the black tube (fitting)*

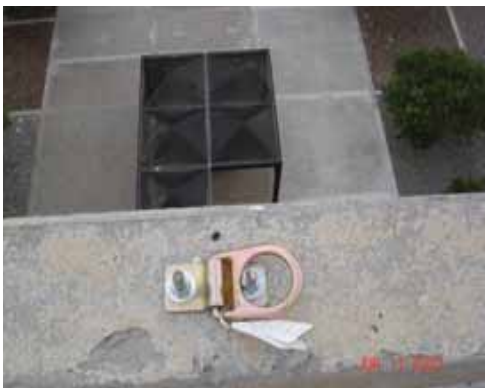
On June 9, 2007, at Sandia National Laboratory, two members of a roofing crew for a roofing contractor attached their fall protection lanyards to anchor points that were not completely installed. They did not notice that the anchor points were not fastened to bolts epoxied into a parapet wall. After scraping gravel from the roof, the roofers took a morning break. While disconnecting their fall protection lanyards from the anchor points, one of the roofers noticed that the anchor point was not bolted down. When the hook was removed from the D-ring, the anchor point came off the bolts and fell four stories to the ground. This event is significant because the roofers believed their fall protection system was adequate. (ORPS Report NA--SS-SNL-NMFAC-2007-0006; Final filed 07/29/2007)

On May 30, 2007, a craftsperson for the construction contractor installed the tie-off points along the roof edge of Building 891. The bolts that would be used to attach the fall protection anchors to the parapet wall were epoxied in place and the anchors were placed over the bolts. However, the craftsperson did not have the nuts necessary to complete the task and planned to finish the job the following day but was reassigned to another work location and the nuts were not installed. Figure 2-1 shows the anchor correctly bolted in place.

**Figure 2-1. Fall protection anchor bolted in position. Note: The canopies are 45 - 50 feet below.**

Investigators determined that the roofing contractor's superintendent failed to ensure that the anchor points were properly bolted down before he directed the roofing crew to use them for their fall protection equipment. Also the construction contractor's superintendent failed to ensure the task of installing the anchor points had been completed before reassigning his craftsperson. Investigators also determined that the anchors purchased by the roofing contractor and provided to the construction contractor for installation were not engineered to be installed on the top of the parapet wall. Neither contractor superintendent contacted the project manager or construction manager to obtain approval before using the anchor points; consequently no structural or safety engineer reviewed the installation.

*The installation of fall protection anchors should be well planned and engineered. It is important to carefully calculate the amount of load the anchor needs to support during normal operation and in the event of an accidental fall. Any installation should be reviewed by a safety professional and approved before allowing workers to attach their fall protection system to the anchor point. Don't make the anchor point the weak link in your fall protection system.*
