OPERATING EXPERIENCE SUMMARY

U.S. Department of Energy
Office of Health, Safety and Security
OE Summary 2007-08
December 18, 2007

Near Miss — Excavator Windshield Broken by Flying Debris

Type A Accident Investigation of the Mixed Waste Spill at Hanford Tank Farms — Part 1: Engineering Design Factors

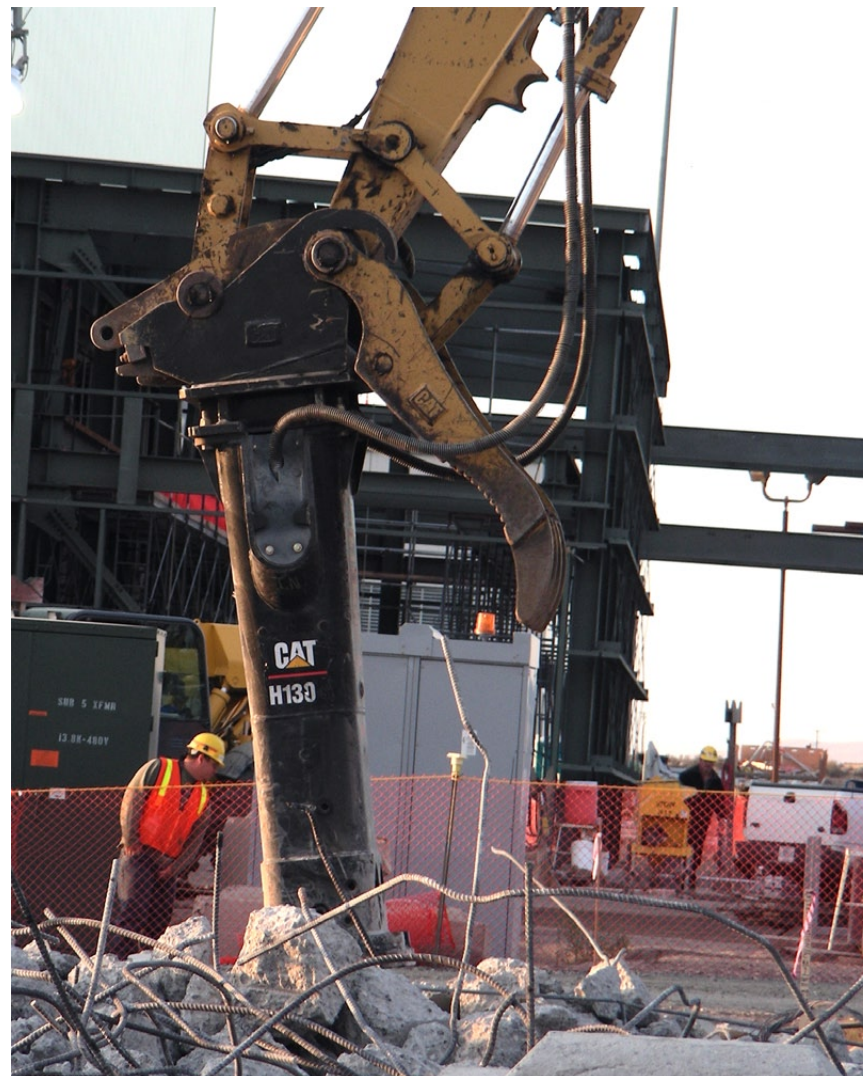
Workers were using two excavators to demolish a reinforced concrete slab. One excavator had a hydraulic hammer attachment (Figure 1-1) to break up the slab; the other had a bucket attachment to remove debris. The excavator with the hammer had an expanded metal windshield guard, but the one with the bucket had no guard. As the excavator with the bucket attachment was relocating a 3-foot-diameter piece of concrete and rebar, it was dislodged, and the windshield was damaged (Figure 1-2). The damaged excavator was removed from the work location, and operators were directed to use only the excavator with the windshield guard. They were also told not to move any material containing rebar over 4 feet long.

Figure 1-1. Hydraulic hammer attachment at location of rebar and concrete debris

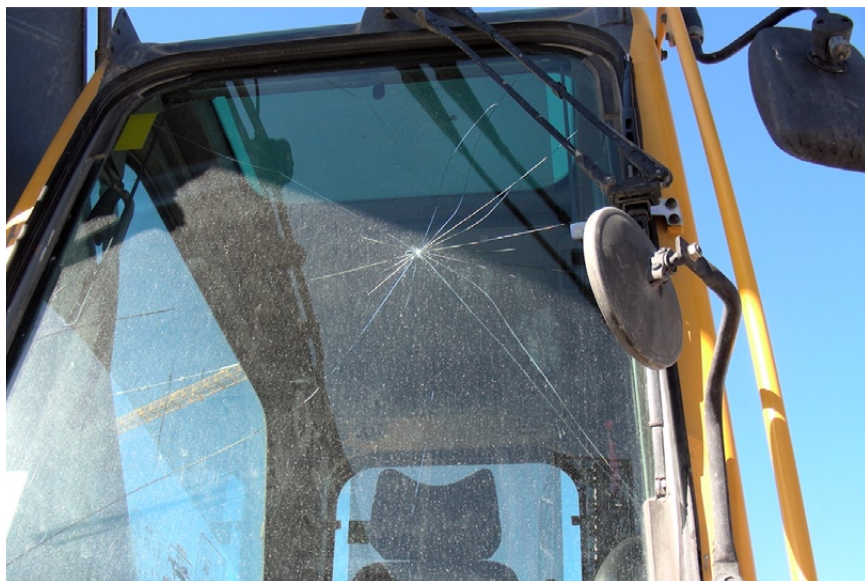
On September 26, 2007, at the Hanford River Protection Project, an operator was using an excavator bucket to pick up a section of concrete and rebar when a piece of entangled rebar dislodged, sprang backwards toward the excavator, and struck the windshield in two locations. The rebar penetrated the windshield approximately 1 inch near the excavator operator's foot. Fortunately, the operator was not struck by the rebar or debris. (ORPS Report EM-RP--BNRP-RPPWTP-2007-0017; final report filed November 9, 2007)

Figure 1-2. Cracked windshield on excavator

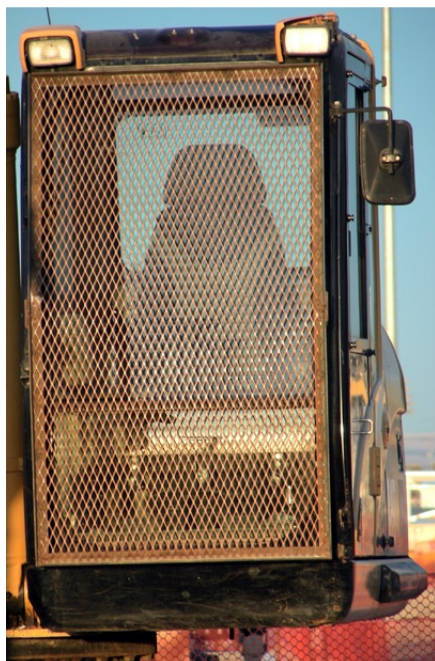
Figure 1-3. Metal screen over windshield of excavator cab used in the Hanford rebar event

use of stronger glass as a replacement or installing additional layers of a polycarbonate material or metal screens (Figure 1-3).

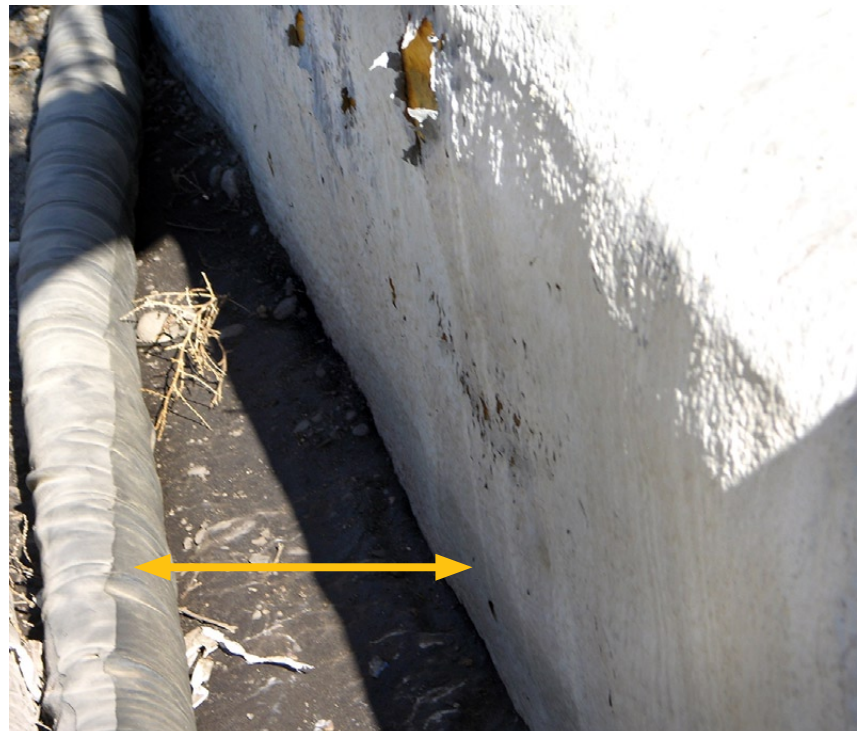
On July 27, 2007, at the Hanford Tank Farms, a health physics technician performing a tank waste transfer shutdown radiological survey identified unexpected high radiation levels (about 200 mrem/hr) in an area 8 to 12 feet from a transfer pump. An entry team responded, took initial radiation readings, and measured 25 rem/hr (beta window open) and 1 rem/hr (beta window closed) within a foot of the liquid. The entry team also found a dark stain and standing liquid around the pump pit. (Figure 2-1, taken post-event, shows a “bathtub ring” on the inside of this cavity several inches deep along the top of the hose and on the north face of the pump pit wall.) Access to the area was immediately restricted, and the spill area was stabilized. Subsequent analysis indicated that as much as 85 gallons of tank waste, including suspended solids and vapors, were released in a short period of time from a ruptured dilution hose near the pump. (ORPS Report EM-RP--CHG-TANKFARM-2007-0009)

Figure 2-1. Double-sided arrow shows “bathtub ring” along the top of the hose and on the pump pit wall

pressurizing it. At that point, the hose connected to the dilution line failed, releasing the mixed waste to the ground near the pump platform at the top of the tank.

The Board concluded that the direct cause of the spill was an overpressure of a hose connected to a dilution line on the retrieval pump system.

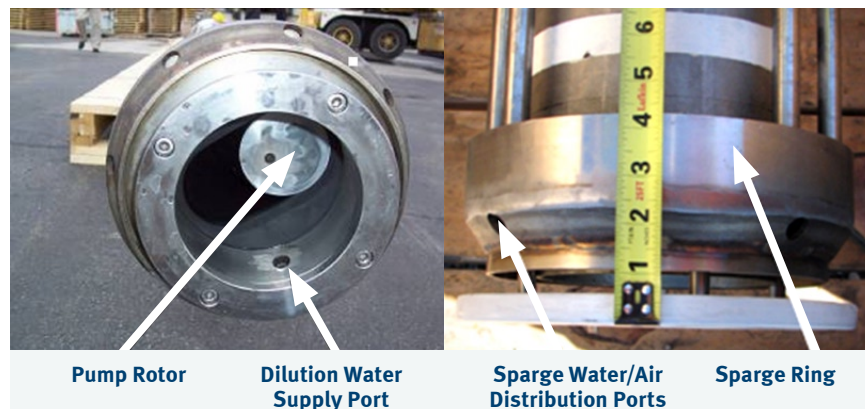
The Hanford Tank Farms are designated as a Category 2 nuclear facility. The tanks, pumps, and related safety systems are covered by a Documented Safety Analysis (DSA) and by Technical Safety Requirements (TSR). The pump that was involved in this accident was installed in mid-July 2007, and was operated for only a few days before the accident occurred. The pump dilution water and sparge water nozzles are shown in Figure 2-2.

Figure 2-2. Dilution water and sparge water nozzles

The overpressurization and spill resulted from the lack of an isolation device (e.g., a backflow preventer) between the dilution water system (a non-waste transfer system) and the waste transfer route. Both the DSA and TSRs require such a device. The Board also determined that the sparging water system met the DSA definition of a “non-waste transfer system not physically connected” to the waste transfer route and, thus, also required an isolation device. However, there was no isolation device in place. They identified the root cause of the event as the failure to implement the DSA requirement to provide isolation of the hose from the waste transfer route as prescribed in the TSRs.

1. Improve incorporation of the design features, testing, and operating limits and specifications into operating procedures associated with the tank and the pump to ensure its ability to move waste without becoming fouled.
2. Revise the design review processes, procedures, and implementation to ensure approved designs are technically correct and satisfy the requirements of the DSA.
3. Perform an engineering analysis to determine whether the pump can continue to be operated safely following the deformation that occurred when excessive shaft torquing was applied during maintenance.
4. Change the safety basis to require that new primary pressure boundaries for the tank be classified as safety significant, and treat existing installed systems, structures, and components as if they were safety significant to the extent practical.
