OPERATING EXPERIENCE SUMMARY

U.S. Department of Energy
Office of Health, Safety and Security
OE Summary 2007-09
December 28, 2007

Near Miss – Shelving Units Collapse

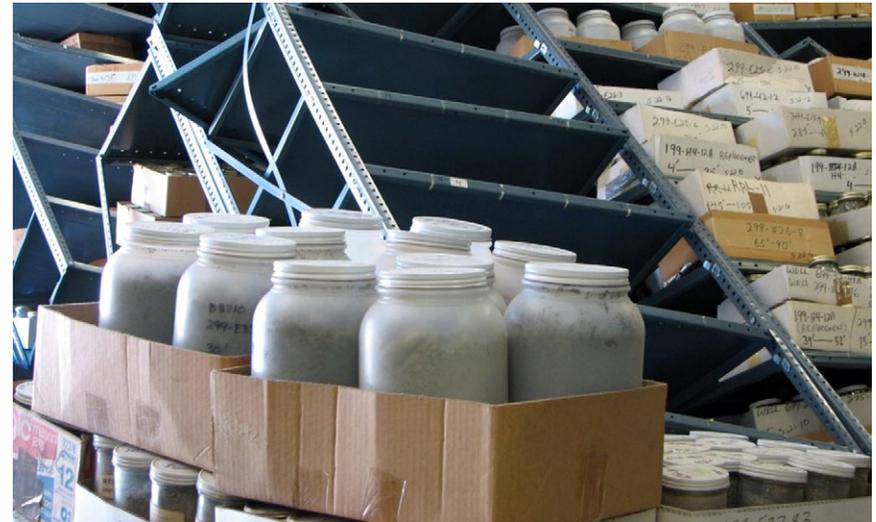
The storekeeper was relocating boxes of soil samples from a pallet to the free-standing shelving where they were stored. As he was pushing a box from the front of a shelf to the rear of it, the bottom part of the shelf wall gave way, and the entire unit began to collapse and fall. Figure 1-1 shows the box of soil samples that the storekeeper was shelving, as well as the fallen shelving units. Figure 1-2 shows the aftermath of the collapse and the fallen second unit. Had the shelving fallen in the opposite direction, the storekeeper could have been badly injured.

Investigators determined that when the shelves were assembled the manufacturer's instructions were not followed. They also determined that the shelves were poorly braced. In addition, the fasteners used to connect individual sections of shelving were not checked after assembly to ensure that all of them were installed and had been properly tightened.

Figure 1-1. Box of soil samples and collapsed shelves

units. More manual labor would have been required to load the heavy soil samples on the shelves without the fork truck, so the decision was made to install the cross-bracing after the shelves were loaded. Because neither the bottom nor top tier of shelves was cross-braced, the shelving was vulnerable to failure when it was carrying a normal vertical load.

1. Always obtain and use manufacturer's assembly instructions.
2. Never make modifications which may degrade structural integrity without an engineering analysis and approval.
3. Inspect and verify that free-standing shelving fasteners used to connect sections are present and tightened; ensure adequate cross-bracing is present in each section and that it is adequate for the loads they contain and is attached to the facility structure in some fashion (bolted to the floor, fastened directly to the wall, or uses a grid system of bracing to fasten one section to another).

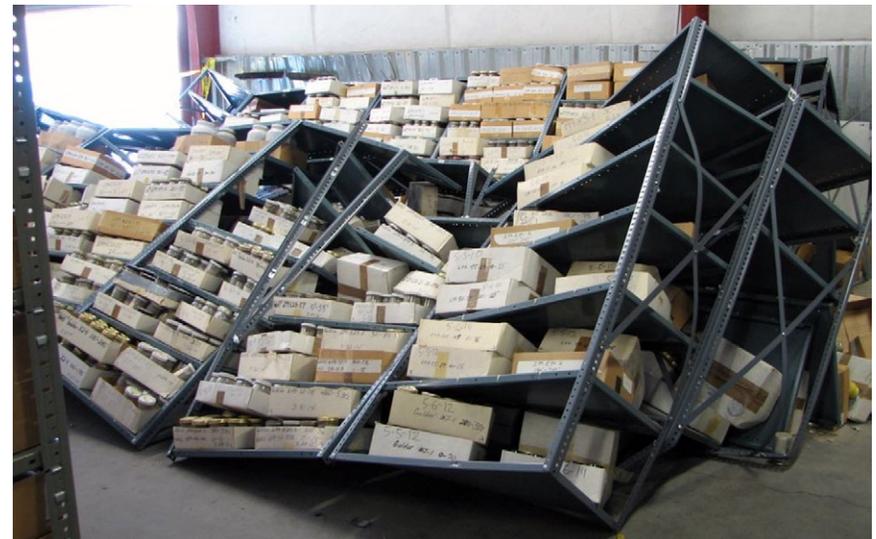
Figure 1-2. Aftermath of shelving collapse

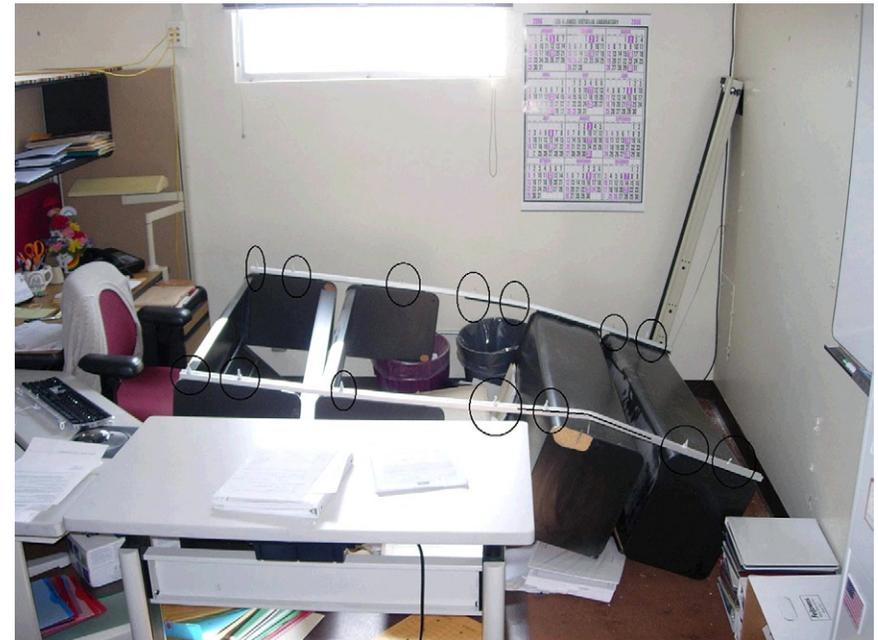
On June 29, 2006, at the Nevada Test Site (NTS), wall-mounted cabinets in an office fell to the floor. The shelving had been mounted to drywall with self-drilling drywall anchors and weighed about 250 to 350 pounds. No one was in the room when the shelving fell, but as can be seen in Figure 1-3, the employee who worked in the office could have been injured, perhaps seriously. (ORPS Report NA--NVSO-BOPNV-2006-0001)

the cabinets be removed so that rail attachments to the wall could be strengthened; however, the shelving fell before repairs could be made. Investigators determined that only 7 of the 12 manufacturer-required anchors had been installed. When several anchors pulled through the drywall, the remaining anchors could not support the weight of the cabinet and shelves. A Lessons Learned Bulletin (2006-LANL-NTS-001) on the event states that “not following manufacturer's instructions for wall-mounted cabinets can result in catastrophic failure.”

Figure 1-3. Fallen office shelving (anchors are circled)
