OPERATING EXPERIENCE SUMMARY

U.S. Department of Energy
Office of Health, Safety and Security
OE Summary 2008-02
March 14, 2008

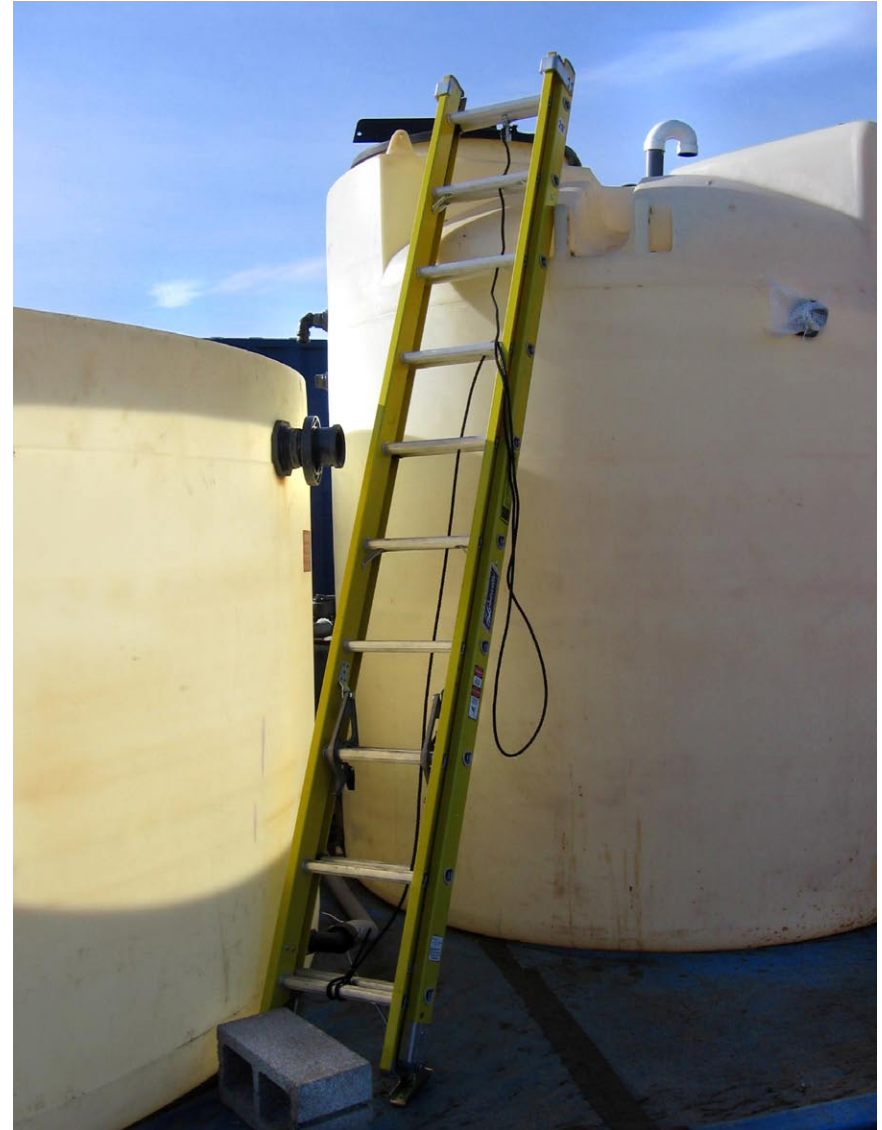
The worker had installed three or four bolts that were directly in front of him on the tank lid and then reached to the left back side of the lid to install another bolt. He leaned to the side to tighten the bolt, shifting his center of gravity, and the ladder began to slide sideways. The worker tried to stop the ladder from moving, but it was too heavy from his weight, so it continued to slide. The worker fell into the adjacent effluent tank while still holding the ladder, and it fell on top of him. After a few moments, he pushed the ladder off, set it up inside the tank, and climbed to the top of the tank. An engineer, who heard him call for help, put a step ladder on the outside of the tank, helped the worker out of the tank, and took him to the first-aid station.

Figure 1-1. Tank and extension ladder
(the worker fell into the tank on the left)

Following their investigation of this fall event, investigators concluded that the worker did not follow the safety training he had received and did not follow safety plan requirements to tie off the ladder.

This event demonstrates the importance of securing ladders to prevent any unexpected movement or sliding across a smooth surface, as well as the importance of analyzing any potential hazards and developing actions to mitigate them.

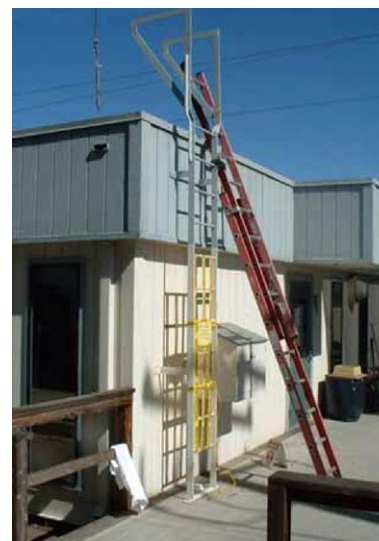
Figure 1-2. Accident scene showing the fixed ladder and an extension ladder added post-accident for temporary roof access

worker had maintained three points of contact with the ladder (i.e., used his feet and hands in any combination of three). Had he followed this technique, he would have been able to recover from the missed step without falling. (ORPS Report NA--LSO-LLNL-LLNL-2006-0037)

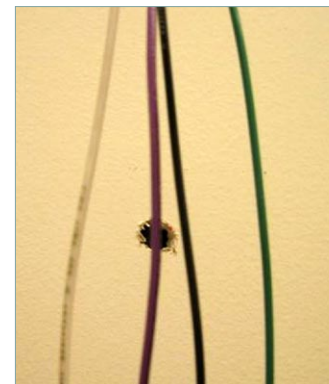
Seven storage cabinets had been placed along a wall in the corridor before being secured to the sheetrock, and the carpenter had already installed three of them successfully. One of the remaining cabinets was in front of the electrical receptacle, hiding it from view, so the carpenter did not see it before he began to drill. When he stopped to inspect the penetration, according to procedure, he saw what he thought was a galvanized sheet-metal wall stud and proceeded to drill a 1/8-inch pilot hole. Following the procedure, the carpenter stopped again to inspect his work and realized that what he thought was a metal stud was the conduit for the electrical receptacle. Figure 2-1 shows the penetration and the wires

Members of a post-event critique determined that the carpenter, who had performed similar tasks successfully for many years, had carefully followed the site blind penetration procedure during installation of the cabinets. However, the procedure did not address penetrations into hollow walls, ceilings, or floors and did not caution workers to stop work if they encountered metal during the drilling operation.

Figure 2-1. Wall penetration and wires pulled from conduit post-event

To address situations such as those encountered in this event, the blind penetration procedure was revised to limit the depth of penetration to the thickness of the external surface of hollow cavities, or no more than 2 inches into solid materials, when using power tools. The procedure also was revised as follows:

asbestos), inspect the inside of the penetration by looking into the hole with a flashlight or boroscope or by probing with a nonconductive or insulated tool, such as a screwdriver or wooden handle punch. Stop work and notify your supervisor if this check reveals any potential hazards, such as asbestos-containing material, or any metallic material, such as a metal wall stud or conduit.

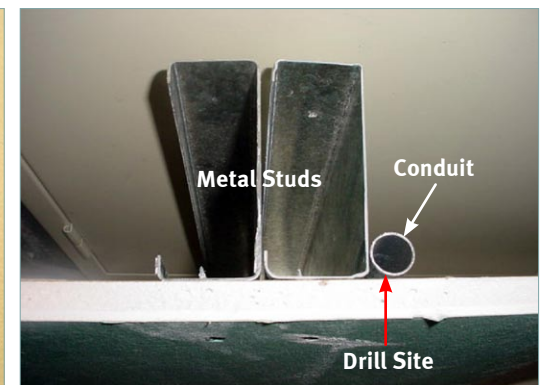
removed from the conduit for inspection after the event. Figure 2-2 shows the drill site, the metal studs, and the conduit.

Figure 2-2. Drill site, studs, and conduit
