OPERATING EXPERIENCE SUMMARY

U.S. Department of Energy
Office of Health, Safety and Security
OE Summary 2008-05
June 10, 2008

Near Miss — Worker Pinned Between Manlift and Overhead Pipe

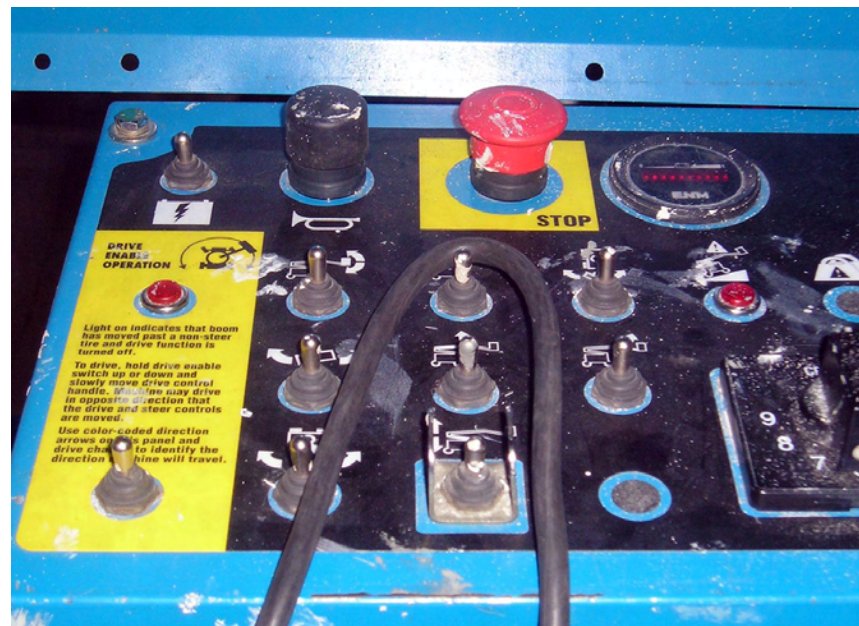
On April 23, 2008, at Hanford, a subcontractor painter working from a boom lift while cleaning pipe hangers with an electric grinder was caught between the lift and an overhead pipe when the cord of the grinder looped around a toggle switch on the control panel (Figure 1-1), causing the boom to rise. The painter was able to hit the stop switch and reach the controls to move the lift basket enough to free himself and lower the lift to the ground. He received contusions to his back, chest, and jaw; a slight cut on his chin; and scrapes on his hand, but this incident could have resulted in a life-threatening injury or a fatality.

Figure 1-1. Cord looped over the toggle switch (re-enactment)

Investigators determined that the cord wrapping around the toggle control resulted in unexpected movement when power was provided and that there were not sufficient guards on the control panel. However, several barriers were in place that helped prevent a more serious event, including a “stop” button at the base of the lift that the spotter engaged, a similar button on the control panel that the painter engaged, and a slow setting on the operating speed of the lift. The manufacturer includes some toggle-switch guards on boom manlifts, but not all toggle switches are guarded. The contractor will add toggle-switch guards to all of the toggle switches (see Figure 1-1). Control panel covers that can be lowered during work tasks to protect the control panel will also be added to all lifts.

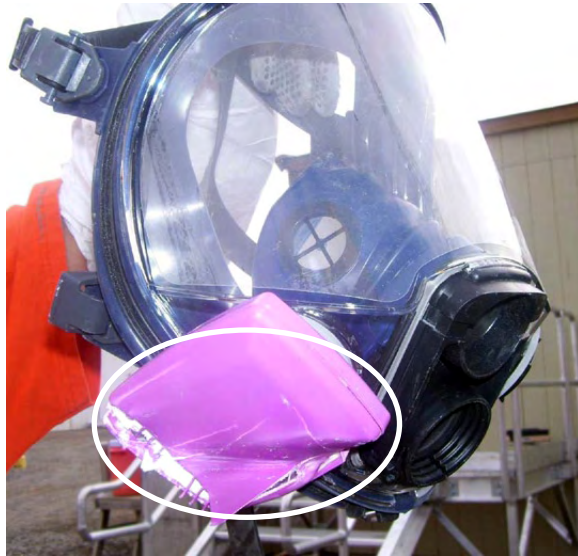
Figure 1-2. Damage to pink filter on painter's respirator

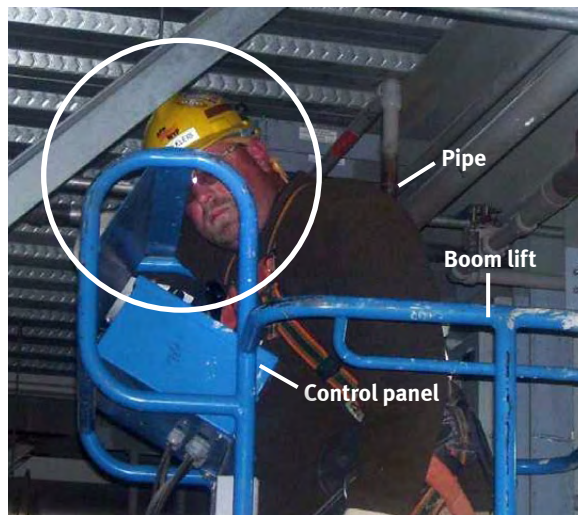
The painter was working in tight quarters (i.e., pipe supports, piping, I-beam, and ceiling) and was wearing a respirator. When the foreman asked him to stop work, he put the grinder down, but was unaware that the cord had looped around the toggle switch. He began to lower himself to the ground, and when he engaged the foot pedal and pulled the stop switch to the “on” position, the lift moved unexpectedly. The worker’s left hand was pinned between the control panel guard and an I-beam; his head, neck, and back were pinned between the control panel guard and a 2-inch-diameter pipe. The worker had not removed his respirator, and investigators believe that may have impaired his ability to see the control panel as he began his descent. Figure 1-2 shows the filter on the painter’s respirator, which was crushed in the accident. Figure 1-3 shows a re-enactment of the event, with the worker’s back against the pipe and his chest and head pressed into the control panel.

Figure 1-3. Re-enactment of the accident

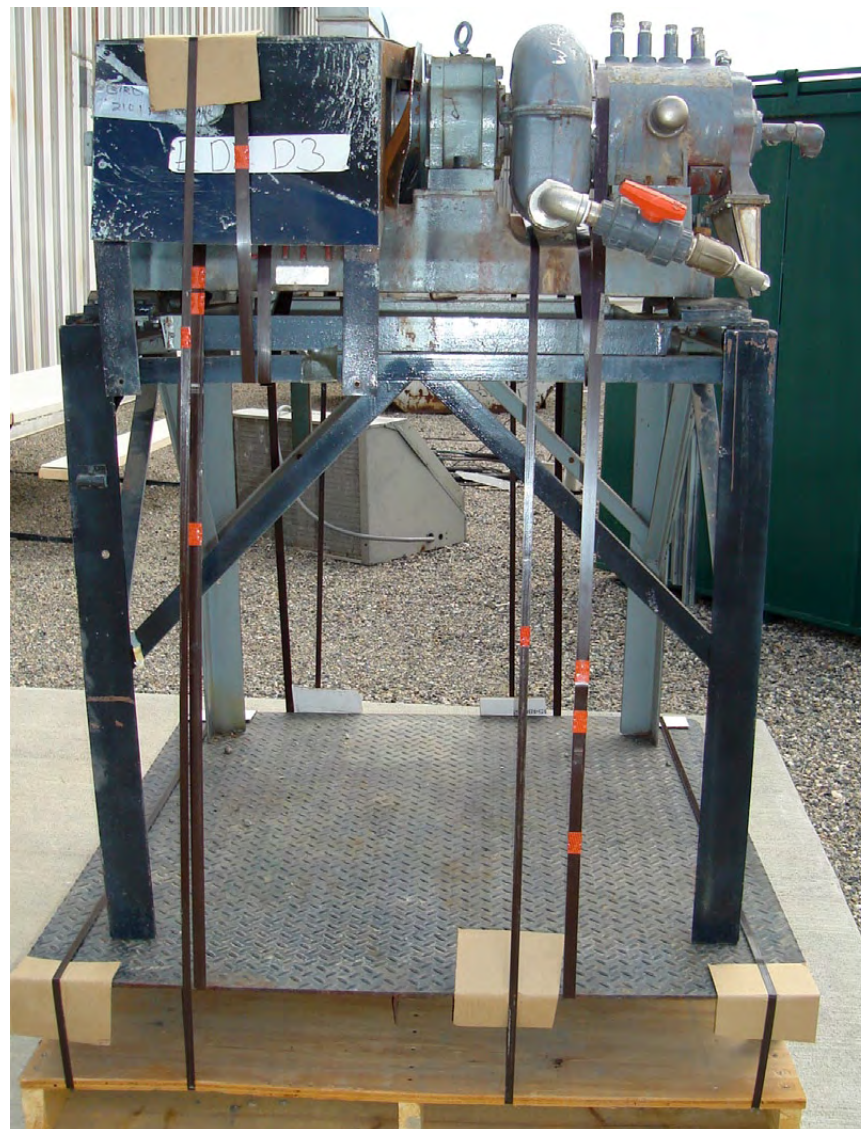
On April 17, 2008, at the Hanford Site, a pump assembly loaded on a Fluor Hanford Transportation Services flatbed semi-trailer fell off the bed of the truck and landed on the ground. The pump assembly (Figure 2-1), which weighed 1,260 pounds, was being transported to an excess yard when the near-miss event occurred. No personnel were within the vicinity of the dropped load. (ORPS Report EM-RL--PHMC-FSS-2008-0004; final report issued May 28, 2008)

A storekeeper used a forklift to load the pump assembly, which was sitting on a diamond plate metal skid, onto the flatbed trailer, and the driver secured the metal skid to the trailer with a 4-inch strap rated at 12,000 pounds. The two workers believed that the pump assembly, which had been on the metal skid for approximately 19 years, was welded to the skid and painted in place. However, the two pieces were never physically attached to each other.

Figure 2-1. The pump assembly shown banded back together on the metal skid after the incident

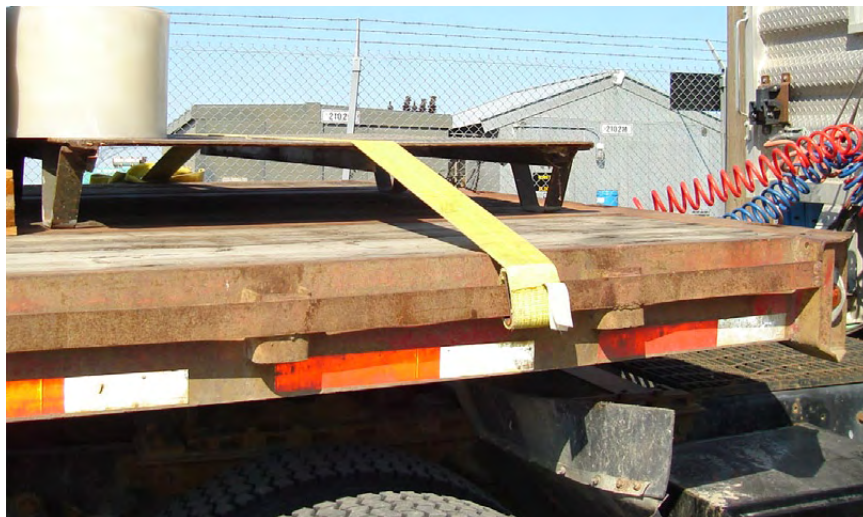
The metal skid remained secured to the truck (Figure 2-3), but the pump assembly was damaged in the fall. All loading and unloading operations and all movement of material using tractor-trailers were stopped pending a review of the event with Fluor Hanford drivers, identification of methods for safely hauling unstable materials, and approval to resume work from Senior Management.

Figure 2-3. Metal skid held down by yellow strap

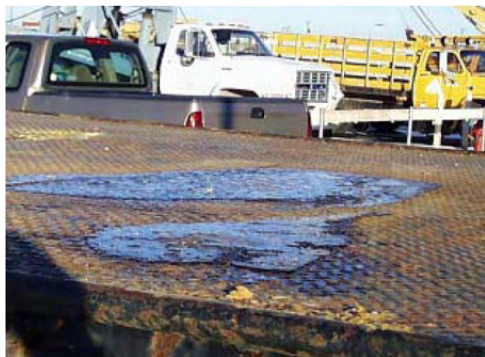
The initial investigation determined that the flatbed had been recently oiled and it had rained that morning, which contributed to the flatbed surface being considerably more slippery than normal. Although the driver was traveling at a low speed, the lack of tie-down straps, combined with the slippery deck and the sharp corner, caused the box to slide off. A similar event occurred at the Laboratory on January 6, 2003, when an unsecured multiple-ton crane counterweight slid off a flatbed truck because of ice on the metal bed (Figure 2-4). (ORPS Report EM-ID--BBWI-CFA-2003-0001)

Figure 2-4. Ice on metal bed of trailer

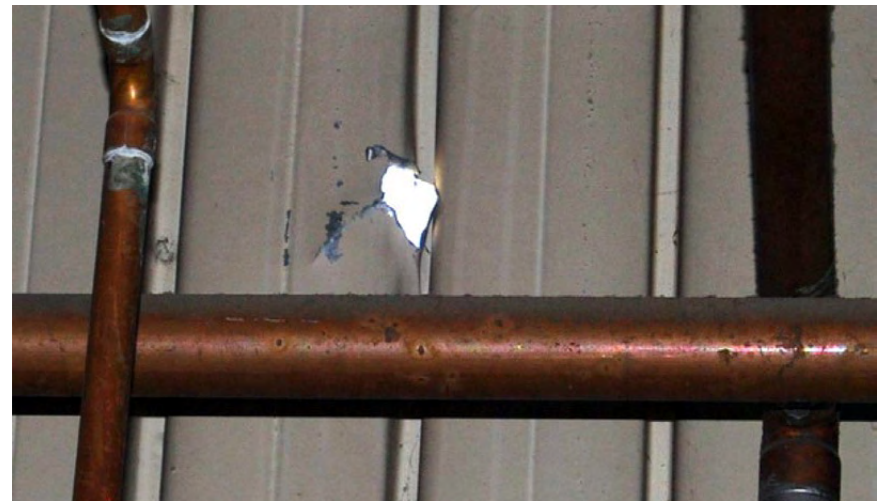
On September 13, 2007, at the Stanford Linear Accelerator Center (SLAC), a subcontractor welder was performing a hot tap into a carbon steel pipe when the heat from the acetylene torch ignited residual vapor trapped inside attached polyvinylchloride (PVC) piping and caused an explosion. The force of the explosion threw shrapnel at least 60 feet outward, and one piece was found 100 feet from the scene. Although pieces of the pipe punctured a sheet metal wall (Figure 3-1), the two workers closest to the explosion were protected by an alcove wall that separated them from the pipe. Four other workers standing about 25 feet away suffered temporary hearing loss from the concussion of the explosion. Following the explosion, the facility manager evacuated the accelerator tunnel below the work area as a precaution, and the area was barricaded. (ORPS Report SC--SSO-SU-SLAC-2007-0011; final report issued October 26, 2007)

Figure 3-1. Shrapnel penetration

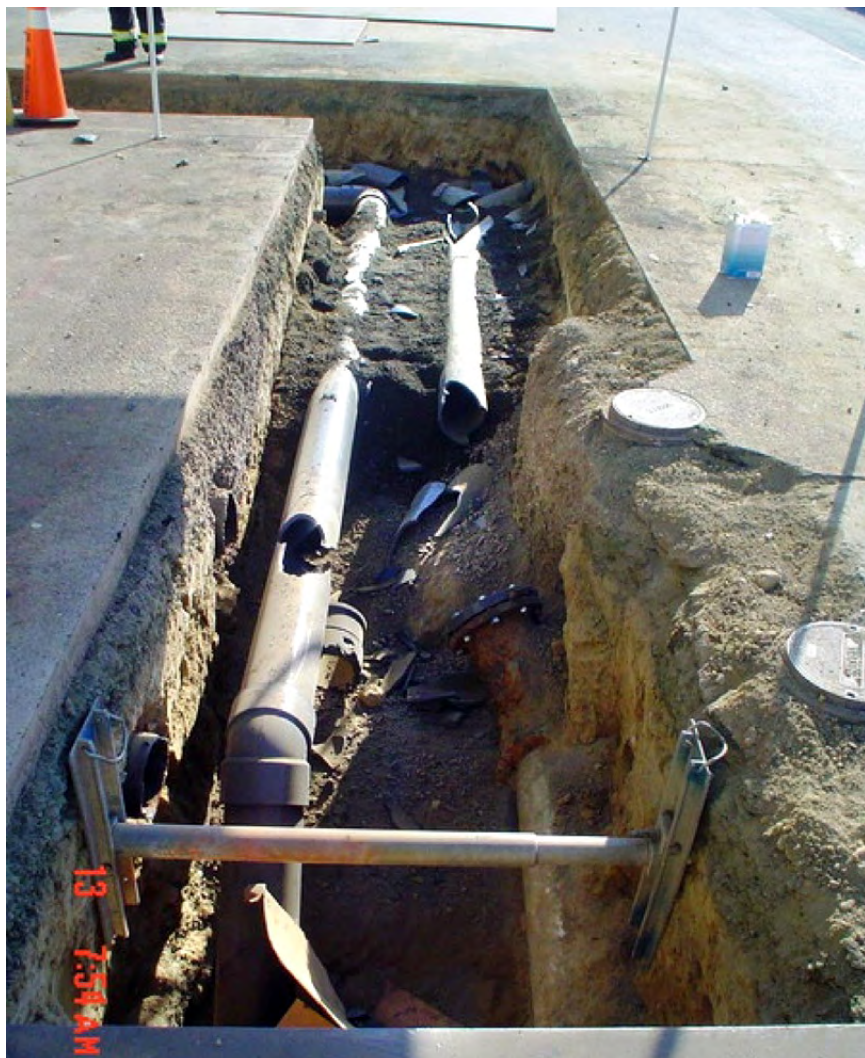
Subcontractor workers had used PVC cement and primer when installing new PVC piping that connected to a steel pipe, which extended into the alcove. The workers then blanked off (i.e., capped) the new pipe to prepare it for pressure testing. On the following day, the welder began to cut a hole in the steel pipe section to install a “threadlet” for pressure testing, and the vapor that had been trapped inside the blanked pipe ignited from the heat of the torch, rapidly increasing the pressure in the pipe and resulting in the explosion. Figure 3-2 shows the hole in the PVC piping after the explosion.

Figure 3-2. Hole in PVC pipe following the explosion

Importantly, the pressure gauge was not installed during preassembly work, which resulted in the need for the welder to cut into the new steel pipe after it had been attached to the PVC piping. In addition, the cement fumes were not allowed to dissipate to the atmosphere after the piping was assembled and before the new pipe sections were blanked off. The need to install the pressure tap constituted a change in job scope, which should have led to a re-evaluation of the hazards, but the potential for an explosion was never discussed. Also, the lack of a pressure test plan and a sequence of tasks that included installing the pressure gauge before capping the pipe, left it to the welder to decide how to proceed.
