# OPERATING EXPERIENCE SUMMARY

U.S. Department of Energy  
Office of Health, Safety and Security  
OE Summary 2008-06  
July 18, 2008

## Hoisting Cable On Leased Truck Breaks

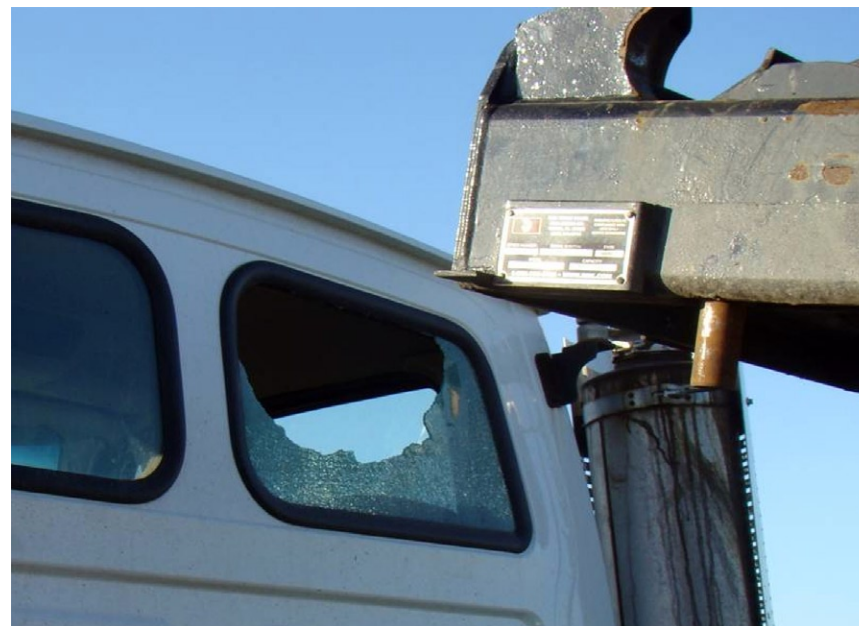
As the waste container came to rest against the container stops, the teamster heard a loud bang at the rear of the truck and realized that the cable had broken. The hydraulic rams had continued to apply pressure to the hoist system in excess of cable tensile strength after the container reached the end of the deck, causing the cable to break. Figure 1-2 shows the empty container after it slid off the rails; Figure 1-3 shows the broken cable underneath the truck rails.

**Figure 1-1. Passenger side rear window damage**

As result of this event, the hydraulic pressure setting will be verified during initial onsite inspections. Rear cab protection is also being added to shuttle hoist trucks to ensure that the driver is protected if a similar event should occur. A site lessons learned bulletin (Identifier RCCC-08-009) on this event is available at <http://www.washingtonclosure.com/about/safety/docs/RCCC-08-009.pdf>. The textbox on the following page shows the recommended actions from the bulletin.
