OPERATING EXPERIENCE SUMMARY

U.S. Department of Energy
Office of Health, Safety and Security
OE Summary 2008-08
September 4, 2008

Plutonium Spill at Boulder NIST Facility

Unsafe Liftgate Operation Results in Worker Injuries

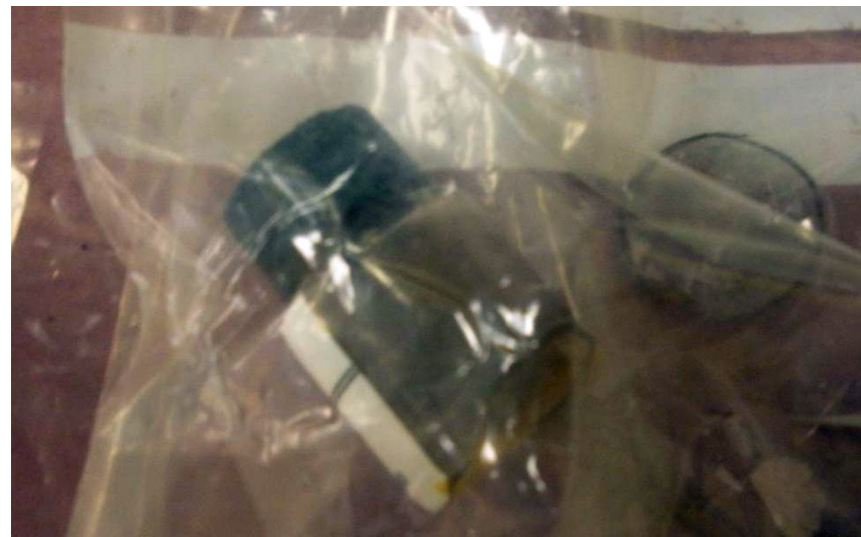
The small plutonium sample (smaller than a dime in size) was being used in a research project to develop improved radiation detectors for use by nuclear inspectors outside NIST and contained about 0.25 gram of plutonium. A few days before the accident, the guest researcher tapped the source bottle on a marble laboratory bench in an attempt to “settle the powder” inside the bottle in one location, which may have damaged the bottle. The bottle later broke when it was accidentally knocked against either the lead shield “bricks” or the detector (Figure 1-2).

The guest researcher, who was working alone in the laboratory and who had received no previous training in handling the sample, was not wearing gloves; and, although he noticed that the bottle was cracked, he continued to handle it. When the bottle broke, spilling the plutonium, he was unaware of the course of action that needed to be taken. He spread

Figure 1-1. Broken glass container inside multiple plastic bags (broken bottom in upper right-hand corner)

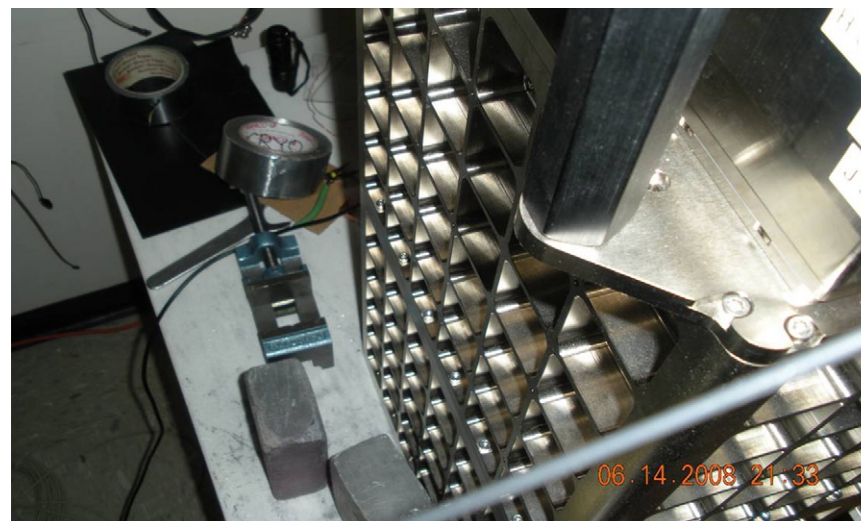
Figure 1-2. Area between detector and electronics rack (note lead bricks)

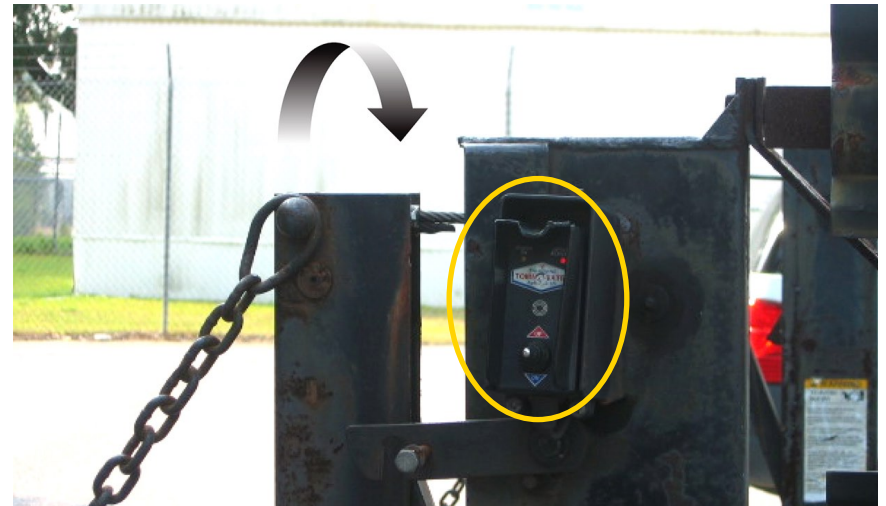
The worker offloaded a refrigerator being transported to the SCCB trailer warehouse and was putting a pallet jack back inside the delivery truck. He was holding the pallet jack with his left hand, operating the liftgate control switch (Figure 2-1) with his right hand, and riding on the liftgate.

When the pallet jack began to slide, the worker reached down to maintain control of it, while continuing to engage the lift switch. This positioned his right arm in the path of the liftgate operating mechanism. As the liftgate came up, his right

Figure 2-1. Control switch (circled) on right side of the delivery truck (arrow shows the scissor-like movement of the mechanism)

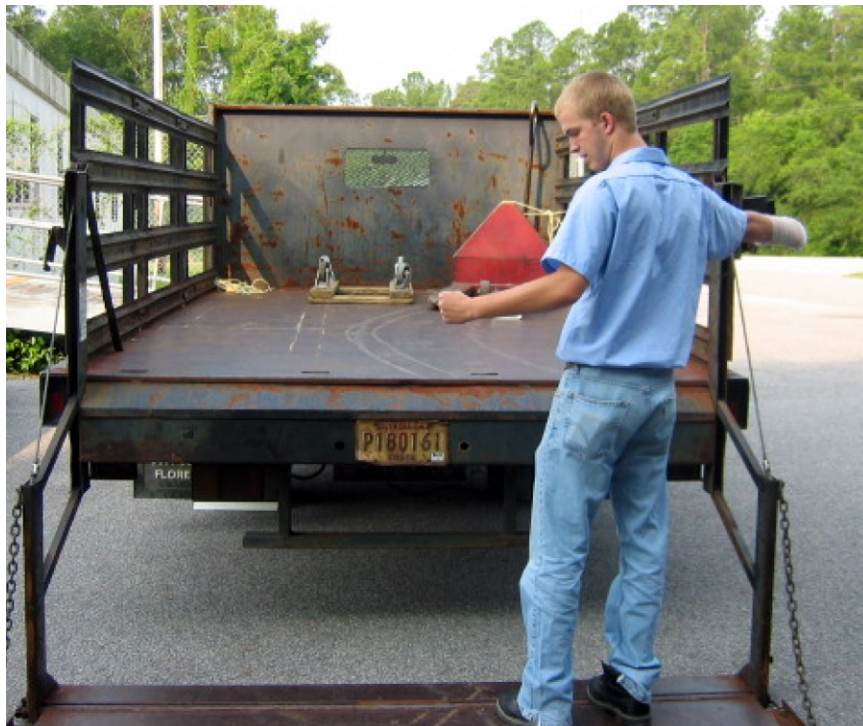
forearm (a few inches from the wrist) was pinched between the two sections of the liftgate (Figure 2-2).

Investigators determined that the cause of the accident was inattention to the task. The worker was not watching his surroundings; the load (pallet jack) was not properly secured; and the worker placed his arm in an area where it would be in a pinch point. The manufacturer of the liftgate (Tommy Gate®) warns that their lifts are industrial products for material handling only and are not to be used as a personnel lift, so the worker should not have been riding on the lift gate.

Figure 2-2. Injured worker reenacts the accident, showing how he was positioned on the lift while operating the control switch (note worker's bandaged arm)
