OPERATING EXPERIENCE SUMMARY

U.S. Department of Energy
Office of Health, Safety and Security
OE Summary 2008-09
October 8, 2008

Chemical Safety Board Completes Investigation of Danvers Explosion

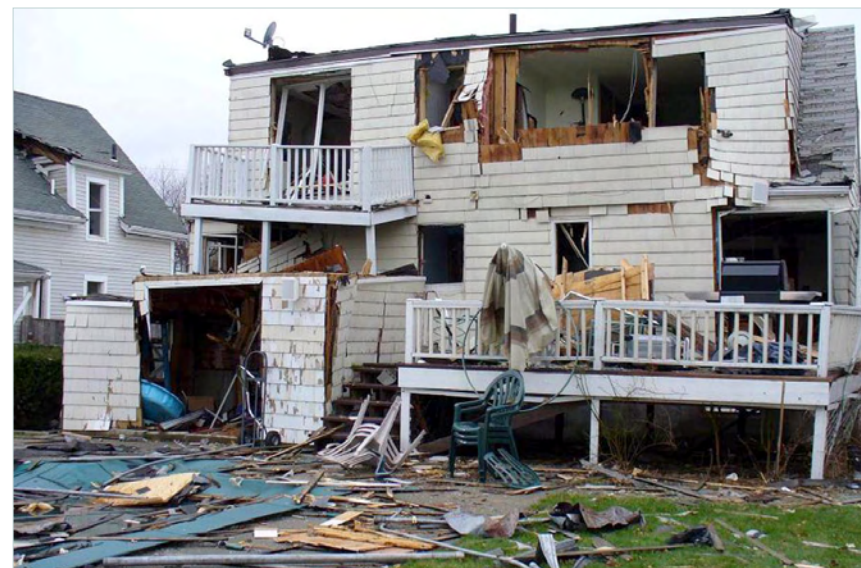
Figure 1-1. Nearby home destroyed in CAI explosion

The CSB investigators concluded that the open steam valve would have caused the liquid to boil. As long as the steam valve remained open, the boiling mixture continued to release many hundreds of pounds of flammable vapor into the unventilated production area. Because the mix tank was not vented to the building's exterior, uncontrolled tank heating caused the mixture to rapidly vaporize and release enough vapor into the production area to fuel the explosion. They determined that an unknown ignition source ignited the flammable atmosphere, causing the explosion, and that thousands of gallons of flammable liquids stored inside the building and some 51,000 pounds of industrial-grade nitrocellulose material stored nearby were ignited. The resulting fire burned for over 17 hours. Figure 1-2 shows the area surrounding the CAI facility before the accident; Figure 1-3 shows the same area following the explosion.

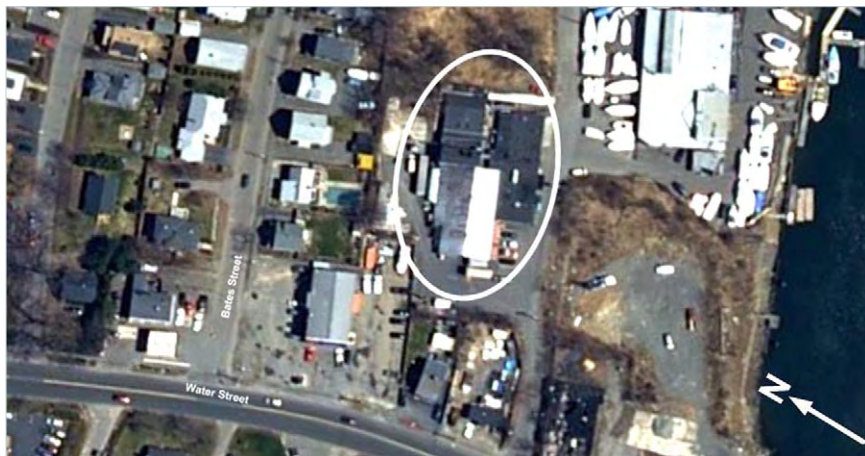
Figure 1-2. Area surrounding CAI before the explosion (plant circled)

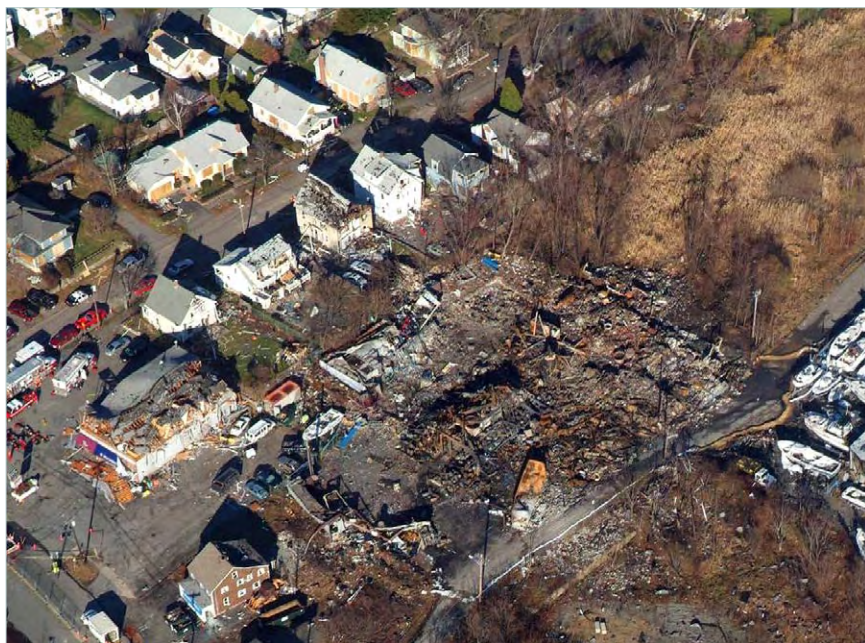
Figure 1-2. Aftermath of explosion

- CAI management did not conduct a process hazards analysis or similar systematic review to ensure that the flammable liquids processes were safely designed and operated.
- CAI heated Class I flammable liquids in unsealed tanks inside a closed building.
- CAI did not install or use automated process controls, alarms, or safeguards when heating flammable liquids in process equipment inside a closed building.
- CAI did not maintain adequate building ventilation during all flammable liquids process operations.
- CAI management did not use written procedures or checklists to ensure that flammable liquids manufacturing processes were operated safely.

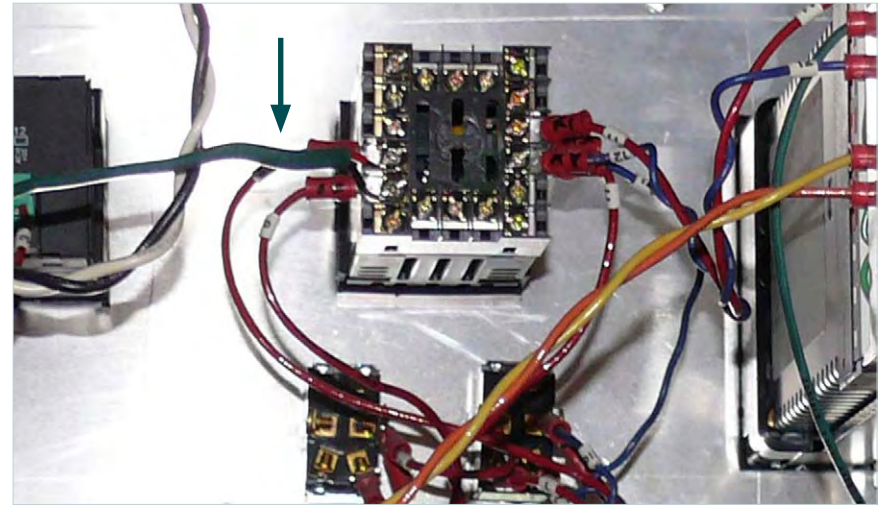
After the incident, an electrician tested both the oven and the control unit and determined that the control unit had been miswired. Incoming 240-volt power and the thermocouple leads were both landed on the thermocouple terminals in the controller. Figure 2-1 shows the over-temperature controller and the green power supply wires, which are attached to the same terminals as the thermocouple wires. The electrician determined that the researcher encountered 118 volts when he touched the wires.

Figure 2-1. Closeup of controller showing power supply wires (green) attached to same terminals as the thermocouple wires (red)

Corrective actions included revising the electrical safety procedure to require electrical worker qualification for all staff members performing maintenance, modification or component replacement and repair of electrical equipment. In addition, an inspection checklist that includes performing post-maintenance testing will be developed for staff use.

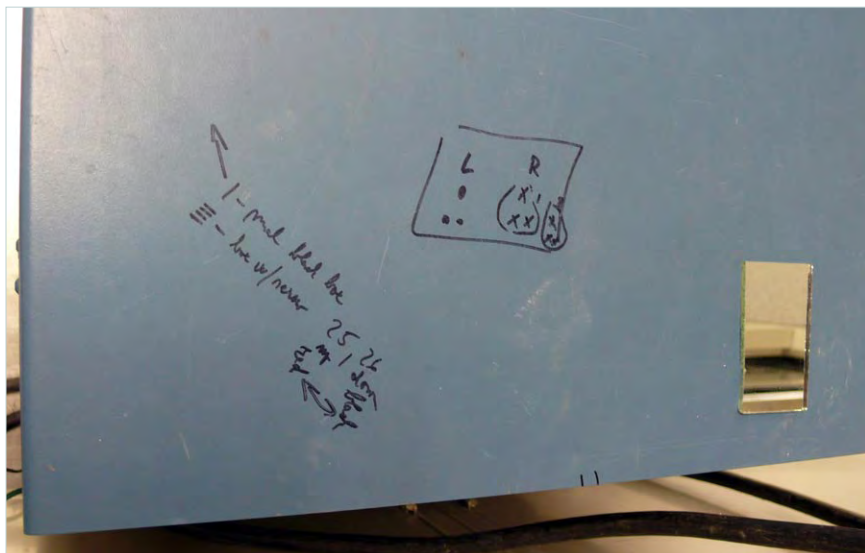
The controller had last been replaced in 2006 based on a wiring diagram made by a third researcher. Figure 2-2 shows the diagram (drawn on the controller unit). The researcher told investigators that he was certain that he had rewired the controller correctly, but they determined that the wiring diagram did not include enough detail to successfully perform the task.

Although it was not required by procedure, a key step missing in the replacement process was a post-maintenance function test to ensure that work was properly performed. Had such a test been performed on the over-temperature controller, the miswiring would have been discovered and corrected.

Figure 2-2. Wiring diagram drawn on controller unit
