# OPERATING EXPERIENCE SUMMARY

U.S. Department of Energy  
Office of Health, Safety and Security  
OE Summary 2008-12  
December 31, 2008

## NRC Identifies Problems with Concrete Placement

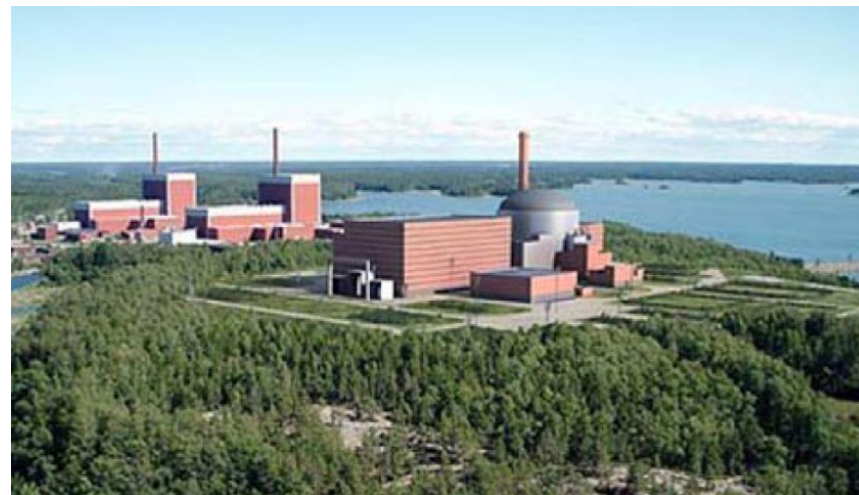
A July 10, 2006, investigation report issued at the Olkiluoto 3 Nuclear Power Plant in western Finland (Figure 1-1) identified several contributing factors that resulted in plant construction delays. During placement of the reactor building concrete basemat, Teollisuuden Voima Oy (TVO), the licensee, detected inconsistencies in concrete from different truckloads and confirmed that plasticizer caused the variation. Additional problems involved water-cement ratios outside of design requirements and changes in the composition of the concrete made by the contractor without TVO's knowledge. Testing on the concrete indicated that the concrete met minimum standards. An investigation of site operations found that

**Figure 1-1. Olkiluoto 3 Nuclear Power Plant (foreground) as it will appear when completed in 2012**

the delays were also caused by lack of communication and defined responsibilities and by poor quality control. Although the concrete was ultimately found to be acceptable, the construction delays had a negative impact on public confidence.

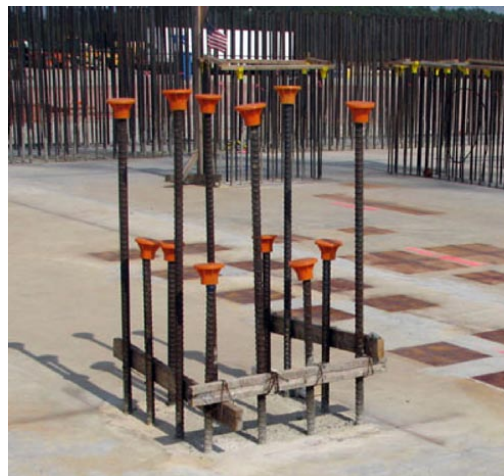
In September 2007, an NRC inspector observed problems with concrete placement at the Mixed Oxide (MOX) Fuel Fabrication Facility (MFFF) construction site (Figure 1-2) at the Savannah River Site. Based on the rejection of five truckloads of concrete by Shaw AREVA MOX Services (the applicant) because concrete slumps were outside the design value, the concrete batch plant, which was operated by a contractor, was inspected. The NRC inspector determined that chemical plasticizer and water in excess of both the manufacturer's recommendation and the design specification were being added to the design mix at the plant. The addition was made without

procedural guidance and was not documented. In response to the NRC report, the applicant assumed responsibility for concrete testing at the batch plant, provided immediate quality assurance coverage of all batching operations, ensured that batch plant procedures were written or revised as necessary, and consulted independent experts for recommendations for improvement.

In January 2008, at the MFFF construction site, a concrete reinforcement steel bar fractured near a bend location because of work-hardening during the bending process. An NRC inspection in February 2008 identified problems with bent rebar, primarily in the foundation of the facility. NRC inspections of the reinforcing steel vendor revealed five non-conformances: (1) inadequate surveillance of rebar fabrication; (2) inadequate audits of sub-suppliers; (3) failure to verify adequacy of design in the dedication of commercial grade items; (4) failure to write a corrective action process condition

report for a significant condition adverse to quality; and (5) failure to properly disposition a code deficiency. An inspection of the MFFF yielded no findings. The applicant had already issued more than 80 condition reports addressing problems with vendor parts and had increased oversight of vendor activities.

**Figure 1-2. Concrete mat and rebar installation during construction of MFFF**

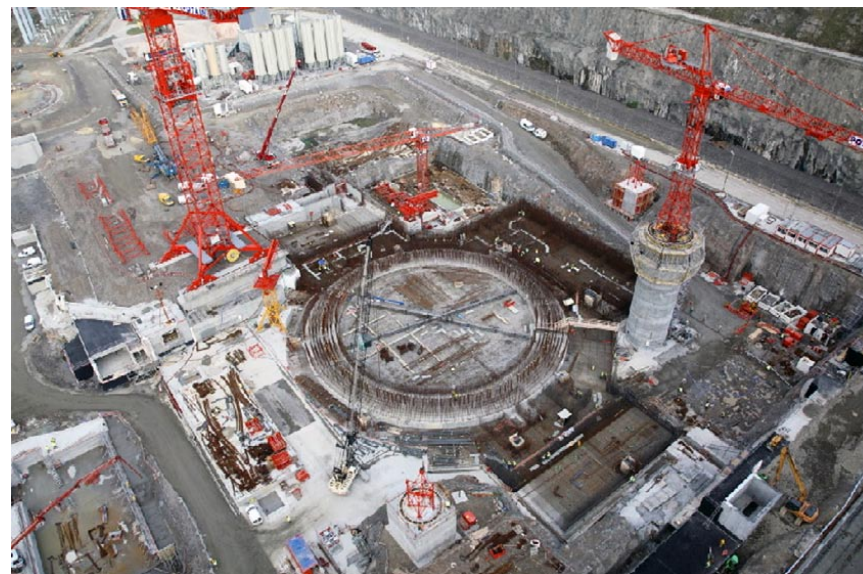
In March 2008, an inspection by the Autorite de Surete Nucleaire (ASN) revealed several problems with reinforcement steel bars and concrete placement for the basemat of the fuel storage buildings at the Electricite de France (EDF) Flamanville 3 European Pressurized Reactor construction site (Figure 1-3). The inspection revealed improperly spliced and tied rebar and reinforcing steel placement that did not conform to approved procedures and design requirements. Despite these deficiencies, the concrete contractor had initiated concrete placement. ASN was able to verify that corrective actions had been taken before concrete had actually been placed in the area.

**Figure 1-3. Flamanville 3 construction site and circular basemat for reactor containment**

In another case at the Flamanville 3 site, the concrete reinforcement and placement did not follow construction specifications and drawings. A review of site conformance records indicated that some aspects of the work were flagged as potential nonconformances, with specific notations, but follow-up actions were not tracked. Accordingly, ASN requested the licensee to provide additional information, including assurances that prior concrete placements were free of design-requirement inconsistencies with regard to the issue of improperly spliced and tied rebar and nonconforming reinforcing steel placement. Where implementation did not match the construction specifications and drawings, ASN asked the licensee to document and validate the alternate methods and explain the reasons for failing to follow approved construction procedures. ASN also requested information about the causes leading to the failure, so deficiencies identified in field records could be tracked and closed.

On May 21, 2008, EDF informed ASN about the lack of stirrups in the reinforcement steel of the basemat of the safeguard auxiliary buildings. Beyond the technical nonconformance, ASN considered the main issue to be the licensee's quality management system. A preliminary analysis of the root causes indicated that the nonconformance had not been corrected before concrete placement, even though both the subcontractors and the licensee had identified the lack of stirrups in time to do so. Consequently, ASN stopped concrete placement of all buildings relevant to safety until the licensee provided detailed plans that identified managerial and organizational enhancements to support improved oversight of field activities and facilitate field task tracking. In addition, the licensee was required to submit a technical analysis of the nonconformance and proposed correction.

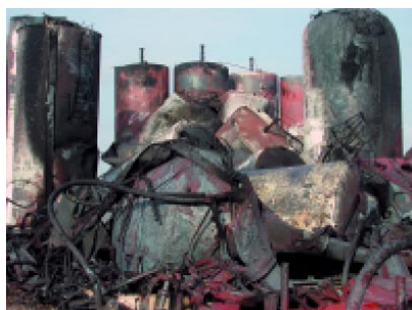
The fire, which began as a small fire on an outdoor worktable located between two warehouses, quickly grew to a flaming pool of liquid 65 to 80 feet wide and engulfed two semi-trailers full of empty drums. The flames also surrounded a 6,000-gallon tank wagon that contained synthetic motor oil, heating the oil and igniting flammable vapors vented from the tank. The intense heat ultimately resulted in the tank melting into several puddles of aluminum. Flames also surrounded several 2,000-gallon blending tanks, which collapsed and spilled their contents into the fire (Figure 2-1). Pipelines from nearby storage tanks also ruptured (Figure 2-2).

All of these burning fluids flowed toward the tank farm through a cracked and broken dike wall and ignited the storage tanks. Eventually the fire spread to other warehouses at the plant, breaching metal walls and consuming all the remaining fuel at the site.

**Figure 2-2. Melted storage tanks post-fire**
