OPERATING EXPERIENCE SUMMARY

U.S. Department of Energy
Office of Health, Safety and Security
OE Summary 2009-02
February 28, 2009

Type B Accident Investigation— Worker Injured When Rocket Motor Fires Unexpectedly

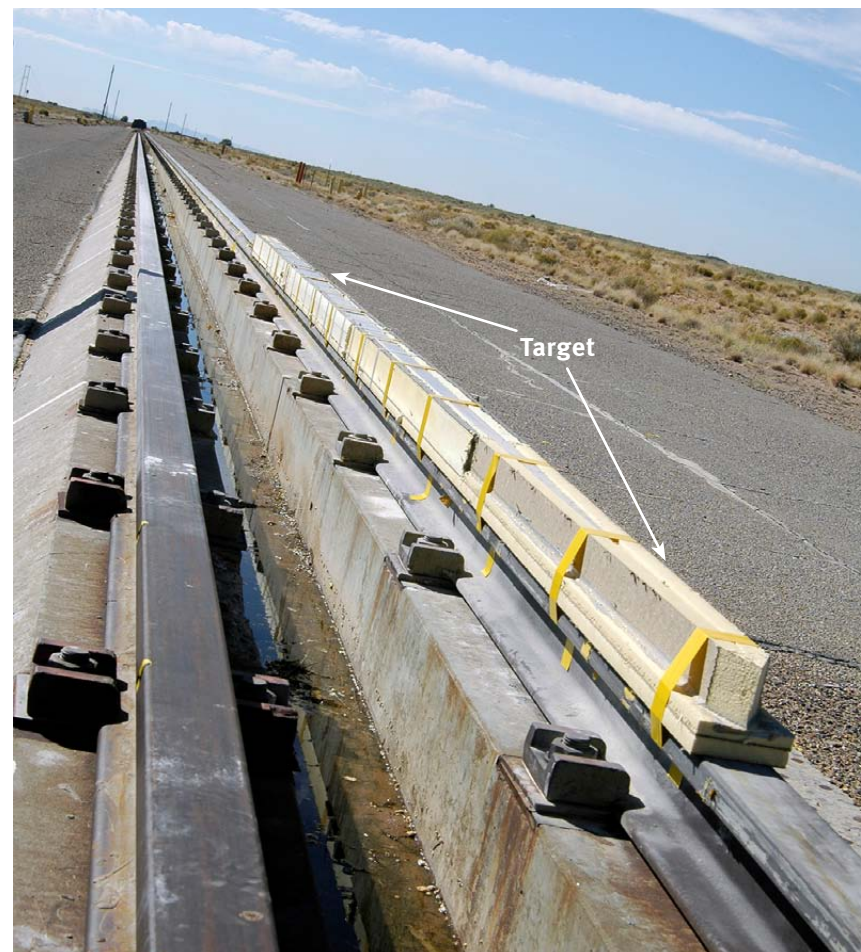
Figure 1-1. Target

The injured worker was installing a Light Emitting Diode (LED) module into a connector at the top of the test package when the rocket motor fired and the sled proceeded down the track. Because he was bending over the test package when the rocket fired, the worker was thrown onto the test track. The rocket sled hit the target (Figure 1-1) and came to a stop.

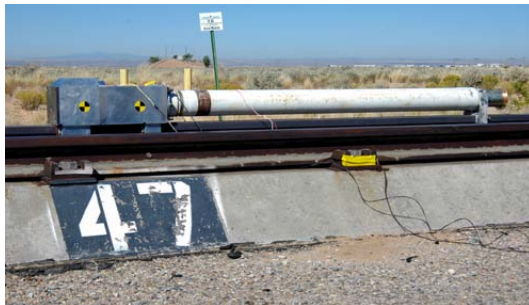
Figure 1-2. Rocket sled pre-event

Figure 1-2 shows the rocket sled on the track before the event; Figure 1-3 shows its position after the accident.

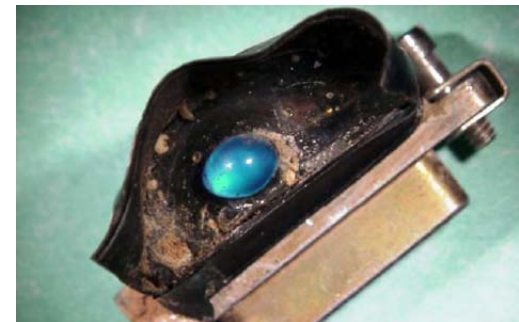
The Board determined that the energy source that caused the rocket ignition was a short at the pin that occurred when the male and female connectors came in contact. Microscopic photography of the female connector confirmed a black mark at the base of a pin connected to the battery (Figure 1-5) that energized the LED. Analysis of the

Figure 1-4. LED module with black electrical tape

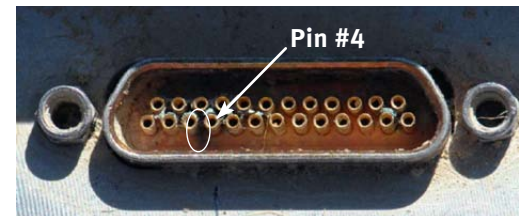
circuit schematic indicated a circuit configuration that would have caused the energy from the short to flow from the female connector, through the test sled body, and through the rocket igniter.

Figure 1-5. Black mark (circled) at pin #4
