OPERATING EXPERIENCE SUMMARY

U.S. Department of Energy
Office of Health, Safety and Security
OE Summary 2009-05
May 29, 2009

Type B Accident Investigation— Electric Cart Passenger Injury

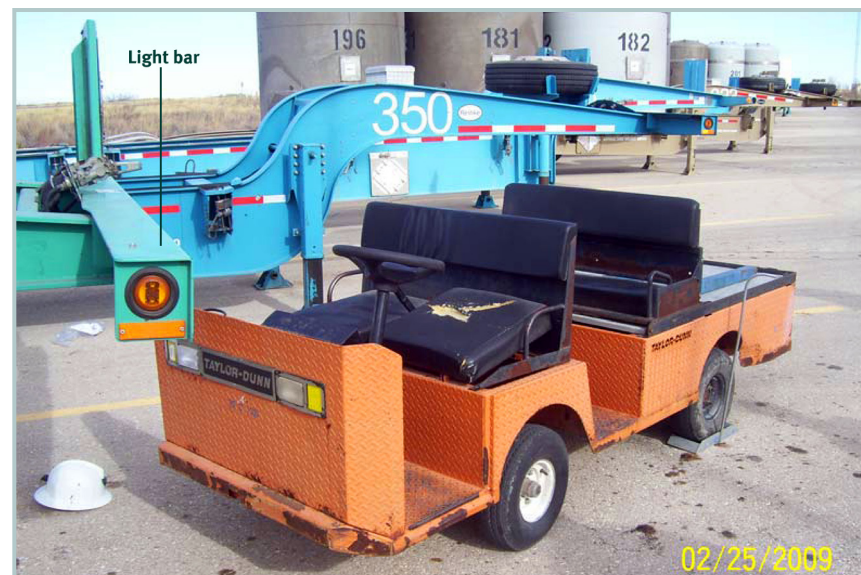
The driver tried to turn away from the trailer when he realized the cart would not stop, but there was not enough distance between the cart and trailer for the entire cart to avoid the trailer, and the front-seat passenger was pinned between the front seat of the electric cart and the light bar of the trailer. Figure 1-1 shows the position of the cart and trailer post-

Figure 1-1. Electric cart and trailer post-accident
(showing angle of cart to trailer)

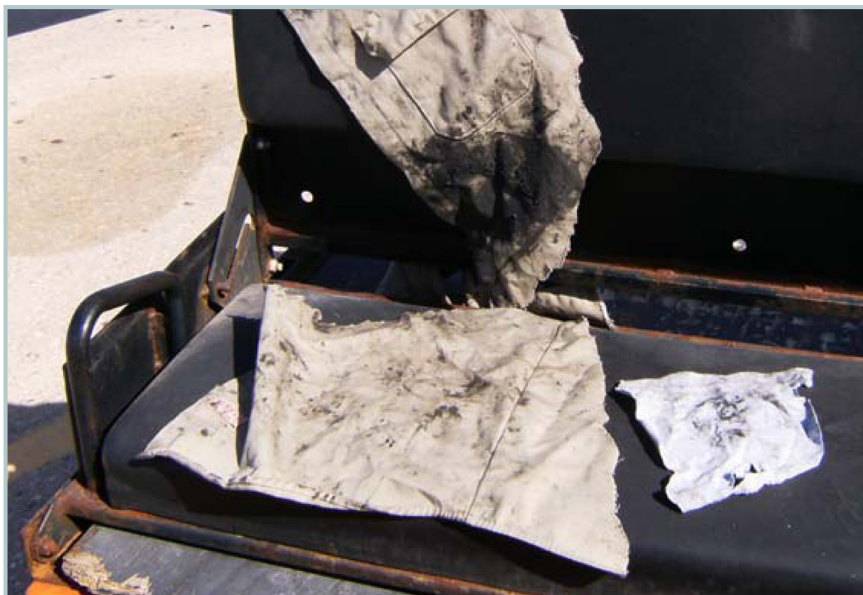
accident. Figure 1-2 shows the injured worker’s shirt, with grease marks just below the front pocket, which resulted from the worker being pressed against the light bar.

Figure 1-2. Grease mark from trailer on injured worker's shirt
(cut from worker post-accident)

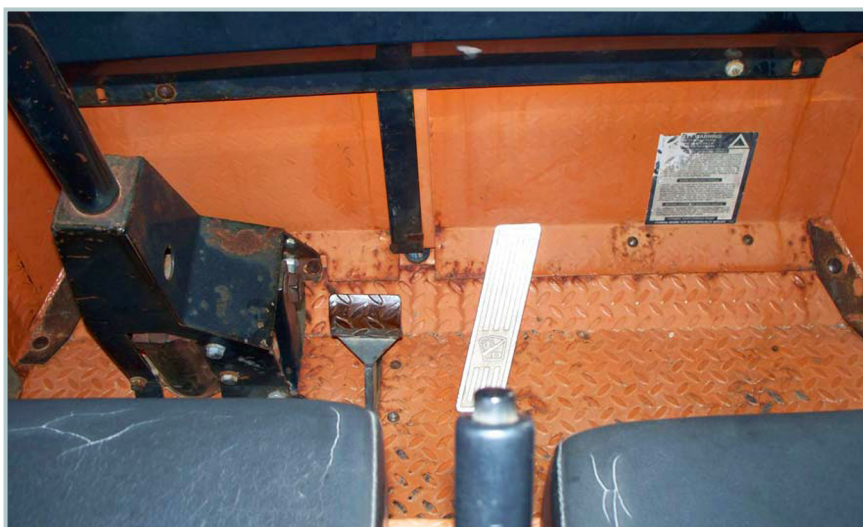
The electric cart involved in the accident was a Taylor Dunn Model B0-210 36 Burden Master. This type of electric cart has been used onsite since the 1990s. One design feature of the electric cart is that the accelerator pedal extends off-center into the passenger’s foot area. Workers told the Accident Investigation Board that they have placed a foot on the accelerator pedal while riding as passengers in these electric carts or that their passengers had, but they never formally informed management about the issue.

Figure 1-3 shows the proximity of the accelerator to the passenger side of the cart. The Board concluded that the location of the accelerator pedal was the leading cause of the

Figure 1-3. Cart accelerator pedal

accident. As a result of this event, the manufacturer designed an accelerator pedal guard for these carts to protect against a future inadvertent engagement by a passenger.

At sites where the Taylor Dunn Model B0-210 36 Burden Master electric carts are used, the manufacturer's approved retrofit (i.e., guard) for the accelerator should be installed to prevent inadvertent engagement of the accelerator by a passenger. In addition, other cart designs should be inspected to determine the applicability of an engineered safety feature (i.e., guard) to protect against similar events.
