OPERATING EXPERIENCE SUMMARY

U.S. Department of Energy
Office of Health, Safety and Security
OE Summary 2009-06
June 25, 2009

Worker Injured When Length of Safety Line Exceeds Distance of Fall

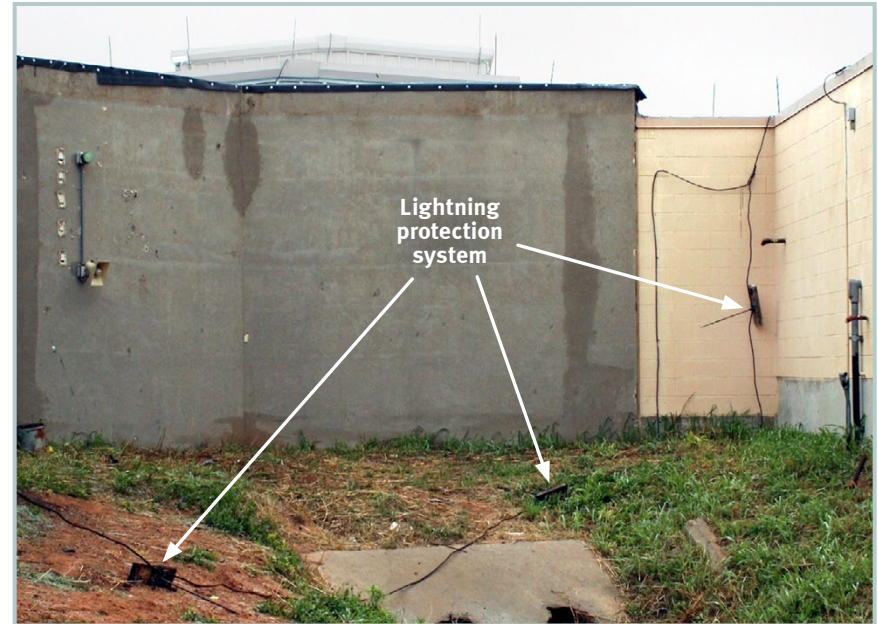
Figure 1-1. Location of lightning protection system

The worker, who was at the end of his shift, was reaching out for the lightning protection system, which was alongside the building and stretched across the ground (Figure 1-1). His self-retracting safety line was tied to a cart referred to as a “Texas Hold’um.” Figure 1-2 shows the cart used for the roofing task, as well as a representative example of the cart. The Texas Hold’um cart weighs over 1,000 pounds and serves as an anchor point so that workers can attach their lanyards in areas where permanent anchor points are not available.

Self-retracting safety lines work much like a seatbelt, automatically extending and retracting to prevent a slack line while a worker moves from place to place. One end of the line is attached to the worker’s safety harness and the other to an anchor point (in this case, the Texas Hold’um cart). If a fall should occur, the line locks immediately to stop the fall after a short distance. The worker was moving from place to place on the roof and had inadvertently run out most of his 50-foot line when it suddenly locked as he stood up to move toward two other workers who were also working on the roof. The locked lanyard knocked him off balance, resulting in the fall.

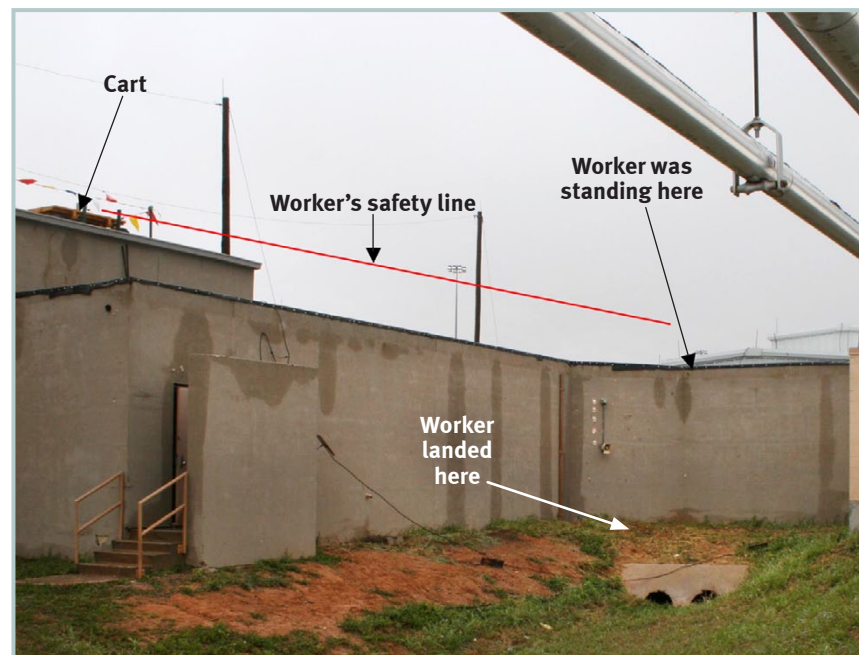
Figure 1-3. Building, location of cart and worker, and relative length of safety line

Figure 1-3 shows the building, location of the cart and worker, and the relative length of his safety line. Because the drop to the ground was only a little over 13 feet, the 50-foot length of the safety line, which was intended to break his fall, allowed him to swing into the ground. When the safety line was unhooked after the accident, it retracted normally.

- The worker exceeded the allowable distance that a retractable lanyard should be extended from its anchor point in relation to the anchor point and working surface leading edge.
- The worker was not cognizant of the distance from the anchor point and the amount of cable pulled out of the retractable lanyard. He did not realize that he was almost to the end of the 50-foot cable capacity of the lanyard.
- The worker's supervisor did not verify that the anchor point (Texas Hold'um) was positioned as required for the work being performed and for the roof design.

Workers who use fall restraint systems need to understand that just wearing the equipment and being tied off may not be enough to protect them from a fall. The equipment must be used properly (e.g., the user should always be aware of working angles from the anchor point, working height, and safe working length of the lanyard). Also, workers must use proper techniques and pay careful attention to their fall protection equipment when moving from one location to another to ensure that they do not inadvertently become vulnerable to a fall.

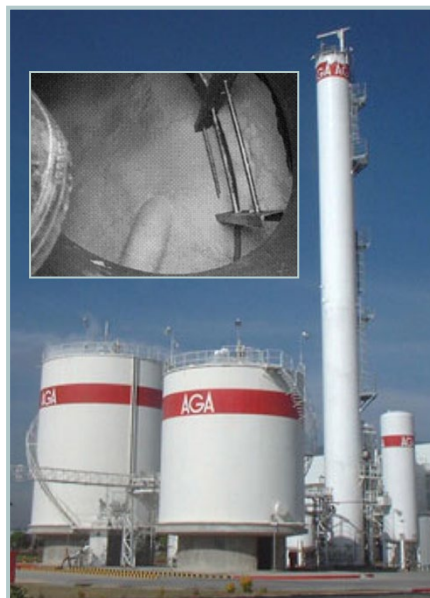
Figure 2-1. Cold box (inset) and Bogota plant where workers died of nitrogen asphyxiation

A 2007 industry confined space event in Bogota, Colombia, resulted in the death of two workers from nitrogen asphyxiation. In that event a nitrogen purge was in operation at the time a worker entered a cold box (Figure 2-1) to photograph an argon re-boiler. Investigators believe that the worker lost consciousness and a second worker apparently tried to rescue him and also died. A work permit had not been issued for the task. This event is discussed in [OE Summary 2008-01](#).
