OPERATING EXPERIENCE SUMMARY

U.S. Department of Energy
Office of Health, Safety and Security
OE Summary 2009-08
September 4, 2009

Inadequate Shift Turnover Results in Serious Burn Injuries

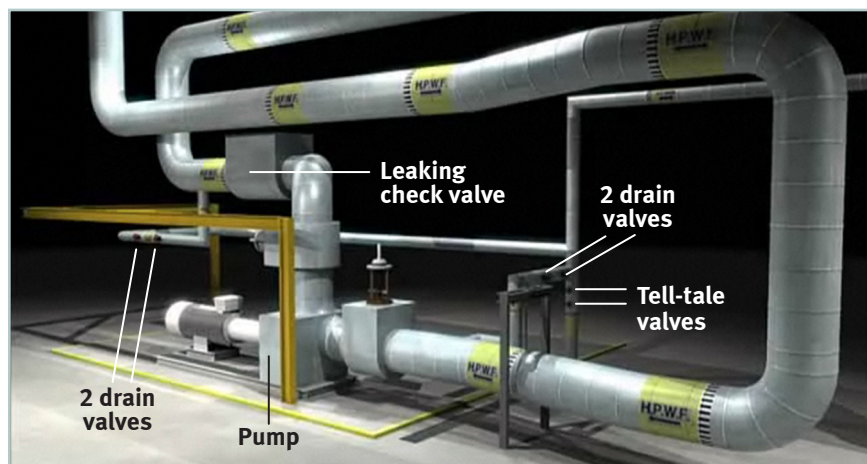
Figure 1-1. Piping arrangement
(Source: Rye House video)

On January 23, 2009, at Rye House Power Station north of London, England, two workers repairing a leaking check valve (non-return valve) on a high pressure recirculation pump for a heat recovery boiler received serious burn injuries when they were engulfed by a wave of hot condensate. Figure 1-1 shows the piping and the location of the leaking valve. The workers were performing repairs from a scaffold approximately 10 feet above the floor; the most severely burned worker was trapped against the scaffold, unable to escape. A third worker, who witnessed the accident and went to the aid of the workers, was also badly burned. A video about the event can be accessed at http://www.scottishpower.com/Ryehouse_Video/default.htm.

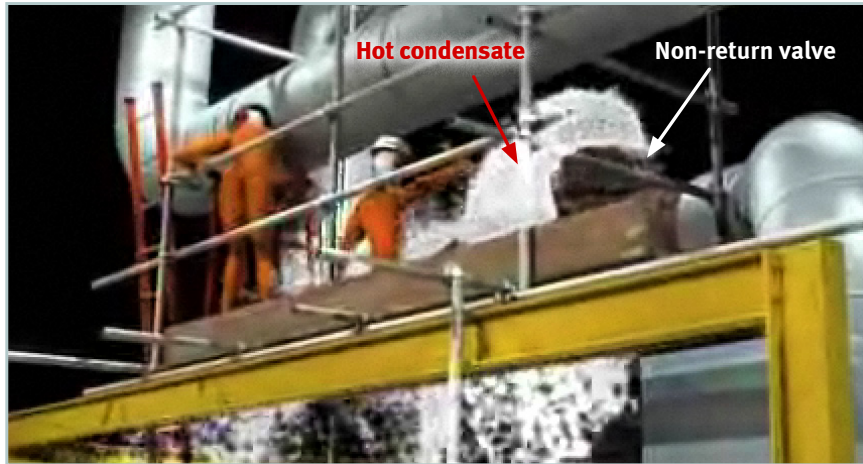
Figure 1-5. Workers engulfed in hot condensate on scaffold (animation)
(Source: Rye House video)

Later, when the day shift team leader inspected the tell-tale valves and saw no steam or water, he, too, assumed the discharge line was fully drained. He did not verify the status of the line, but he completed, signed, and issued the work permit to a maintenance team member and gave permission to start work on the non-return valve on the assumption that the upstream valves were open. The lack of verification led to the release of the hot condensate and the burn injuries (Figure 1-5).

The worker who was trapped on the scaffold received burns over 60 percent of his body; the other worker on the scaffold, who was able to climb down and away from the condensate, received burns over 26 percent of his body; and the worker who came to their rescue was burned as well.

Within hours of the accident, a Panel of Inquiry was established. The Panel quickly determined that the primary cause of the accident was the failure to drain the discharge side of the high pressure recirculating pump where the non-return valve was located. The Panel also identified the following causes.

- Lockout/tagout procedures to prevent the harmful release of energy were not followed.
- The discharge lines on the high pressure system were not completely drained.
- The drainage schedule, completed tasks, and actual status of the discharge lines were not adequately communicated between shifts.
- The blue highlights on the checklist, intended to indicate already-opened drain valves, were incorrectly used for four unopened valves. Additional handwritten notes were highlighted in pink, thus causing confusion.
- The status of the drain valves that had been opened during the night shift was assumed, not verified, by the day shift team leader.
- The hazards and system status were not verified by the day shift team leader.

Following this accident and investigation, Scottish Power launched a project to improve the quality of shift turnover and the communication of plant status, including any evolutions that might be incomplete at the time of turnover. In addition, Scottish Power produced the [video](#) to convey the seriousness of the event to employees, contractors, and industry colleagues and to emphasize clear pre-work communications in order to prevent recurrence. The video is currently used to emphasize Rye House safety rules and as refresher training.

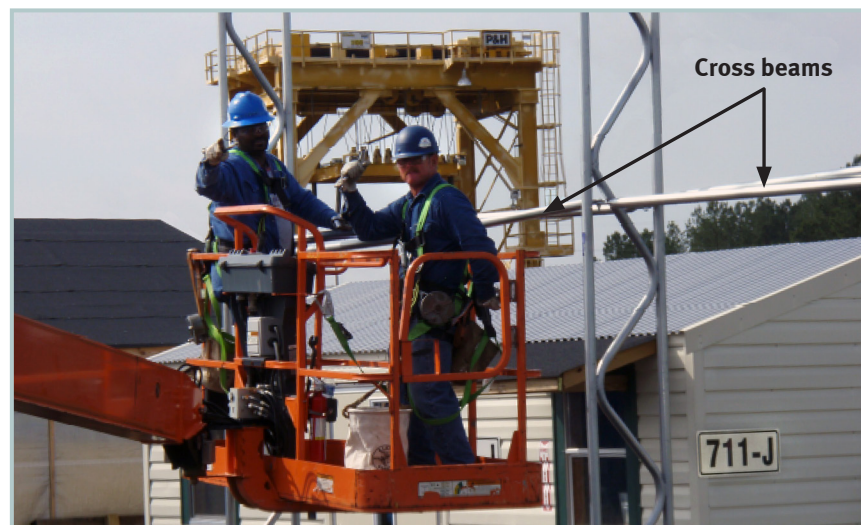
Figure 2-1. Lift basket and cross beam

The lift was moving very slowly as the operator positioned it so the worker could bolt a support. Both the worker and the operator were watching the wheels while positioning the lift, and it took the operator a few seconds to realize that the worker had been pinned. Figure 2-1 shows the lift basket and the 3-inch aluminum pipe cross beam. (Note: The figure does not show a re-enactment of the event or the workers involved in the event.)

Neither investigators nor the rental company identified any problems with the lift during post-event inspections. However, investigators determined that the operator and worker did not properly perform the safety precaution step of using the basket arm to move into position near the tent frame, rather than driving the lift. In addition, both the operator and the worker were watching the movement of the lift wheels during positioning rather than paying attention to the location of the basket and its proximity to the tent frame, and the operator did not ensure that the lift was parallel to the frame.

Investigators determined that the cause of this event was the lift operator's inattention to the direction of travel in the area of the hazard (i.e., the tent frame). In addition, the distraction of watching the wheels and a mental lapse on the part of the operator contributed to the event.

In most cases, the lift should only be driven to move it from one location to another or for gross adjustments in position. Once the lift is driven into position, positioning of the basket using hydraulics provides the safest control near the work area.
