OPERATING EXPERIENCE SUMMARY

U.S. Department of Energy
Office of Health, Safety and Security
OE Summary 2009-09
October 2, 2009

Seemingly Unimportant Changes Result in Crane Accidents

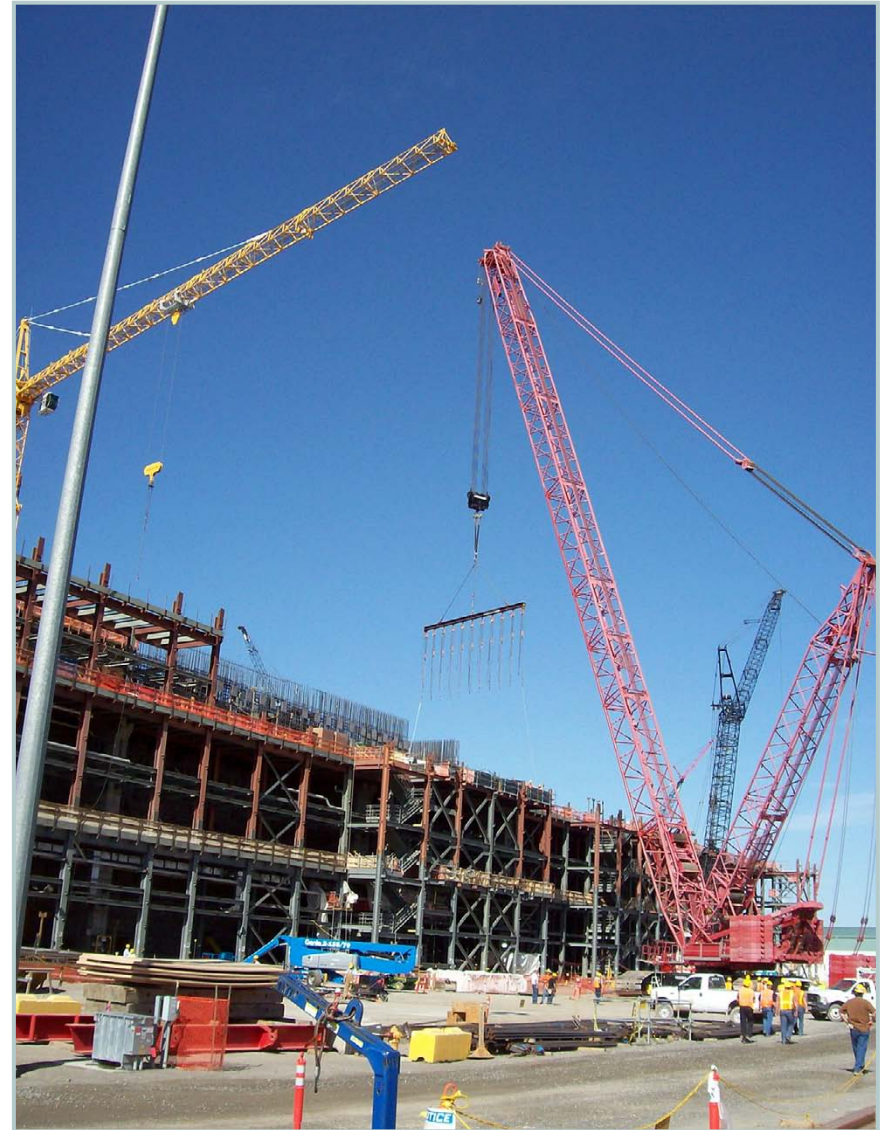
**Figure 1-1. Tower crane (left) and Demag track crane
at the Pre-Treatment Facility**

On May 18, 2009, during construction of the River Protection Pre-Treatment Facility, a tower crane operator attempting to locate and pick up a trash skip hit the pendant of a stationary Demag track crane with the boom of the crane. Although normal crane operating quadrants had been formally established and documented on a quadrant map, neither the map nor the hazards analysis was reviewed and updated when a new hazard (i.e., the track crane) was introduced to the area. After the event, both cranes were taken out of service and crane operations were paused. (ORPS Report EM-RP--BNRP-RPPWTP-2009-0011; final report issued July 2, 2009)

Both cranes were located outside the Pre-Treatment Facility, which is under construction. Figure 1-1 shows the boom of the tower crane (yellow) and the track crane (pale red). The tower crane was operating above the unfinished building, and the skip was inside the building in a location that was not obvious to the tower crane operator. Inspectors determined that neither crane sustained structural damage as a result of the accident, but both were slightly scraped and scuffed. Damage to the tower crane boom (a 21-inch scrape) is shown in Figure 1-2.

Investigators determined that event causes included the following: informal communication used to convey information; no formal established boom limits; lack of knowledge about the location of both the trash skip and the stationary track crane; and treating a new element (the track crane) as commonplace. They concluded that the task had been performed based on previous experience without considering how new or additional obstacles introduced into the work environment could impact the process.

Corrective actions included the following.

- Improve three-way communication protocol for everyone involved, particularly when one crane enters the space of another crane. The protocol will include improved methods for radio communication from someone on the lower level to the crane operator.

- Clarify current controls and develop defined quadrants and maps for situations in which the tower crane shares air space.
- Provide human performance improvement training to crane operators, coordinators, and appropriate personnel.
- Remind operators to take their time during crane operations because a “pick list” of tasks does not have to be completed each day. (Some daily “pick list” items for the tower crane were assigned to other cranes to more evenly distribute the task load.)

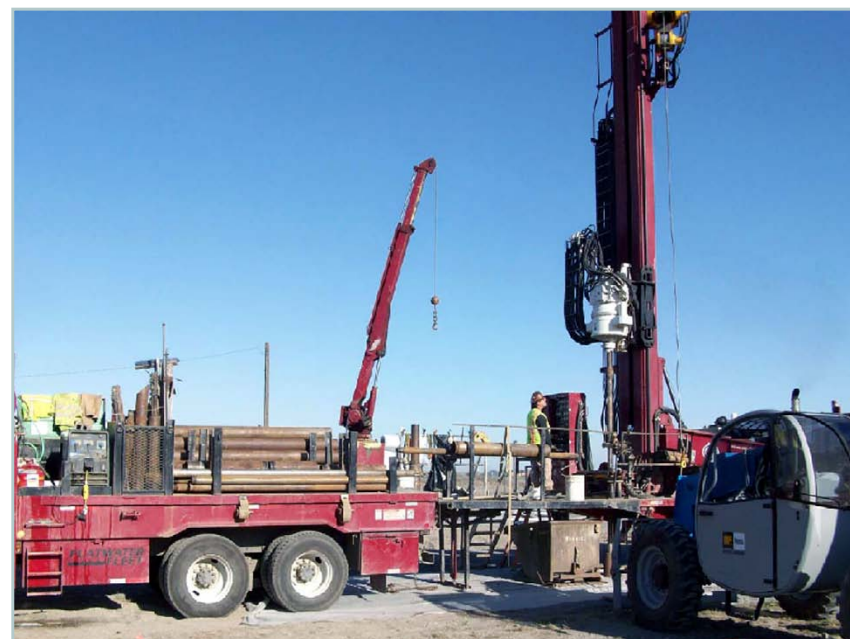
Figure 3-1. Sonic drill rig

Figure 3-1 shows a sonic drill rig similar to the one being used. The core barrel in use when this event occurred was approximately 5 feet long and open at both ends. During core drilling operations, the core barrel is forcibly driven into the ground until the hollow barrel is filled with soil, then removed from the ground to unload the soil before repeating the process. When the core barrel is struck with a hammer, the intent is for the soil to fall out the end. The soil should not be “ejected” or “extruded,” but should simply be unloaded (or dislodged) from the barrel.

Investigators determined that heat generated by friction during the drilling process resulted in pressure buildup in the core barrel, resulting in the worker’s burn. Although they were aware of the heating phenomenon, heat buildup to an extreme

Pressure buildup in the core barrel is not a widely recognized hazard, and investigators found no hard data on this type of event. However, they believe that the pressure buildup was the result of interaction among the following.

1. Dry drilling to ensure the integrity of the sample.
2. Heat buildup in the core barrel during drilling operations.
3. Moisture in the soil at between 8 and 10 feet below grade.

To alleviate this problem, the drilling contractor will limit the potential for pressure buildup by addressing heat buildup in the core barrel. Drilling runs will be limited to no more than 2½ feet to reduce heat buildup, and a thermometer will be used during drilling to ensure that the temperature is less than 175°F before the core barrel is unloaded. In addition, if the temperature exceeds 200°F, drilling will be discontinued until the temperature returns to normal operating temperature. Also, to minimize potential worker exposure to the end of the core barrel, the driller and the driller helper will stand to the side of the core barrel when unloading the core barrel and will wear the appropriate PPE for extreme temperature conditions when handling the core barrel (i.e., leather gloves).

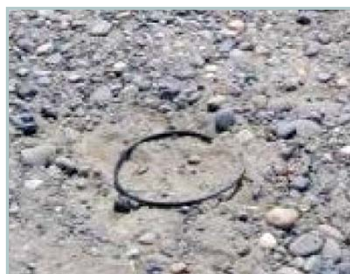
Figure 3-3. Broken dog collar

The second event took place on June 11, 2009, during extraction drilling operations at the same Hanford project, where a piece of a ½-inch thick “dog collar” broke off when it struck a metal, ground-level U-plate, flew approximately 55 feet from the drill rig, and landed on the gravel access road outside the drilling exclusion area. Work was suspended pending a fact-finding meeting. This event was also categorized as a near miss, but with no injuries. (ORPS Report EM-RL--CPRC-GPP-2009-0005; final report issued July 16, 2009)

The dog collar was used to ensure that the drill string was not dropped into the bore hole when the string was not connected to the rig. The collar, which is attached to the drill string, is wider than the external diameter of the wellbore, and holds the tool assembly to prevent it from dropping through the wellbore and being lost. Figure 3-3 shows the broken dog collar lying on the ground where it fell.

To prevent the top of the 12-inch casing from going below the top of the 16-inch casing placed earlier, workers attached the steel dog collar about 3 feet above the U-plate. The driller then tapped the casing, intending to work it down until the dog collar rested on the U-plate. When the driller tapped the casing, it rapidly dropped about 9 feet shearing a piece off the dog collar as it passed the U-plate on its way down.

In the future, when a small-diameter well casing is removed and a larger one is installed, the bore hole will be backfilled with sand to prevent voids in the bore hole.
