OPERATING EXPERIENCE SUMMARY

U.S. Department of Energy
Office of Health, Safety and Security
OE Summary 2009-11
December 1, 2009

Type A Accident Investigation— Vehicle Fatality

Chemical Safety Board Releases Report on Imperial Sugar Dust Explosion

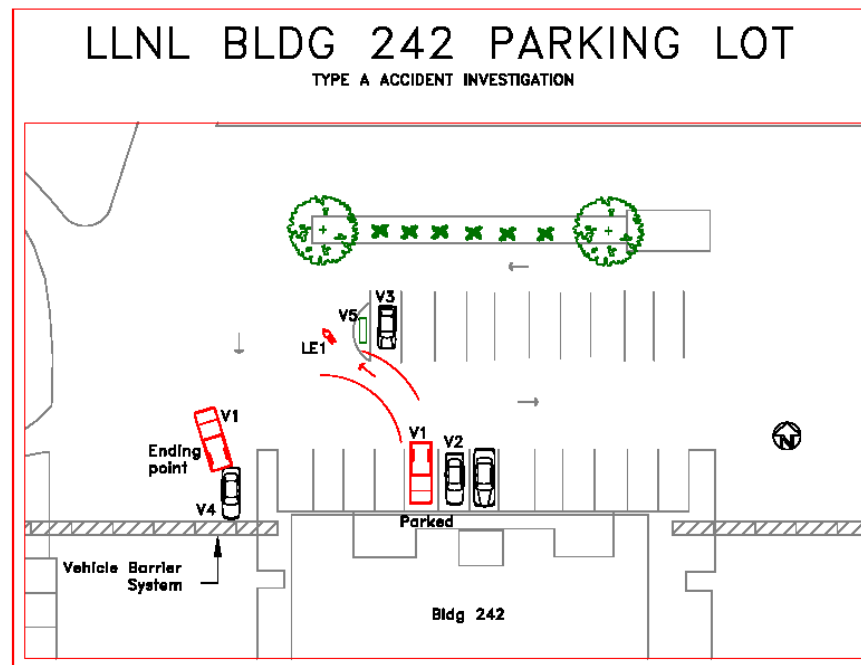
Figure 1-1. Diagram of accident scene

As he backed up with the truck door open, the door hit the front passenger side of an adjacent, parked vehicle (V2), which may have startled the LLNS employee, causing him to try to stop the truck. The Board believes that he either inadvertently depressed the gas pedal, rather than the brake pedal, or his foot slipped off the brake pedal and onto the gas pedal, resulting in the truck rapidly accelerating backwards.

As shown in Figure 1-1, the truck continued moving backwards in a counterclockwise arc and struck the left front corner of another parked vehicle (V3), which resulted in the truck door opening beyond its normal limit (Figure 1-2) and the LLNS employee being ejected. As he was flung to the pavement, the ejected employee hit a parked motorcycle (V5) and knocked it over. The truck then decelerated, but continued moving in the counterclockwise arc until it struck a third parked vehicle (V4) and stopped.

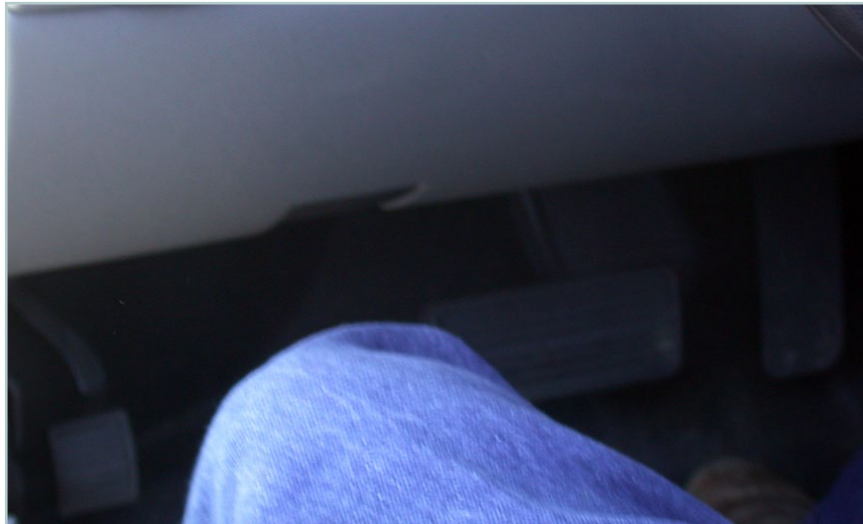
Figure 1-3a. Location of emergency brake release

The Board determined that the direct cause of the accident was the driver's ejection from the pickup truck. They also determined that the LLNS employee did not use the vehicle safety features (e.g., the seatbelt) and that this was the root cause of the accident. A contributing cause was that the employee was unfamiliar with the operation of the vehicle and probably did not know where the emergency brake was located. Figure 1-3a shows the location of the emergency brake release; Figure 1-3b shows the release with the handle extended.

- LLNS needs to improve the safe driving behavior of the site workforce.
- LLNS needs to familiarize the workforce with vehicle safety features of the fleet.

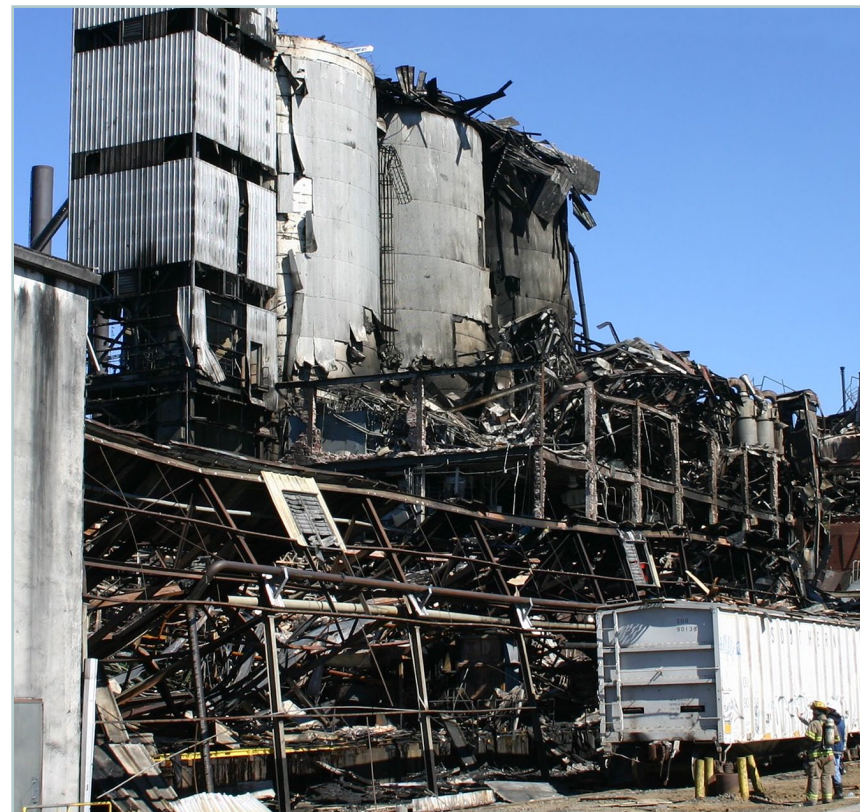
Figure 2-1. Elevator building, silos, and packing facility following explosion and fire

The CSB determined that the first dust explosion occurred in an enclosed steel belt conveyor located below the sugar silos. Secondary dust explosions propagated throughout several buildings, and sudden, violent fireballs erupted in surrounding areas. The fire sprinkler system failed because the explosions ruptured the water pipes.

The CSB also determined that when the granulated sugar belt conveyors were enclosed the hazards associated with combustible dust generation and accumulation inside the new enclosure were not evaluated and a dust removal system was not installed to ensure that the sugar dust did not reach the minimum explosible concentration inside the enclosure. Because the large open work areas were not equipped with airborne dust removal equipment, sugar dust accumulated on overhead conduit, piping, ceiling

The CSB concluded that the Port Wentworth Imperial Sugar facility incident was a combination of a primary and multiple secondary dust explosions. Secondary dust explosions would have been highly unlikely had routine maintenance and timely housekeeping activities been performed to remove accumulations from elevated horizontal surfaces and spilled granulated and powdered sugar on the floors.
