# OPERATING EXPERIENCE SUMMARY

U.S. Department of Energy  
Office of Health, Safety and Security  
OE Summary 2009-12  
December 31, 2009

## Type B Accident Investigation— Arc Flash Results in Burn Injuries

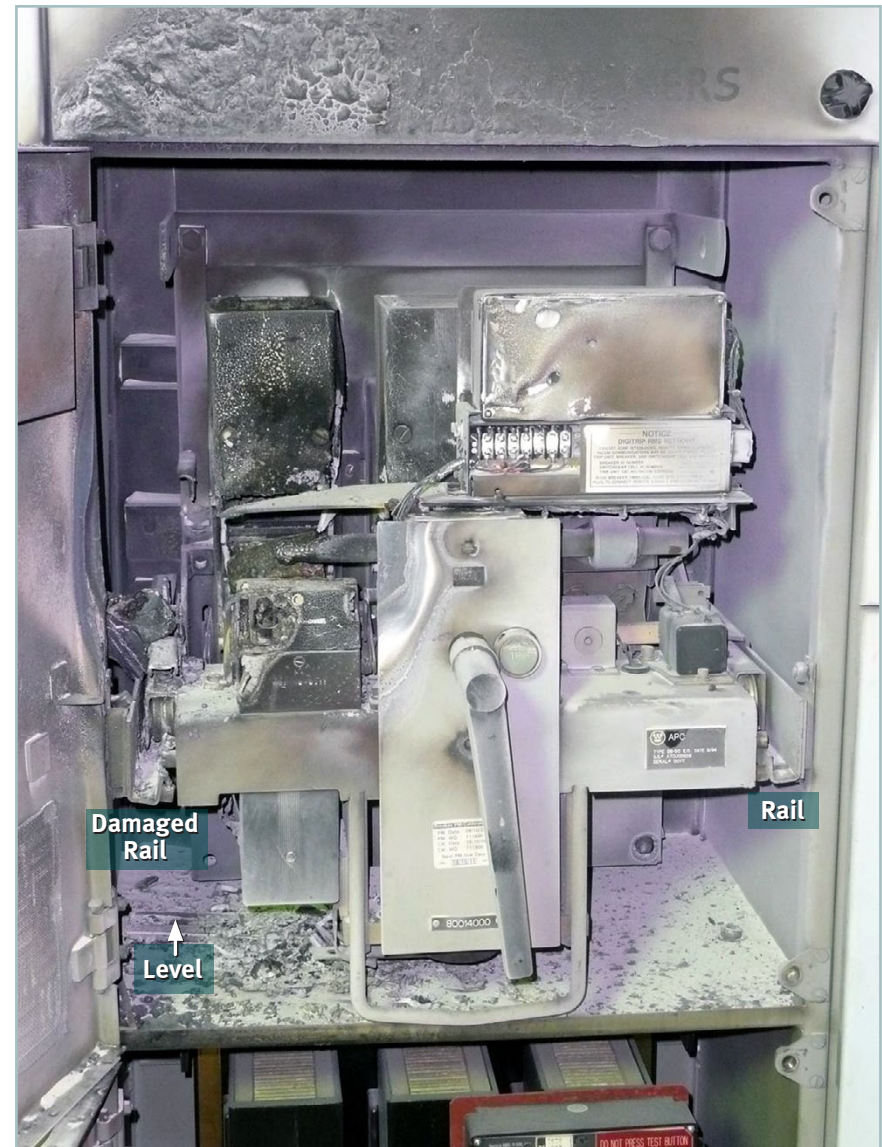
On the morning of the event, the mechanics were troubleshooting in the cubicle because the circuit breaker would not close. They concluded that the track was not level and the breaker was misaligned. That afternoon, following a pre-job briefing with their supervisor, they entered the cubicle intending to reposition the breaker. Mechanic 2 placed the level in the energized cabinet so they could determine the extent of adjustment needed and then left the cubicle. Seconds later, Mechanic 1 saw the level begin to fall, tried to stop it, and failed. The level fell and lodged between the energized “A” phase breaker contact and a breaker support brace, resulting in a short to ground and the arc flash. Figure 1-1 shows the breaker, level, and damage to a rail following the arc flash.

Figure 1-1. Damaged circuit breaker and position of level post-event

The Board concluded that although the direct cause of this event was the non-insulated level falling into the circuit breaker, the root cause of the event was that experienced workers did not comply with required and expected safe electrical work practices. Among the contributing causes of this event were work control processes that failed to prevent work activities from occurring in the vicinity of energized equipment and the lack of an effective pre-job briefing.

- Develop a process to ensure adequate control of tools and equipment used on or near energized electrical components.
- Ensure that work documents contain specific activities that are defined in sufficient detail to permit proper identification of hazards and implementation of hazard controls.

- Ensure that work is reviewed, authorized, supervised, and performed by personnel who clearly understand the work scope, limitations, hazards, and controls before work begins.
- Ensure that effective pre-job briefings are performed that include discussing the specific work scope, limitations, associated hazards, and controls necessary to perform work safely.

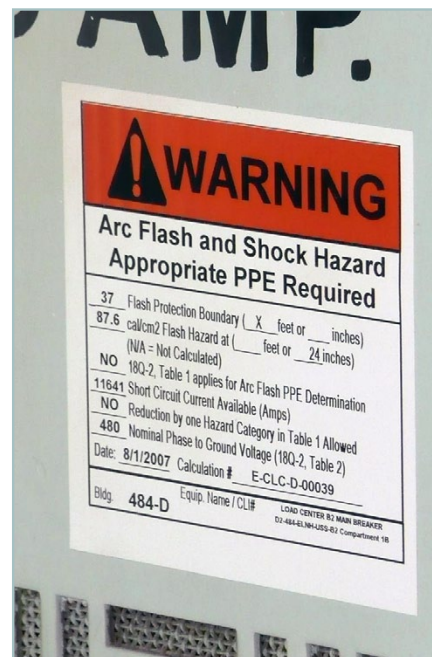
package before work was performed because of the potential for arc flash; however, review board approval was not obtained. Arc flash calculations for the breaker had been completed and labels had been clearly affixed to the front of the cabinet door (Figure 1-2) in accordance with NFPA 70E, *Standard for Electrical Safety in the Workplace*. The potential for an arc flash indicated the need for arc flash-rated clothing, and the workers would have

been required to wear appropriate PPE had the review board been involved in the work planning.

Figure 1-2. Arc flash warning label
