# OPERATING EXPERIENCE SUMMARY

U.S. Department of Energy  
Office of Health, Safety and Security  
OE Summary 2010-01  
February 24, 2010

## Russian Hydroelectric Plant Accident: Lessons to Be Learned

## Incorrect Jumper Cable Connection on Battery Causes Arc Flash and Electrical Burn

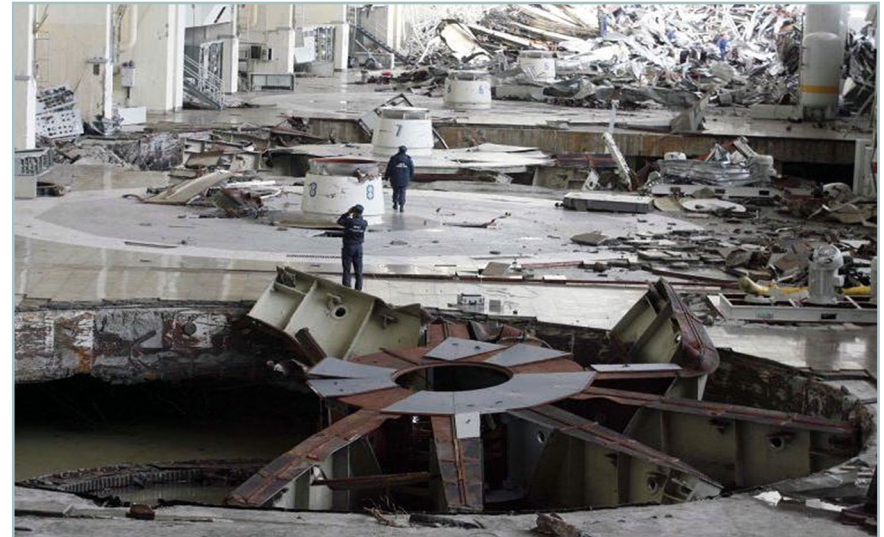
On August 17, 2009, at the Sayano-Shushenskaya Hydroelectric Plant in Khakassia, Russia, a catastrophic “pressure surge” (i.e., water hammer) occurred in Turbine 2 (one of 10 turbines), ejecting the turbine and all its equipment (approximately 900 tons of material); flooding the engine and turbine room; severely damaging four other turbines; and causing a transformer explosion. Figure 1-1 shows some of the destruction to the turbines. The entire plant output (6,400 megawatts) was lost, leading to a widespread power failure in the area. There were 74 fatalities as a result of the accident and one person was listed as missing, but presumed dead. The accident also resulted in an oil spill that released at least 40 tons of transformer oil into the Yenisei River, killing approximately 400 tons of cultivated trout in two riverside fisheries.

**Figure 1-1. Turbine hall destruction**

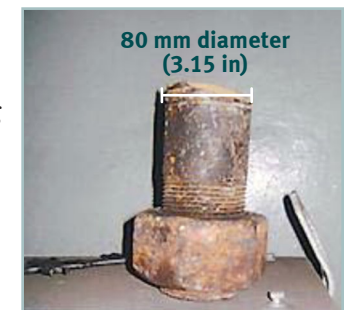
When the accident occurred, turbine vibrations were more than five times the specified vibration limit. This high vibration accelerated bolt fatigue, and the functional capacity of the bolts was lost. Nuts on at least 6 of the bolts that held the turbine cover in place were missing and, of 49 bolts that investigators evaluated, 41 had fatigue cracking, with 9 bolts showing fatigue damage that exceeded 90 percent of the total area. Figure 1-2 shows one of the degraded bolts recovered after the accident.

**Figure 1-2. Degraded bolt found post-accident**

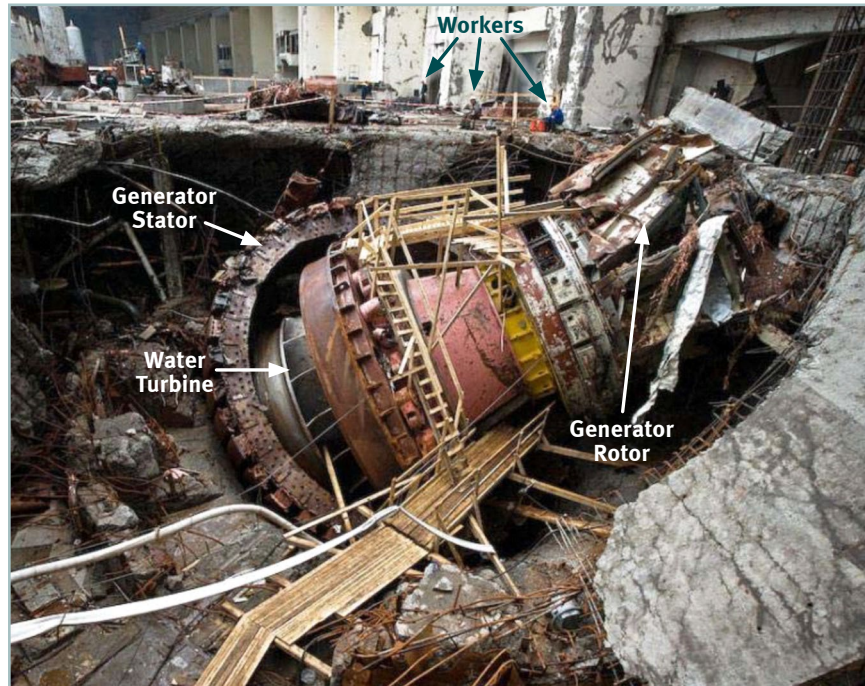
Investigators concluded that a combination of water pressure, which created an enormous uplifting force, and the deficient bolts resulted in the turbine, along with its cover and generator rotor, moving upward, destroying the machinery. Figure 1-3 shows the damaged turbine generator. At the same time, pressurized water flooded the turbine room and continued damaging other areas of the plant, including additional turbines. The flood of water severely damaged the main concrete structure of the powerhouse, which included partial collapse of the roof and walls.

**Figure 1-3. Damaged turbine generator**  
(workers identified for perspective only)

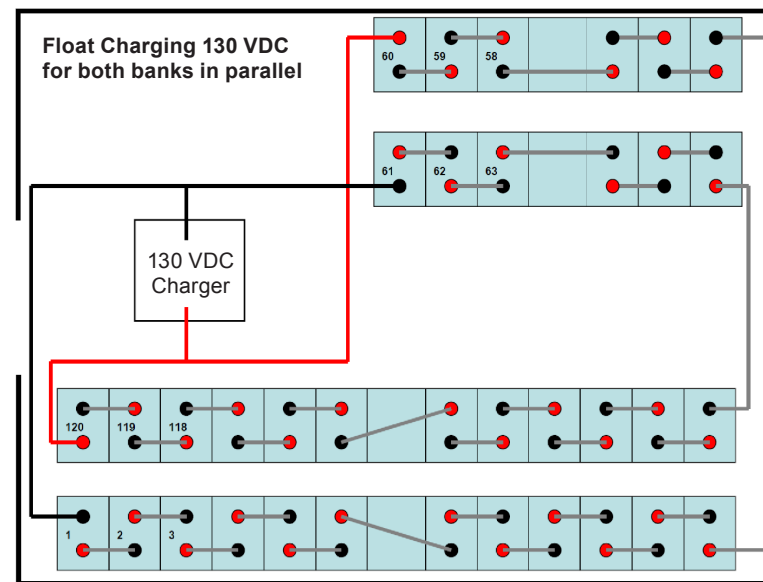
A work order had been issued to change a 120-cell, 250-volt DC, battery bank into two parallel 60-cell, 120-volt banks, so that a 130-volt charger could be used to charge the batteries. Two electricians were assigned to connect jumper cables to parallel the two, 60-cell battery banks. Figure 2-1a is a diagram showing the correct connections; Figure 2-1b shows how the electricians believed the connections were to be made.

Figure 2-1a. Correct connections

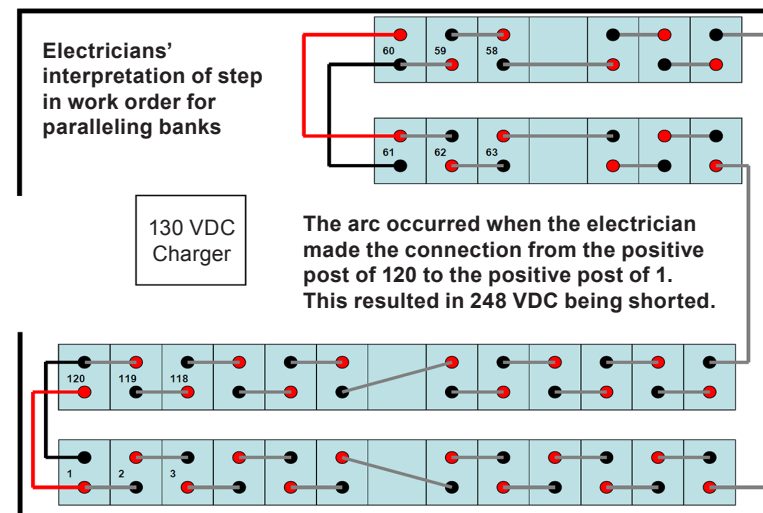
Electrician 1 was going to connect positive to positive and negative to negative on battery cells 1 and 120, while the second electrician (Electrician 2) made the same connections on cells 60 and 61. Although they planned to do the connections simultaneously, Electrician 1 had only connected his cable to the positive terminal of cell 120 when Electrician 2 completed putting his jumpers between cells 60 and 61. Electrician 2 had connected the positive terminal of cell 60 to the positive terminal of cell 61 and then connected the two negative terminals of these cells together (Figure 2-2). This incorrect connection electrically paralleled only cells 60 and 61, which then configured the two battery banks as one battery with 118 cells in series.

Figure 2-1b. Electricians' interpretation of correct connections

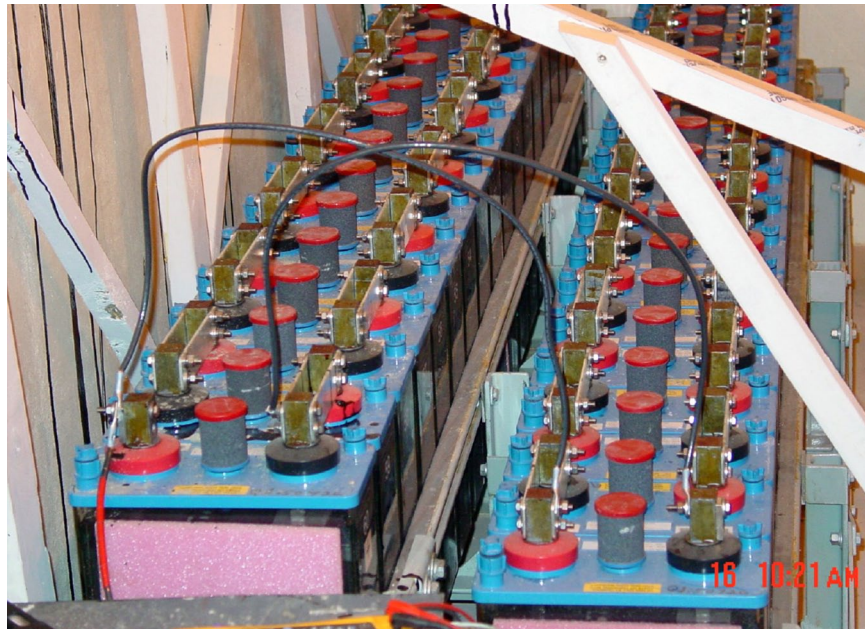
**Figure 2-2. Incorrect connection of cells 60 and 61**

Investigators determined that because Electrician 2 had incorrectly connected the two cells in parallel, Electrician 1 short-circuited the battery banks when he connected the jumper cable. Investigators concluded that, in addition to the lack of experience, work planning and control issues contributed to this event.

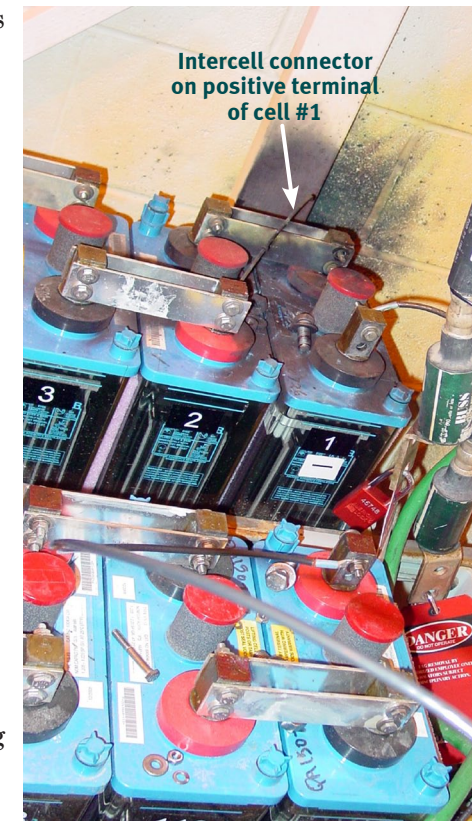
When Electrician 1 attempted to connect by hand his jumper cable, which was already connected to the positive terminal of cell 120, to the positive terminal on cell 1, the resulting arc flash burned his hands and damaged the battery cell. Figure 2-3 shows the connection made by Electrician 1 and the results of the arc flash.

the hazard. The electricians also connected the jumpers to the wrong terminals, those terminals with intercell connectors attached, as shown in Figure 2-3. Instead, they should have connected the jumpers to the load terminals on the batteries, which do not have intercell connectors.

**Figure 2-3. Connection of cells 1 and 120 and aftermath of arc flash**

Corrective actions for this event included (1) evaluating the engineering, work control, and conduct of operations interfaces for temporary modifications to clarify management expectations and (2) developing specific training focused on battery disconnection/connection. In addition, the need to include specific directions or wiring diagrams in work orders will be discussed with job planners, and electricians will be reminded about the need to wear appropriate electrical PPE.
