OPERATING EXPERIENCE SUMMARY

U.S. Department of Energy
Office of Health, Safety and Security
OE Summary 2010-05
September 1, 2010

Fatal Accident at White Bluffs Substation — The Investigation Results

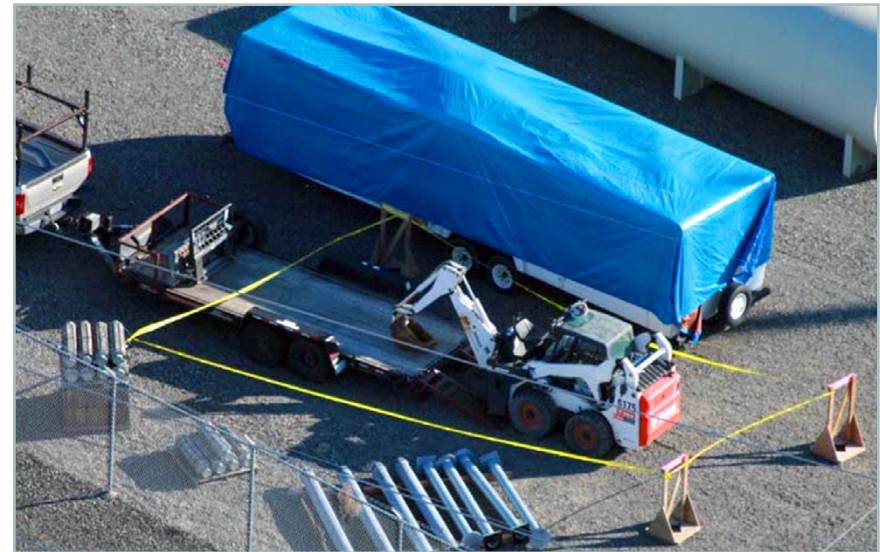
Figure 1-1. The accident scene surrounded by yellow tape

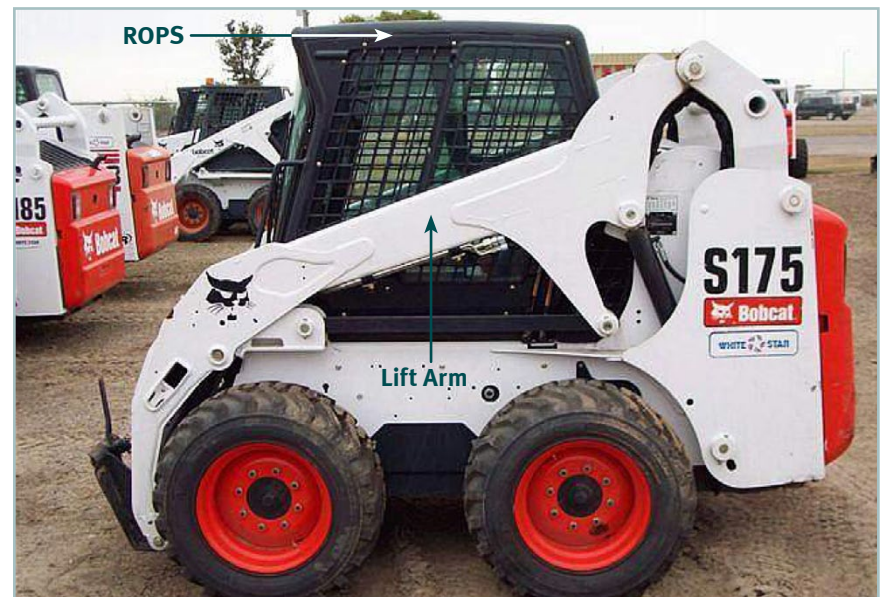
The accident occurred when the operator moved into a position between the Rollover Protection Structure (ROPS) cage and the backhoe attachment, lowered the seat bar, bypassing the Bobcat Interlock Control System (BICS™), and engaged the hydraulic systems. This caused the Bobcat lift arms to raise the backhoe attachment, pinning the operator between the seat and the ROPS. Figure 1-2 shows the ROPS and lift arm; Figure 1-3 shows the pinch point.

Figure 1-2. ROPS and lift arm

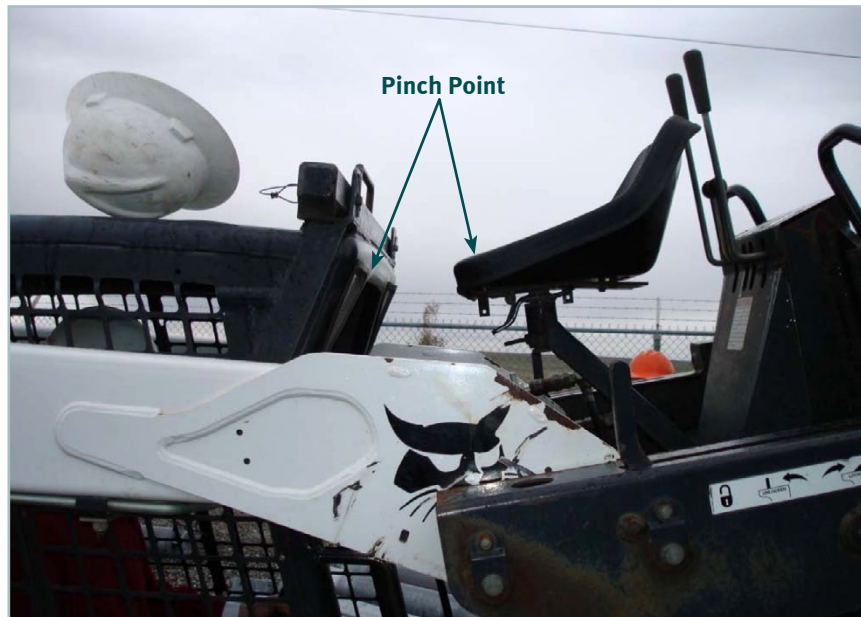
Figure 1-3. Pinch point

The Accident Investigation Board determined that the second time the operator entered the Bobcat he either remained standing, put the seat bar down, and activated the BICS™ system or he put the seat bar down, sat on the bar, and activated the BICS™. They also determined that he reached for the backhoe attachment seat to either pull himself up from a seated position or held onto it for support. In either case, the operator apparently depressed the left foot hydraulic pedal, which raised the Bobcat lift arms, pinning him between the backhoe attachment seat and the ROPS of the Bobcat. The Board concluded that the direct cause of this accident was that the operator activated the hydraulic controls while standing in the pinch point.

- Require contract personnel to follow instructions in the operation and maintenance manuals of mobile fleet equipment.
- Ensure that all members of a crew assigned to perform work receive an adequate job briefing.

- Develop and implement skid-steer training requirements, and require all BPA employees who operate mobile fleet equipment to receive proper training in the safe use of this equipment.

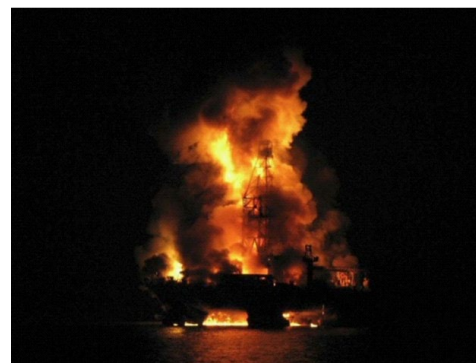
On April 20, 2010, an explosion and fire erupted on an offshore drilling rig called the Deepwater Horizon, located in the Gulf of Mexico (Figure 2-1), where an exploratory well had just been completed 52 miles from shore in 4,992 feet of water. Eleven crew members were killed in the explosion; the remaining crew members abandoned the rig and were rescued by a nearby supply vessel. The fire destroyed the rig (Figure 2-2), which sank on April 22, 2010.

A failed blowout preventer (BOP) on the Deepwater Horizon drilling platform appeared to be the primary cause of the spill, which is one of the worst disasters in the history of oil production.

Figure 2-2. Deepwater Horizon just after explosion

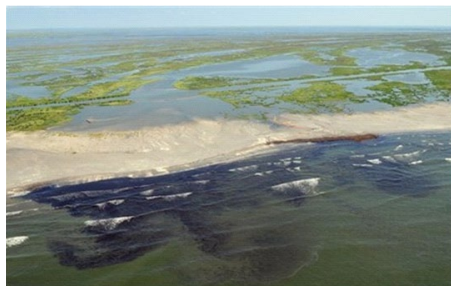
For nearly 3 months, crude oil continued to flow from a broken pipe on the sea floor, spreading across thousands of square miles and damaging local economies, sensitive coastlines, and marine and wildlife throughout the Gulf region. Figure 2-3 shows the oil spreading along the Louisiana coastline, and Figure 2-4 shows one of the many pelicans in the region that are covered in oil as a result of the spill.

Figure 2-3. Oil from spill along the coastline of Louisiana

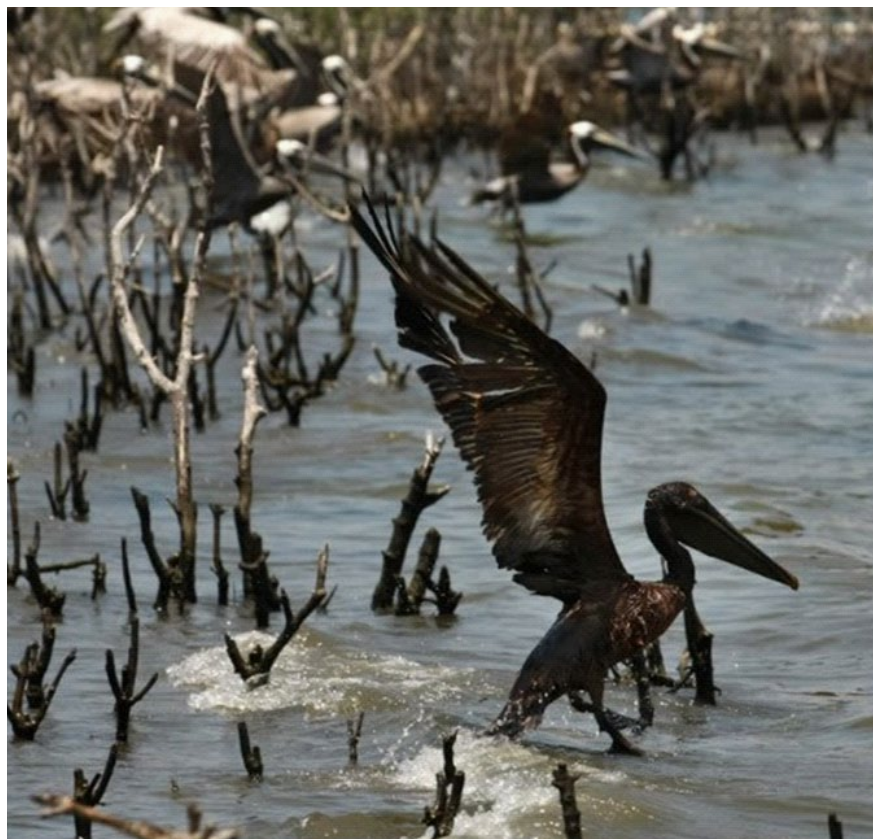
Figure 2-4. Brown pelican covered in oil from the spill
