OPERATING EXPERIENCE SUMMARY

U.S. Department of Energy
Office of Health, Safety and Security
OE Summary 2011-01
February 2, 2011

Type B Accident Investigation: Technician Punctures Hand During TRU Waste Remediation Activities

No Way Out—Five Workers Die in Confined-Space Tunnel Fire

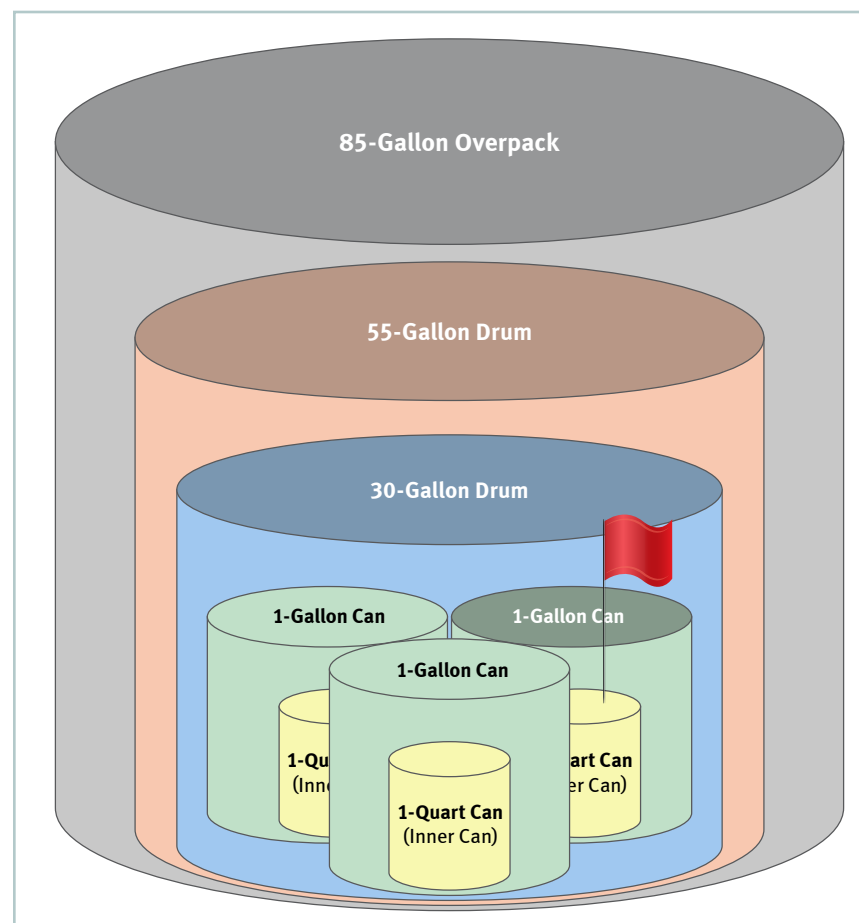
A 55-gallon drum being remediated contained five, 1-gallon waste cans, each of which had a 1-quart waste can in its interior (Figure 1-1). To segregate prohibited items and liquids from transuranic waste items, technicians first punctured the cans and then placed a wire survey flag into the can so that subsequent radiography could verify that it was punctured and not pressurized. The technician had bent the wire survey flag into a “U” shape, with the unprotected end of the flag pointing upward. When he attempted to insert the flag into the can, the wire tip penetrated his personal protective equipment (PPE),

Figure 1-1. Typical container configuration showing wire flag inserted to indicate that the can has been vented (not drawn to scale)

The technicians were informally trained (via demonstration) to hold the survey flag at the midpoint with their hands, insert the flag downward into the can, and bend it over at the top of the can. However, in practice, the technicians used at least five alternative methods to install the flags, modifying them with no understanding of the potential hazards they were creating. The Board determined that the alternate technique developed by the technician involved in the accident resulted in the sharp,

cut end pointing upwards so that it was pointing towards his fingers. When he applied force to insert the flag into the can, the sharp end punctured his finger.

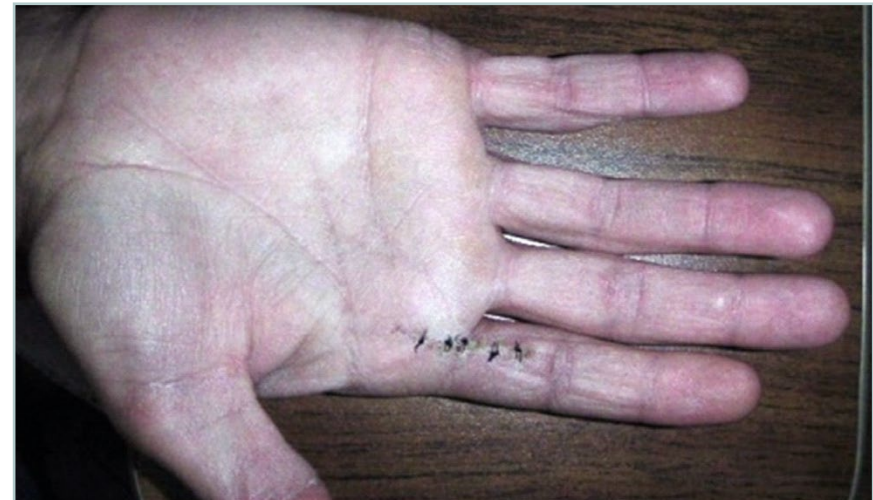
The Board determined that the puncture wound injected approximately 40 nanocuries of transuranics (i.e., Pu-238 and americium-241) into the technician’s hand and that Pu-238 was the main radionuclide of concern. The technician began receiv-

ing chelation therapy (see textbox) and tissue excisions shortly after the injury to try to remove the transuranics from his body. Figure 1-2 shows the technician's hand following three excisions. The estimated dose range the technician received from the intake was between 5 rem and 50 rem committed effective dose (CED) to the whole body and between 166 and 1,657 rem committed equivalent dose to the bone surface.

Figure 1-2. Technician's hand after excisions

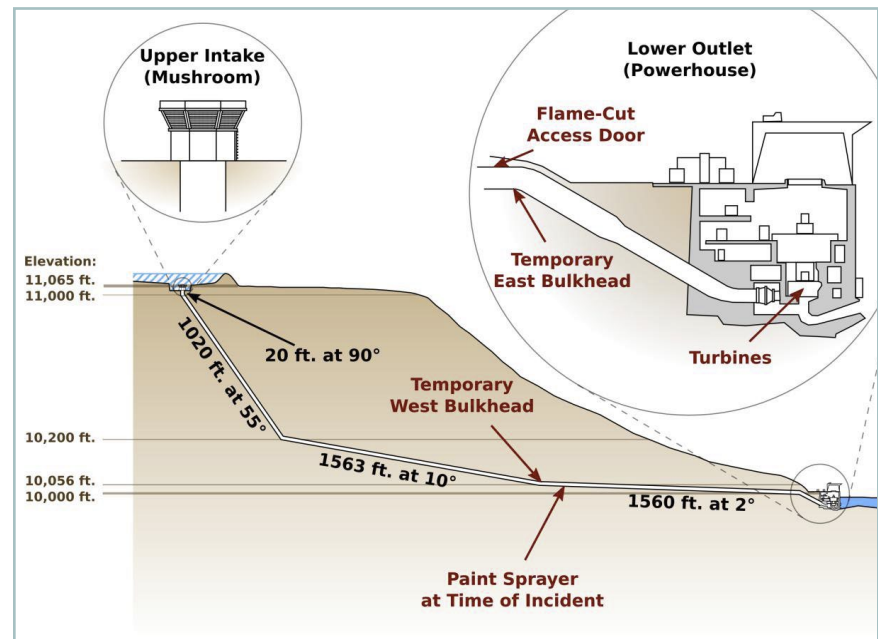
Figure 2-2. Overall penstock configuration (upper right inset shows location of flame-cut access door—the only traversable escape route in the penstock)

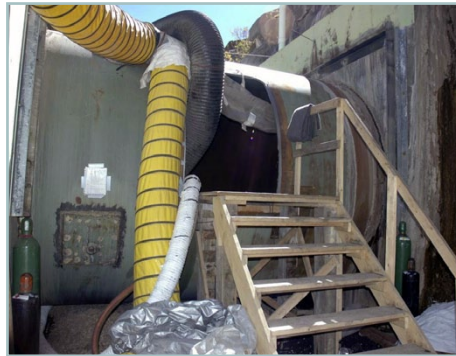
Figure 2-3. Access door cut into penstock for recoating work

Weeks prior to commencing work, Xcel's consulting engineer had identified the need for a second entrance, which resulted in the 4-foot by 6-foot, flame-cut access door being built into the

side of the penstock (Figure 2-3), near the base of the horizontal section, and 1,450 feet from where the work was being conducted. According to the CSB, this new entry apparently mitigated the concern raised by Xcel's consulting engineer about there being only a single point of escape for workers, since the only other possible escape route was an existing 24-inch manhole at the top of the penstock's mushroom access hatch, a 2,300-foot climb to the top at a 55-degree angle. On the day of the incident, there was no climbing equipment available to facilitate an escape through the manhole entry point, so, given the narrow configuration of the tunnel and the burn radius of the fire, the workers who were trapped from reaching the newly cut entry door had no other way out.

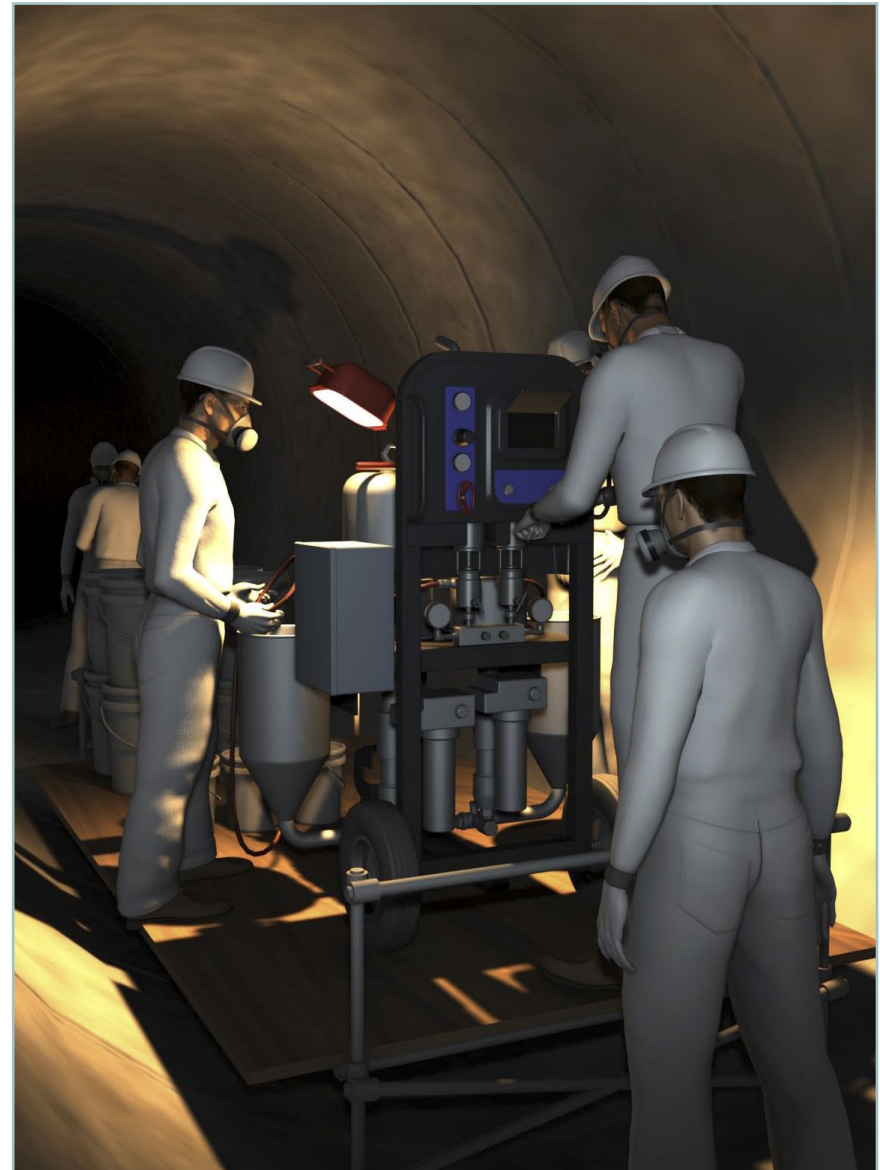
On the day of the accident, workers had finished sand blasting the old epoxy from the tunnel walls and floor and shifted to applying new epoxy in the afternoon. After moving 95 buckets of epoxy and cleaning solvent methyl ethyl ketone (MEK, see textbox) into the confined space, the RPI painters began applying the epoxy with wands connected to the spraying equipment (Figure 2-4), but quickly found that the epoxy was not adhering evenly.

Because they believed the epoxy applicator lines were clogged, the painters repeatedly flushed the epoxy sprayer system with the MEK, as is customary in epoxy application; what is not customary is that this process took place in a confined space.

Figure 2-4. Depiction of contractors working with the sprayer immediately prior to the flash fire

Though several possible ignition sources were examined, according to the CSB's final accident investigation report, it was concluded "that the fire inside the penstock was most likely ignited by a static spark that originated from the electrically isolated (ungrounded) metal swivel connector, attached to one end of the non-conductive hose hand held inside the base hopper of the sprayer as MEK was being flushed through." The CSB calculated that the MEK concentration in the vapor surrounding the connector was well within flammable limits, leading the board to finally conclude that "MEK circulation flow through the sprayer was likely capable of developing a charging current, accumulating stored energy on the electrically isolated metal swivel connector and producing incendiary sparks of sufficient magnitude to ignite the flammable MEK vapor."

Another hazard control that should have been implemented was cleaning epoxy application equipment *outside* of the confined space. The epoxy application equipment used by contractors at the Cabin Creek site was repeatedly flushed *inside* the confined space, some 1,400 feet from the single usable point of escape.
