# OPERATING EXPERIENCE SUMMARY

OE Summary 2011-06

October 14, 2011

## Heat Exchanger Rupture at Goodyear Plant Results in Injuries and a Fatality

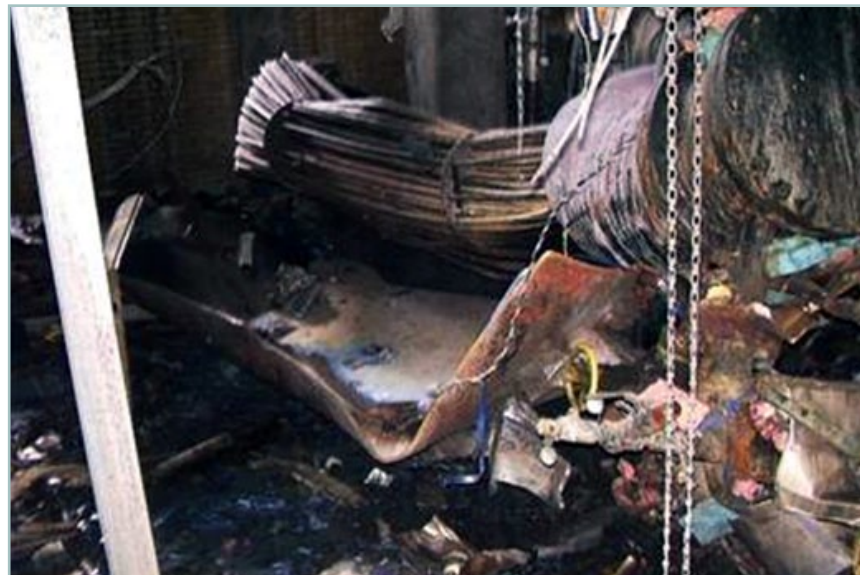
On June 11, 2008, at the Goodyear Tire and Rubber plant in Houston, Texas, a pressure vessel in a heat exchanger ruptured, hurling debris and spewing anhydrous ammonia into an active process area. As a result of the rupture, five workers suffered ammonia exposure injuries, and a sixth worker was injured as he tried to escape the area. Hours after an "all clear" was issued, a supervisor found the body of an emergency response team member, who died when she was struck by debris. Figure 1-1 shows some of the damage caused by the accident, and Figure 1-2 shows the area where the supervisor discovered the fatally injured emergency response team member.

Figure 1-1. Damage caused by the rupture

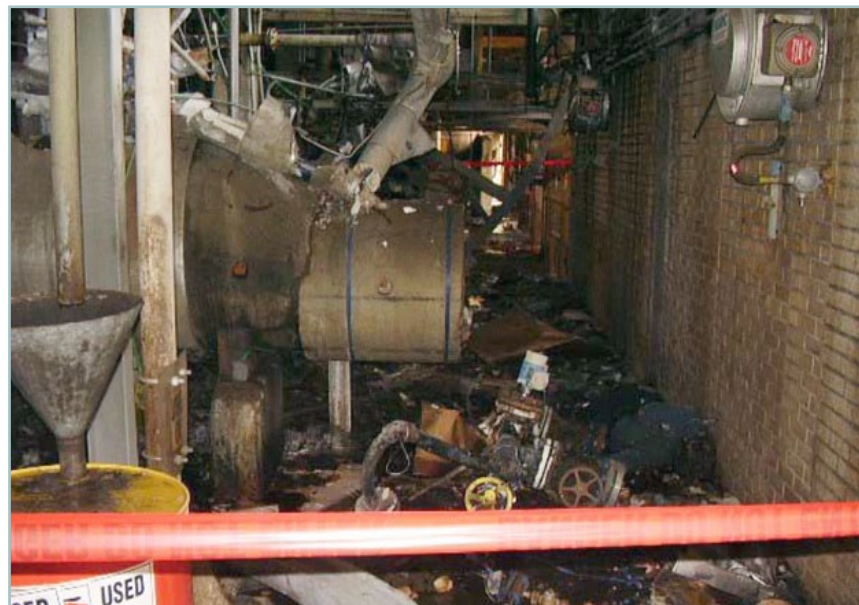
Figure 1-2. Area where the fatality was discovered

Facility procedures required supervisors to account for their employees following an evacuation using a master list generated from a computerized electronic badge-in/badge-out system. However, a system malfunction delayed production of the personnel lists. Instead, supervisors developed handwritten lists as they identified workers who congregated at the muster points or sheltered in place. As a result, plant management erroneously believed that all workers had been accounted for and had safely evacuated. They issued an “all clear,” and workers returned to all work areas except for the accident scene. Several hours after the all clear was issued, an operations supervisor, assessing the damage in the accident area, discovered the fatally injured worker, buried in debris, in a dimly lit area next to the heat exchanger.

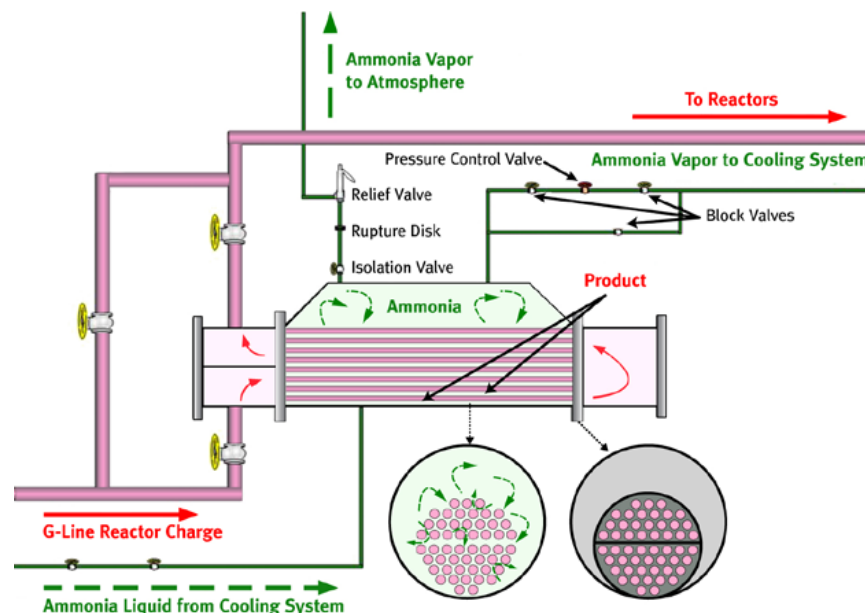
When making synthetic rubber, pressurized anhydrous ammonia is frequently used as a chemical coolant, flowing through tubes around a cylindrical steel shell where chemicals are processed. On the day before the accident, operators replacing a burst rupture disk closed an isolation valve between the heat exchanger shell and an overpressure relief valve; however, they did not re-open the valve

as the procedure specified. Figure 1-3 shows the heat exchanger configuration and the valve locations.

On the morning of June 11, a dayshift operator began steam-cleaning the process piping. He was unaware that the isolation valve was still closed because that information had not been properly communicated at shift turnover, so he closed a block valve, inadvertently isolating the ammonia side of the heat exchanger from overpressure protection. When the operator connected the steam line to the process line, steam flowing through the heat exchanger increased ammonia temperature and pressure in the isolated heat exchanger, and internal pressure increased until the heat exchanger ruptured.

Figure 1-3. Heat exchanger configuration showing the valve locations

ASME Code requires that when a pressure vessel relief device is temporarily blocked and there is a possibility of vessel pressurization above the design limit, a worker capable of releasing the pressure must continuously monitor the vessel.

This event demonstrates the importance of effective communications during shift turnover and the need to provide the follow-on shift with formal, written turnover documents that detail the status of operations. It also demonstrates the need for thorough and accurate procedures that address all aspects of the job, including emergency response.
