Pinholes in MSA Ultra Elite Respirator Masks

Site/Facility: Idaho Cleanup Project (ICP)

Pinholes Forming in MSA Ultra Elite Respirator Masks

Reference: ICP Just In Time 2009 0019 Date: 08/24/2009

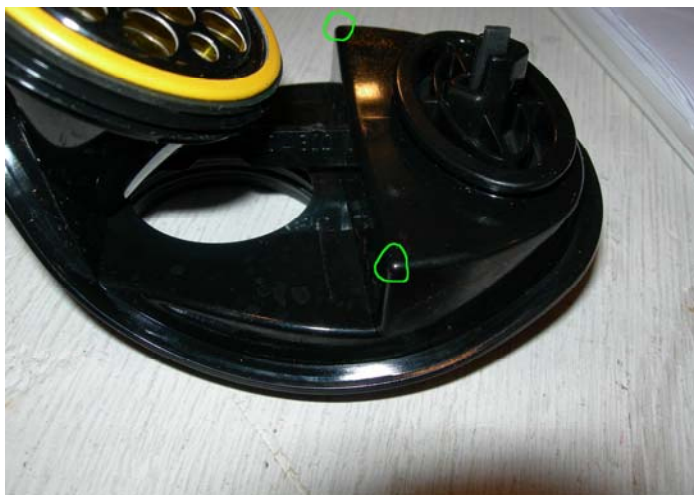
Respirator users at the Idaho Cleanup Project have noticed small pinholes in the mask of Silicone Ultra Elite Respirator Masks during their pre-use inspections. These pinholes are forming directly next to the corners of the insert that holds the speaking diaphragm and exhalation valve together (see photos below). The photo on the left shows the corners where the holes form and the photo on the right shows one of the holes, which has been stretched and exaggerated in size to be better seen in the photo. It should be noted that this problem has only been seen in the silicone masks and not the Hycar rubber masks. An investigation has been performed regarding the handling of these masks to identify any possible scenarios that could cause these pinholes. None have been identified. The manufacturer, Mine Safety Appliances (MSA), was consulted and noted that silicone masks are more susceptible to punctures, tears, and holes than their Hycar rubber masks. MSA also believes that the holes are the result of handling and not a manufacturing flaw.

Location of where pinholes have formed (green circles).

Important Point:	<ul style="list-style-type: none"> • During pre-use inspections, users of the MSA Ultra Elite face pieces, particularly those made of silicone must give particular attention to the corners of the insert that holds the speaking diaphragm and exhalation valve together.
Contributor:	<ul style="list-style-type: none"> • Believed to be a handling problem rather than a manufacturing defect.

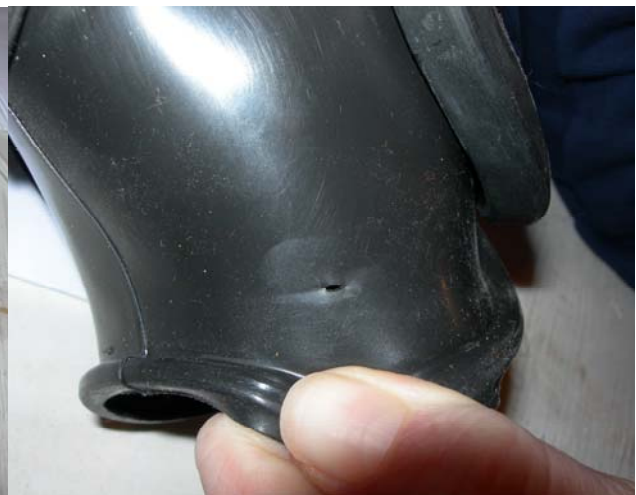
An actual pinhole in silicone mask.
