Subject: Comments Relating to “Safety During Recovery and Resumption of Operations; DNFSB Waste Isolation Pilot Plant Public Hearing, Carlsbad, New Mexico Wednesday April 29, 2015”.

An Assessment of the Flammability and Explosion Potential of Defense Transuranic Waste

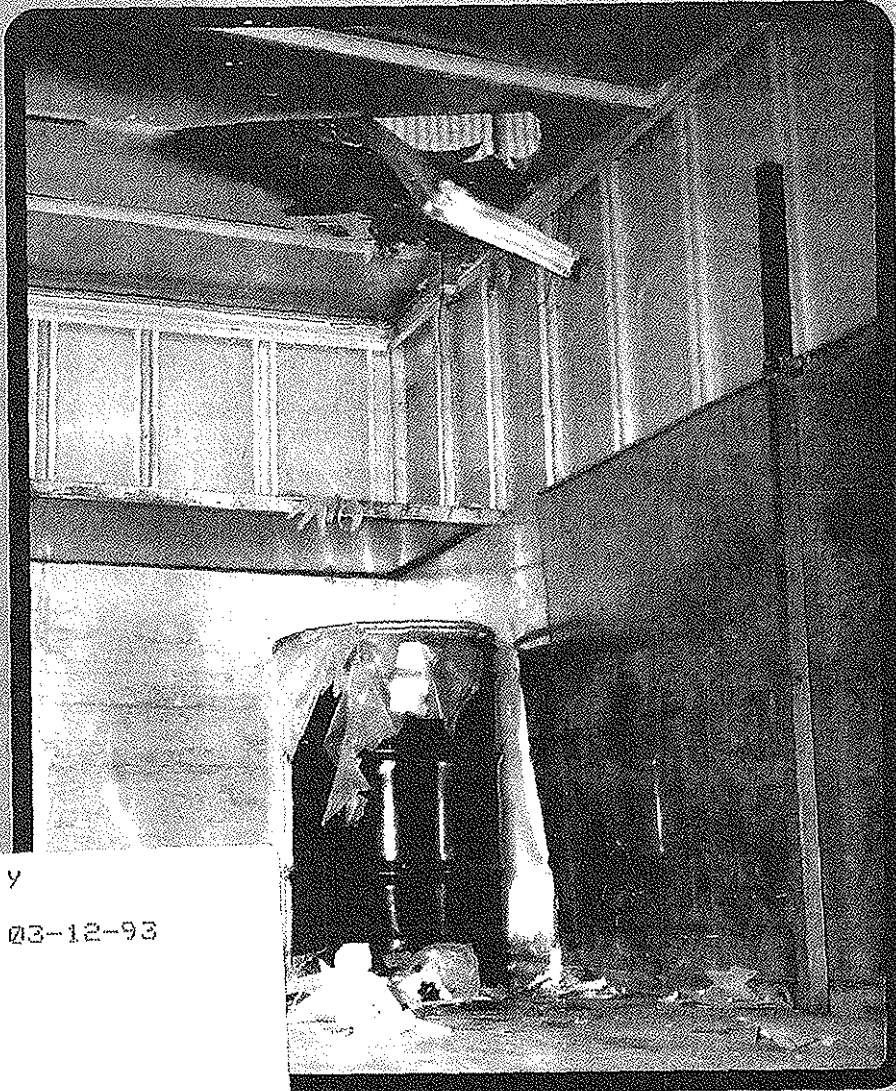
Cover: Our cover picture this month constitutes Figure 1 of the paper "An Assessment of the Flammability and Explosion Potential of Defense Transuranic Waste," by M. Silva, appearing in this issue of *Nuclear Safety*. It shows the results of an explosion in a 55-gal drum containing mixed radioactive waste on December 2, 1976, in a truck van at Argonne National Laboratory. Please refer to the paper for more details.

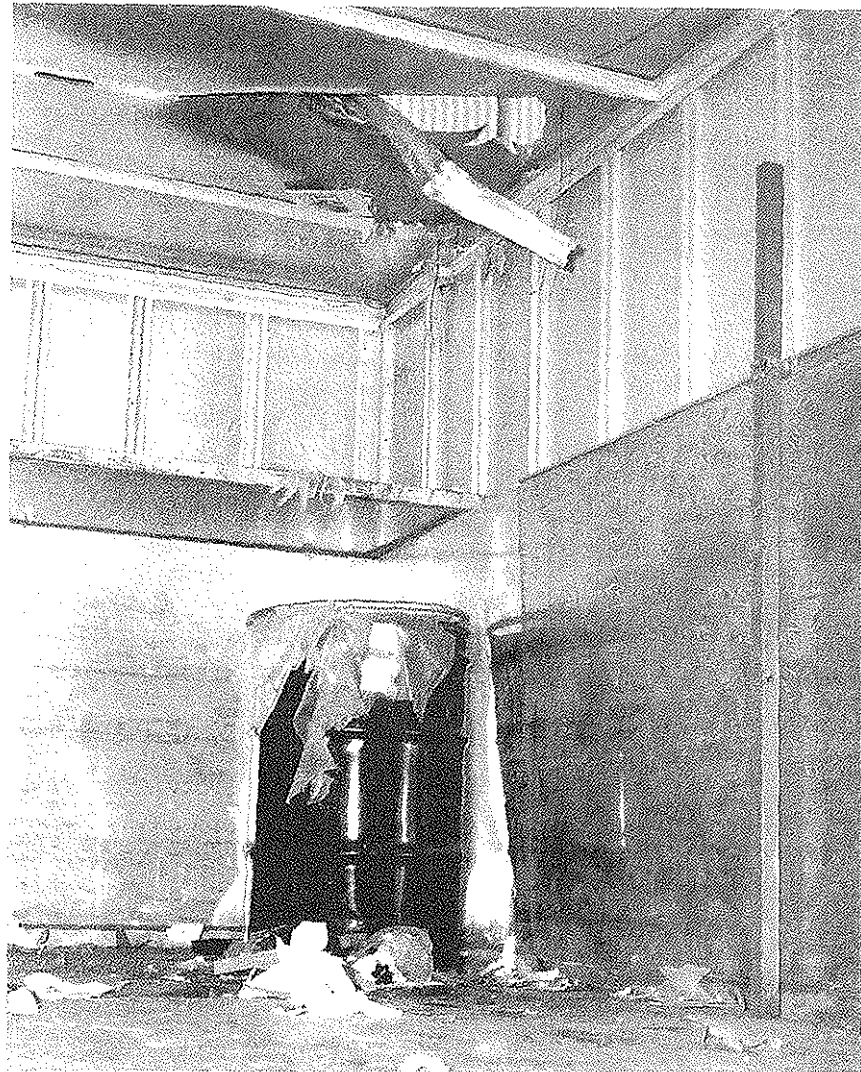
A 55-gal drum containing mixed radioactive waste exploded on Dec. 2, 1976, at ANL-E.⁸ The evidence identified two volatile organic compounds, xylene and pentane, as the most likely fuels causing the explosion. The evidence also suggested that the most likely ignition source was an electrical discharge, either static electricity from the plastic bags containing the waste or electricity gener-

Fig. 1 Damage inside a truck at Argonne National Laboratory-East caused by the explosion of a 55-gal drum containing mixed radioactive waste. Published with permission of authors and the U.S. Department of Energy.

Figure 1^a clearly shows the gaping hole in the metal roof of the van and the mangled reinforcing beam that had been part of the roof structure. Eight 55-gal drums and many fiber cartons of waste were in the truck at the time of the explosion. The explosion apparently occurred in the void space of one of the 55-gal drums and not within one of the bags. The drum lid was found on top of the truck.

The report identified several prevailing conditions that would have enhanced the accumulation of static electricity on plastic surfaces within the drum. The drum contained polyethylene and polyvinyl chloride sheeting, bags, and pouches. The hazard of having polyethylene or polyvinyl chloride in flammable atmospheres has been well established.^{7,10-12} The drum at ANL-E was loaded and sealed under the conditions of low relative humidity where charge densities persist on polyethylene surfaces.¹² The plastic packages were subjected to friction during transportation by truck between buildings.⁸ Charge generation by rubbing can lead to discharges with equivalent energies up to 1 mJ, which certainly exceeds the minimum ignition energies of flammable vapors.¹² The minimum ignition energy for methane in air is 0.29 mJ, for gasoline in air is 0.24 mJ, and for hydrogen in air is only 0.02 mJ. Hord notes that "even a weak spark due to the discharge of static electricity from a human body may be sufficient to ignite any of these fuels in air. . . ."¹³

The waste drum was moved outdoors, which lowered the temperature of the drum dramatically. A drop in temperature can cause static charges to accumulate on the plastic surfaces. Also, solvent vapor condensation and evaporation caused by temperature fluctuations can cause static charges to accumulate. The very low outdoor temperature could have generated dimensional changes in the drum or contents and thus caused the packages to shift and accumulate a static charge.⁸

The committee cited another possible electrical discharge source, a discarded ultrasonic cleaner. The circuit from that piece of equipment consisted of two piezoelectric crystals bonded to stainless steel. As suggested, cooling effects could have generated voltage and a subsequent discharge. Mueller et al.⁸ provided no further documentation nor cited references on the potential role of the discarded ultrasonic cleaner.

As noted by Mueller et al.,⁸ compliance with existing procedures would have prevented this accident. Site practices at ANL-E in 1976 included evaporation of liquids before disposal of containers. In this incident, the evaporation practice was apparently initiated and then abandoned because the material was evaporating too
